Virginia Department of Mines, Minerals & Energy
Division of Mines

Fatal Machinery Accident Investigation Report
February 21, 2014

Dominion Coal Corporation
Mine No. 30
Mine Index No. 14293AH
Linn Camp, Buchanan County, Virginia

**FATAL MACHINERY ACCIDENT
FATALITY INVESTIGATION REPORT
DOMINION COAL CORPORATION
MINE NO. 30**

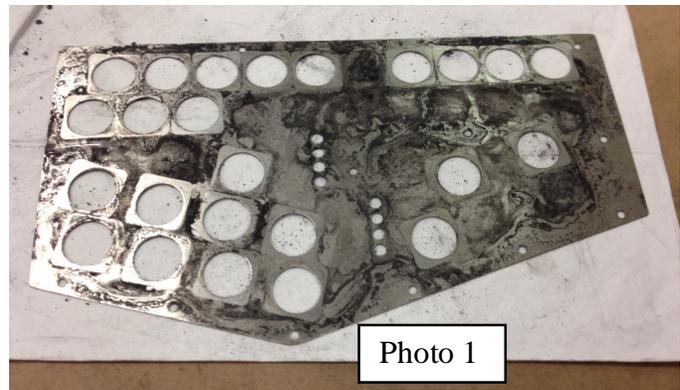
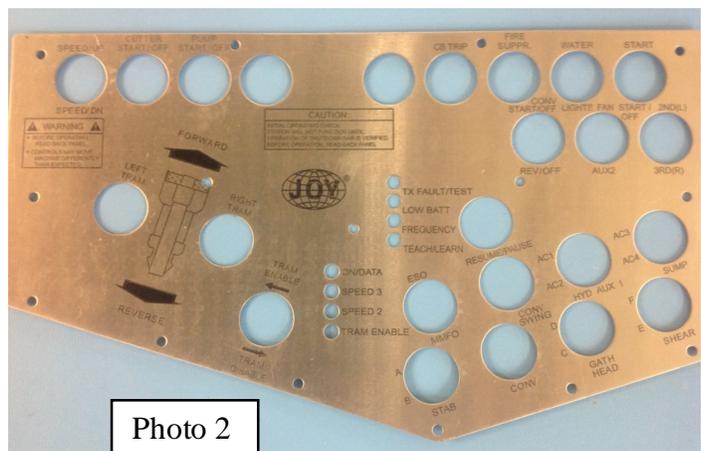
1. The front plate was removed to allow the removal of the 24 switches. (see photo 1 and photo 2)
2. All of the switches were removed from their sockets. Several of the switches had an accumulation of coal around the magnet. The previous day test revealed no deficiencies in the function of the switches. (see photo 2 and photo 3)
3. The Shear up and down had the most accumulation. (see photo 2 and photo 3)

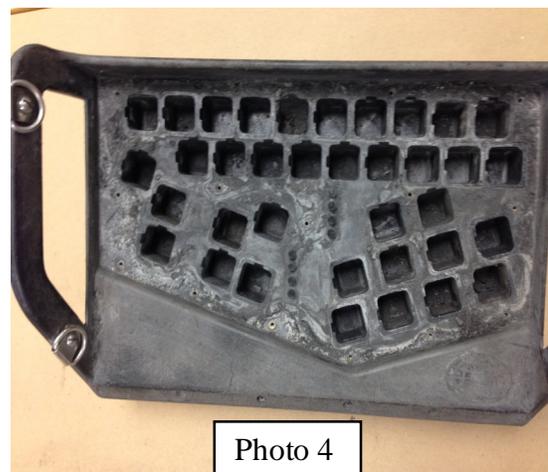
Photo 4

4. The back cover was removed and the circuit board was removed from the remote. (see photo 4)
5. Each of the electronic components was verified with the approved drawings on file at MSHA Tech Support to verify the model number, value, and size. No discrepancies were found. (see photo 5)
6. Measurements of the components were verified with the approval drawings. No discrepancies were found.
7. The circuits on the printed circuit board were verified with the approval drawings. No discrepancies were found.

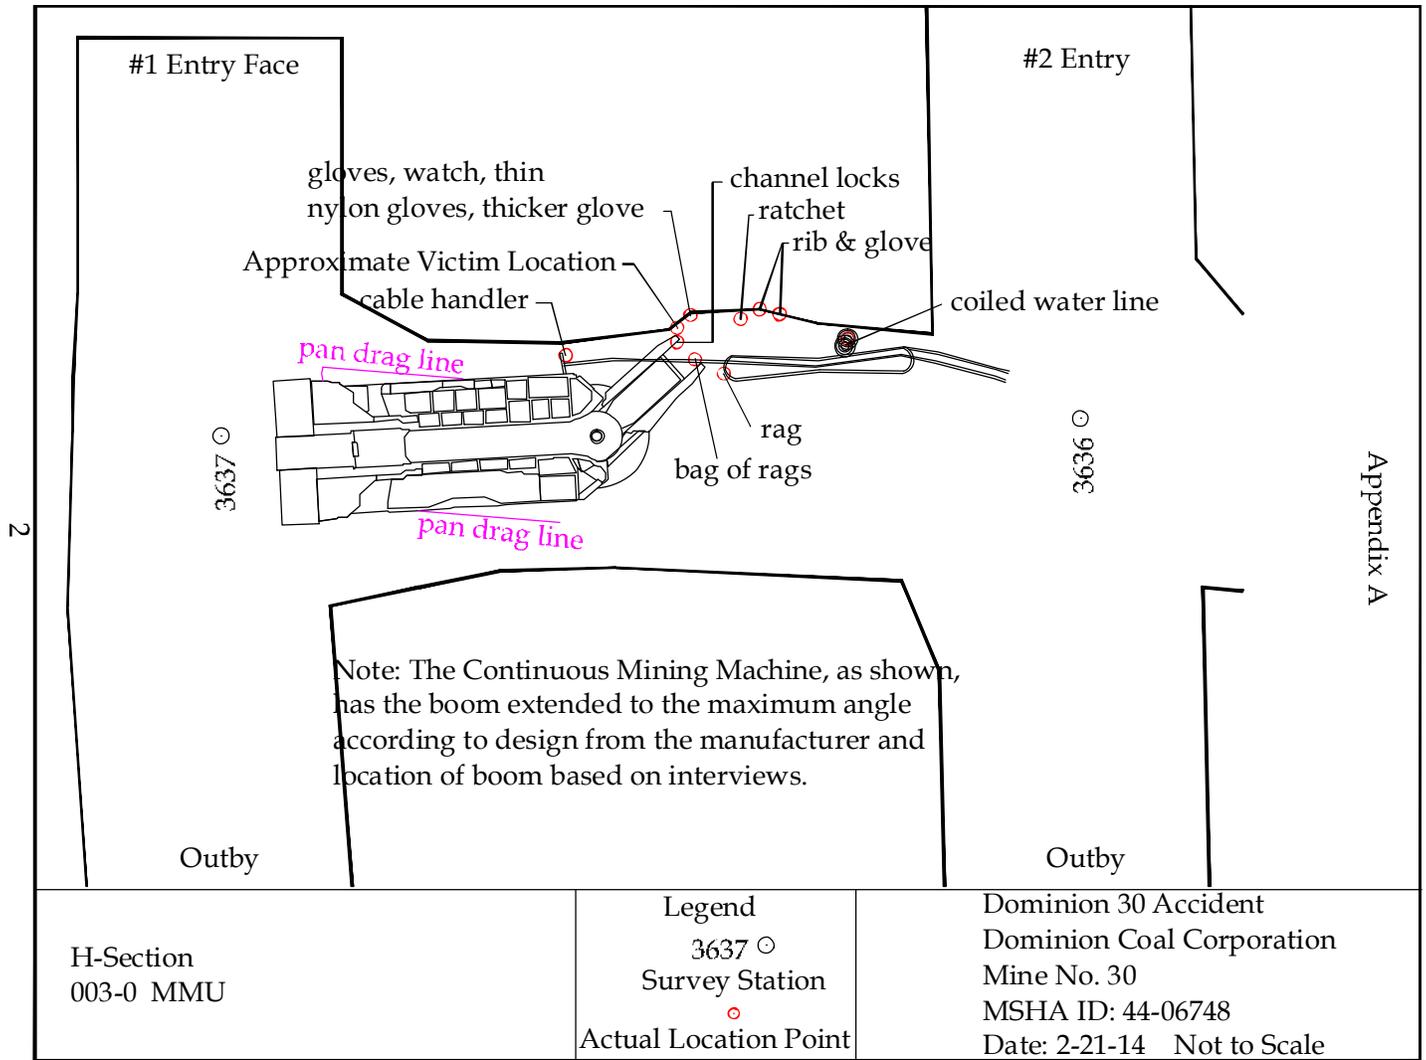
H-Section
003-0 MMU

3. Physical evidence and mine personnel statements confirmed Mr. Gelentser was caught and entrapped between the conveyor boom tail area of the continuous mining machine and the right inby coal rib in the No. 2 Entry left crosscut which was the connecting crosscut developed between the No. 1 Entry and No. 2 Entry. There was an area on the right inby rib where the rock dust on the coal appeared to have been scuffed off indicating Mr. Gelentser's location at the time of the accident.

4. Mr. Gelentser was discovered in the No. 2 Entry left crosscut with his body position kneeling down or crouched down on his feet with his back against the right inby coal rib. The conveyor boom had his left knee pushed against his chest area and the remote control station was positioned between his knees. The conveyor boom had a section of the remote control station caught requiring it to be forced free. His right knee was on the mine floor free from contact with the boom.
