Virginia Department of Mines, Minerals & Energy
Division of Mines

Accident Investigation Report
Underground Coal Mine

Fall of Roof/Rib Material
Fatality Investigation Report
April 22, 2008

Osaka Mining Corporation
Mine No. 1
Mine Index No. 14810AA
Wise County, Virginia

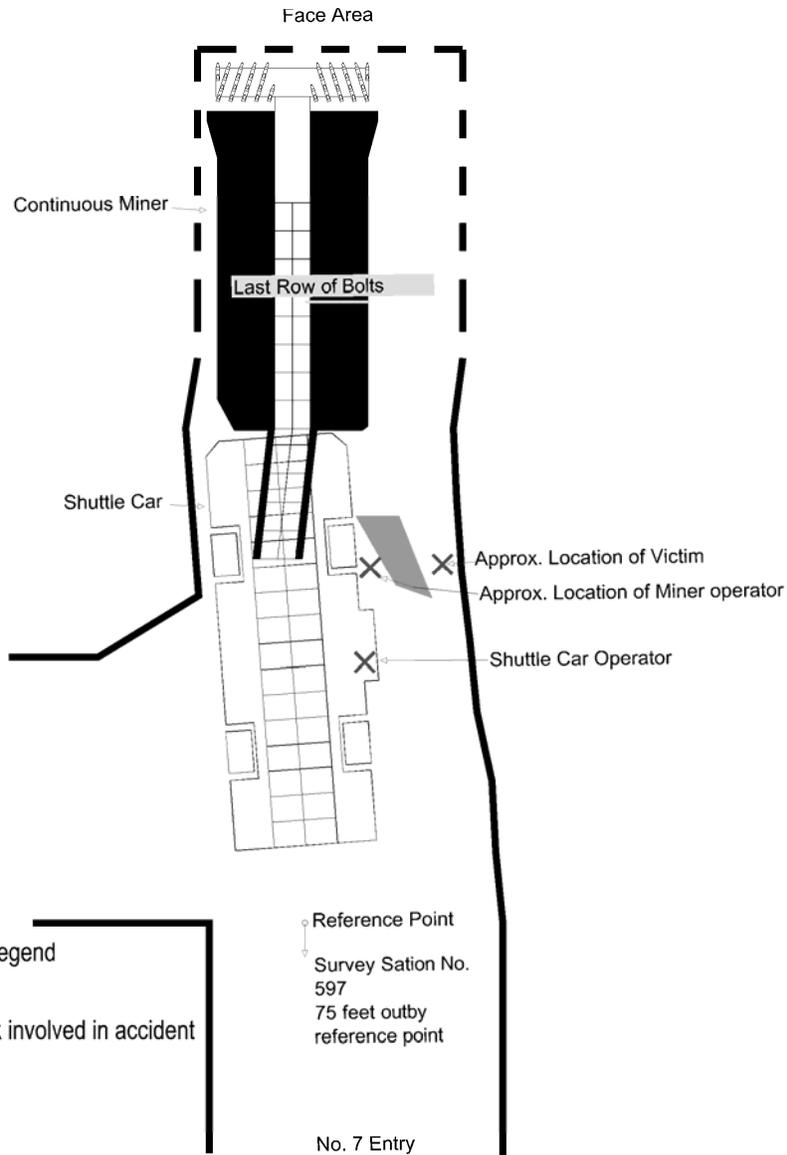
Fall of Roof and Rib Accident After Fall

1. The fall of roof/rib material accident occurred on April 22, 2008, at approximately 8:55 a.m. The accident occurred on the 1 North Mains – 001 Section, in the No. 7 entry just inby the last open crosscut -100 feet inby survey station No. 597.

2. The roof and rib material that fell was approximately 17.5 feet outby the last row of permanently installed roof supports. The roof and rib material that fell was approximately 72 inches in length, 36 inches in width on the wide end and tapered to 19 inches on the narrow end and, was zero to fourteen inches in thickness. The roof/rib rock material weighed approximately 790 pounds.

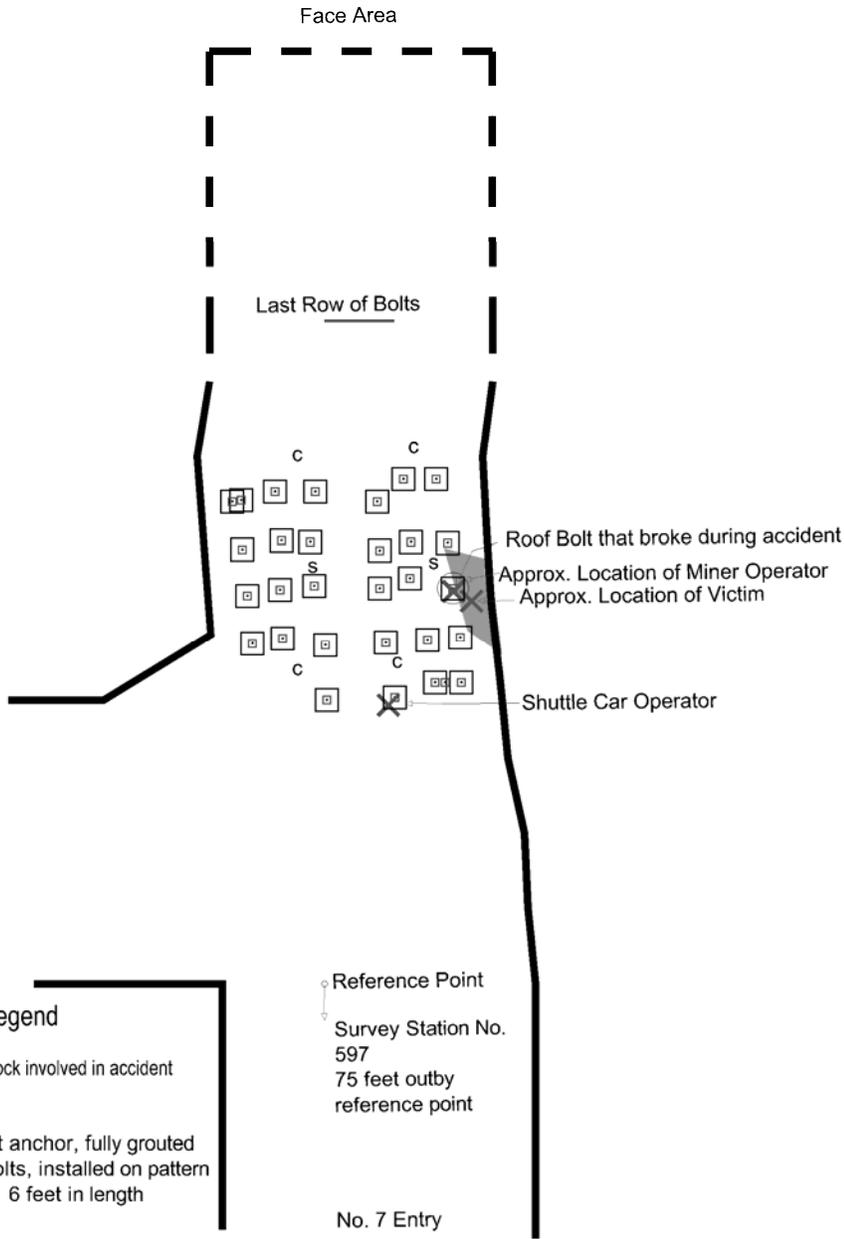
Fall of Roof and Rib Accident Before Fall

7. The segment of roof rock that fell causing the accident was partially secured on each end with square tin draw rock shields. The square tin draw rock shields are 18 inches by 18 inches.

8. The side of the segment of the roof rock that fell had been supported with a point anchor tension rebar roof bolt, six (6) feet in length. The point anchor tension rebar roof bolt had been installed near the edge of the roof rock but did not appear to have been installed through the rock. An eight (8) inch by eight (8) inch bearing plate with a square tin draw rock shield had been installed with the roof bolt and appeared to be holding approximately eight inches underneath the center edge of the roof rock that fell. The point anchor tension rebar roof bolt, bearing plate, and draw rock shield had been installed approximately 18 inches from the right rib.

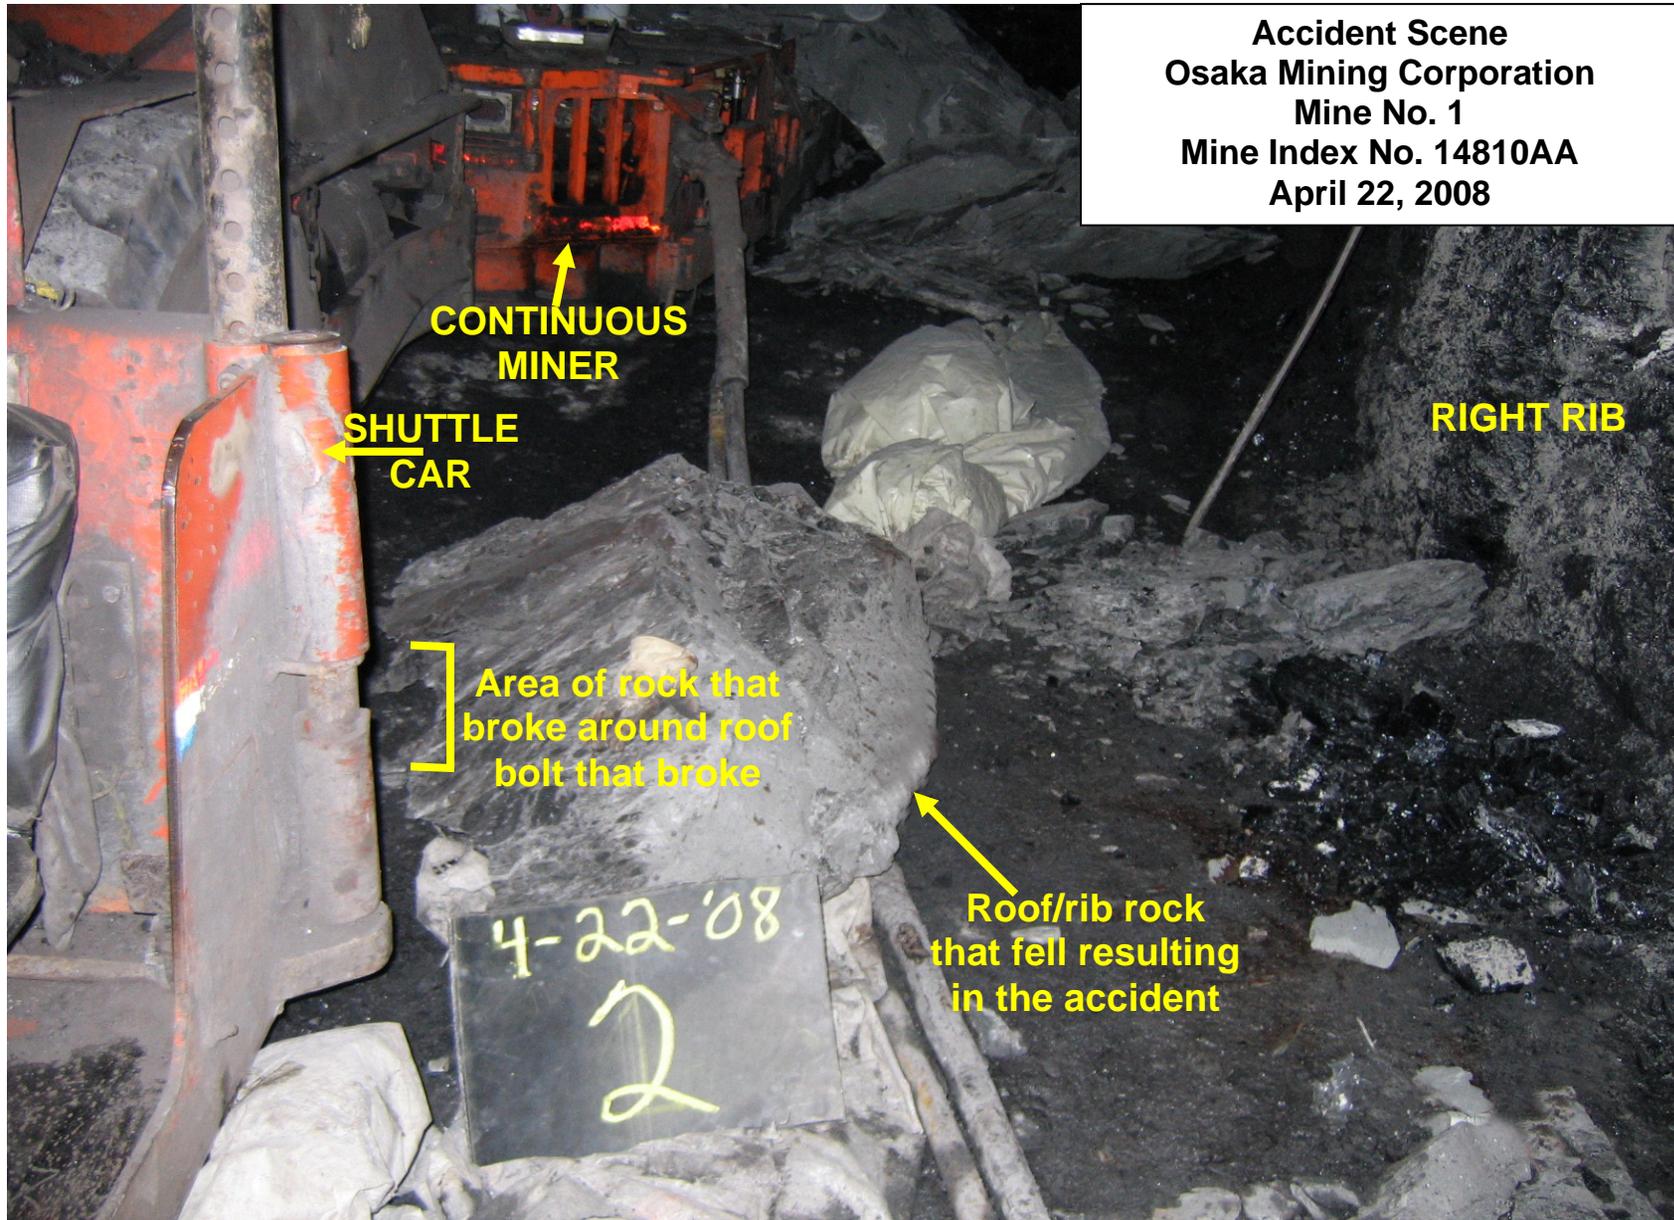
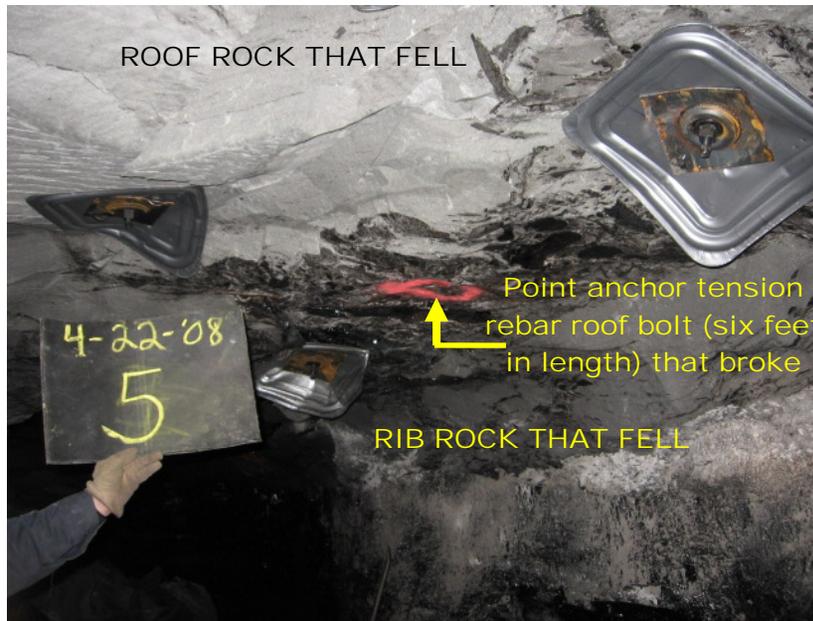
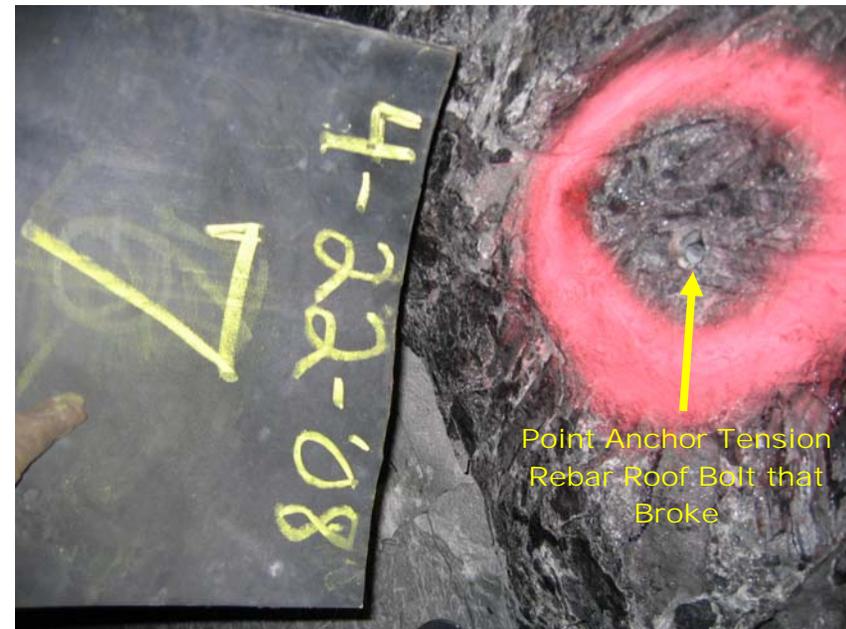
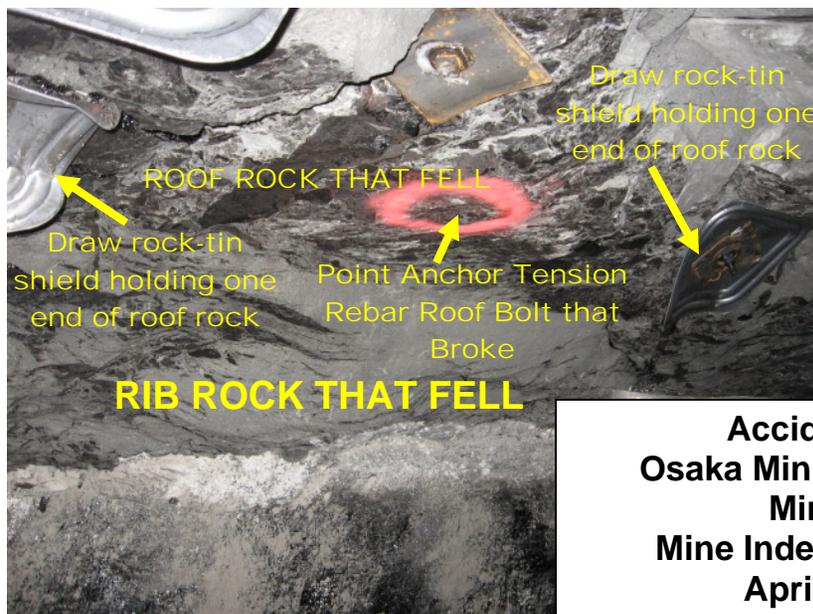
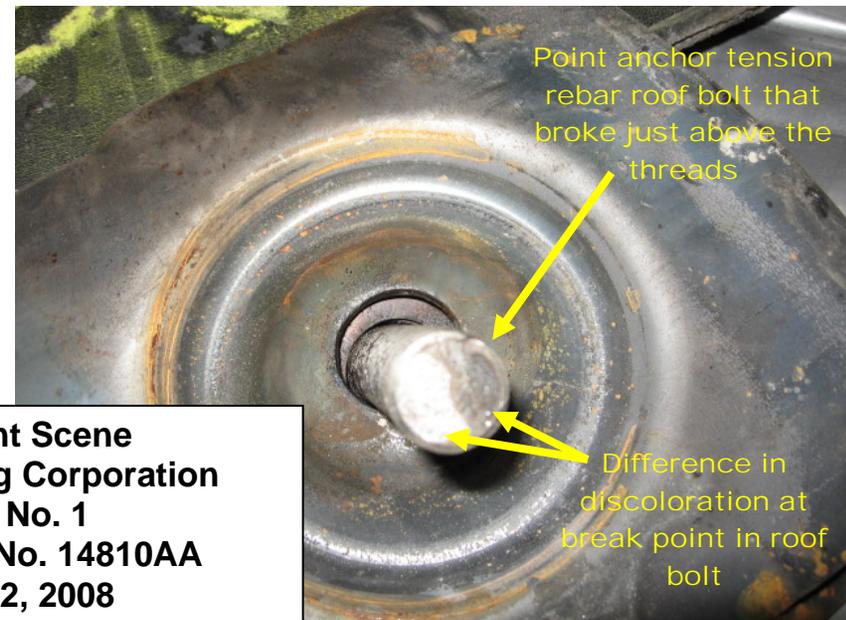
Accident Scene
Osaka Mining Corporation
Mine No. 1
Mine Index No. 14810AA
April 22, 2008

3. The roof/rib rock that fell causing the accident consisted of laminated sandstone with inherent coal streaks. The roof/rib rock that fell consisted of approximately 24 inches of material lying across the mine roof and approximately 18 inches lying on the right rib. The immediate mine roof is composed of inconsistent sandstone and shale.

9. The point anchor tension rebar roof bolt that was holding the roof rock that fell had broken just above the threads of the bolt.
10. The mine roof in No. 7 entry was fully supported with point anchor tension rebar roof bolts, six (6) feet in length in a six (6) bolt-wide pattern and supplemented with cable rope bolts, twelve (12) feet in length and tensioned super bolts, eight (8) feet in length.
