**Accident Investigation Report**  
**Underground Coal Mine**

**Fatal Machinery Accident**  
**June 20, 2002**

**Consolidation Coal Company**  
**Buchanan No. 1 Mine**  
**Mine Index No. 11912AA**  
**Buchanan County, Virginia**

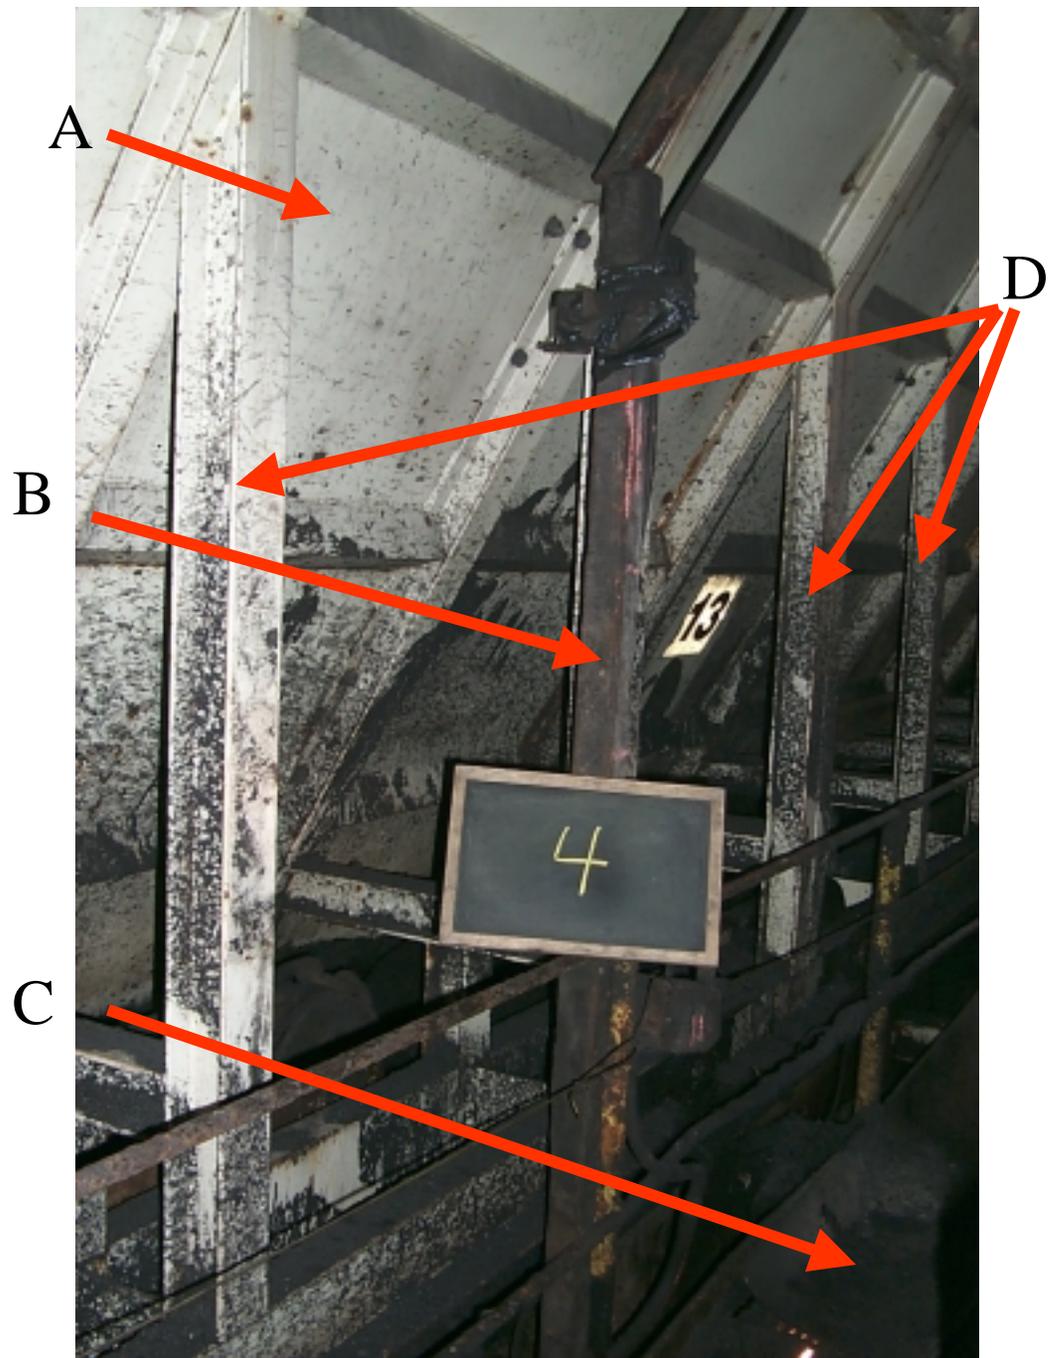
Fatal Accident Scene  
Consolidation Coal  
Company  
Buchanan No. 1 Mine  
Mine Index No. 11912AA  
June 20, 2002

Mr. Wilson was observed slumped over and entrapped between a bunker car metal support frame and a stationary, vertical, metal support beam. Mr. Wilson was unresponsive and positioned with his head facing downward on the loading end of the stationary beam and his feet positioned on the empty end of the stationary beam. Mr. Ball examined Mr. Wilson for vital signs and none could be found. Mr. Ball traveled to the mine telephone, located at the bunker

1. While equipment is in operation or is being trammed, no miner shall position himself or be placed in a pinch point between such equipment, or another piece of equipment in the mine.
2. Machinery shall not be repaired or serviced while the machinery is in motion unless safe remote devices are used.
3. All coal bunker operators should be trained in safe procedures for lubrication of bunker components when positioned inside of the emergency pull cord areas. The training should include detailed, specific instructions to be adhered to at all times such as:
  - Deenergizing power
  - Locking and tagging out procedures
4. The stationary, vertical, metal, support beam with attached overtravel limit switches should be redesigned to prevent a potential pinch point.
