Virginia Department of Mines, Minerals & Energy
Division of Mines

Accident Investigation Report
Underground Coal Mine
Preparation Plant

Surface Haulage Fatality
June 28, 2002

Lone Mountain Processing, Inc.
6-C Mine No. 1
Mine Index No. 14344AA
Lee County, Virginia

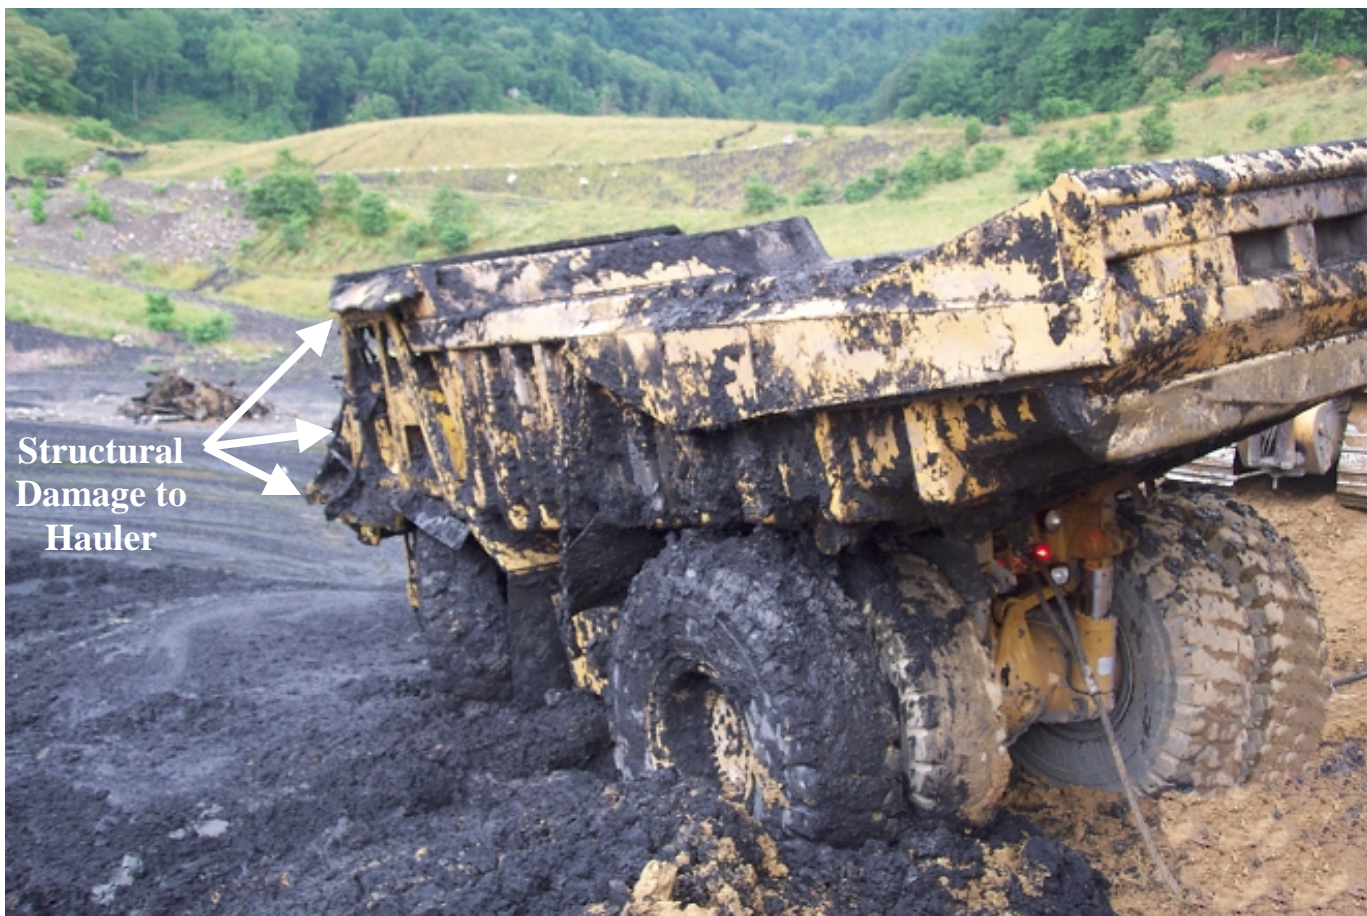
Structural
Damage to
Hauler

10. The seat belt was found unlatched and was functional when examined and tested.
11. The operator's cab and compartment of the 773B end dump truck sustained the following damage:

- A. The steering wheel was bent.
 - B. The steering column housing was broken loose from its mount to the dash panel.
 - C. The turn signal switch was broken loose from the mount on the steering column.

- D. The driver's side mirror was broken.
 - E. The catwalk and handrail at the driver's door was crushed.
 - F. The driver's side door, was crushed in against the driver's seat and steering wheel.

- G. Five of the six cab window glasses were broken. Only the right side door glass was not broken.
 - H. The convex mirror on the right side of the truck was in good condition. Objects are closer than perceived when looking into this type of mirror.

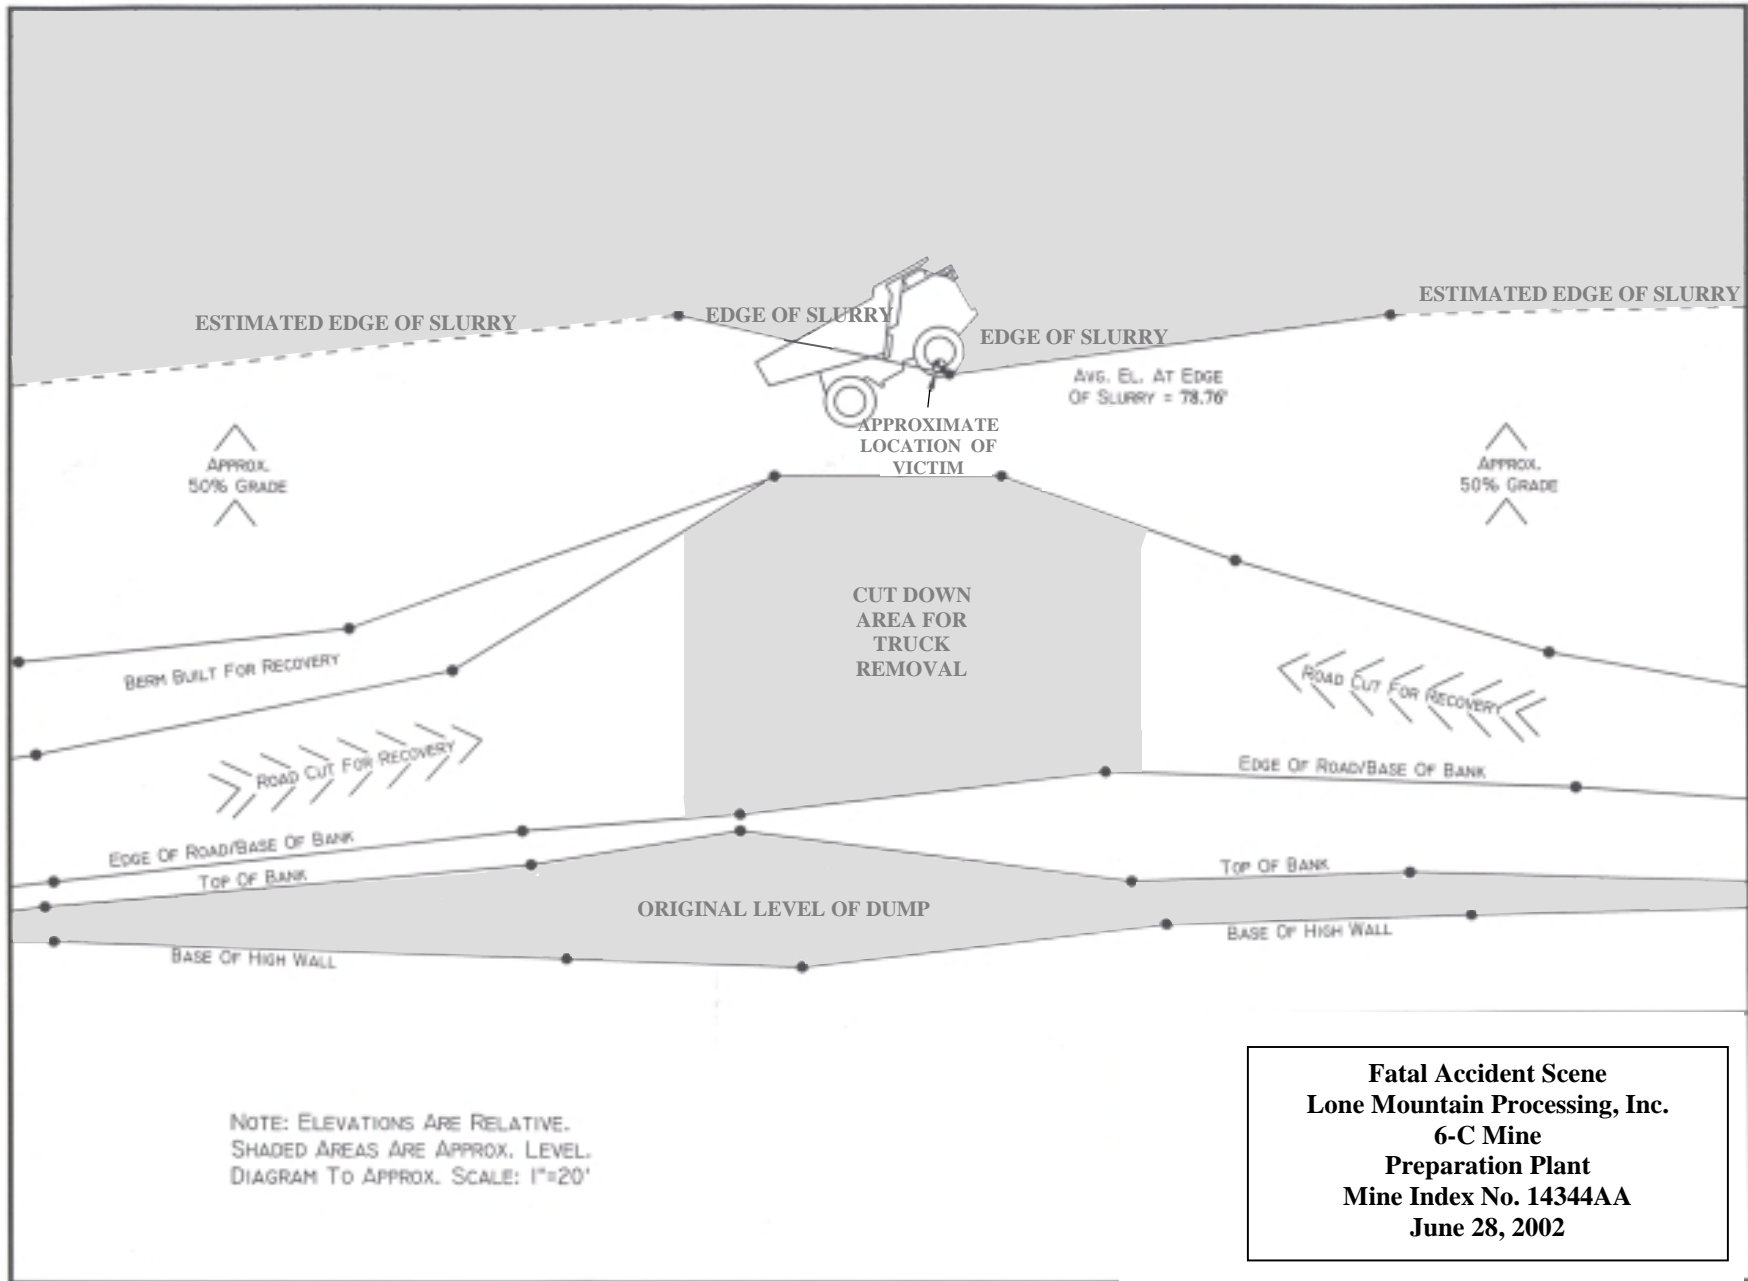
Fatal Accident Scene
Lone Mountain Processing, Inc.
6-C Mine
Preparation Plant
Mine Index No. 14344AA
June 28, 2002
