# **Virginia Department of Mines, Minerals & Energy**

### **Accident Investigation Report**

### **Exploding Vessel Fatality Investigation Report**

Twin Star Mining, Inc.  
Lower Elk Creek Strip

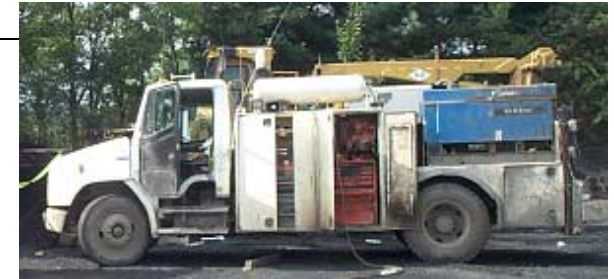
Service Truck
