**Virginia Department of Mines, Minerals & Energy**  
**Division of Mines**

**Accident Investigation Report**  
**Underground Coal Mine**

**Electrocution**  
**September 24, 2004**

**Cumberland River Coal Company**  
**Fork Ridge Mine**  
**Mine Index No. 14718AA**  
**Wise County, Virginia**

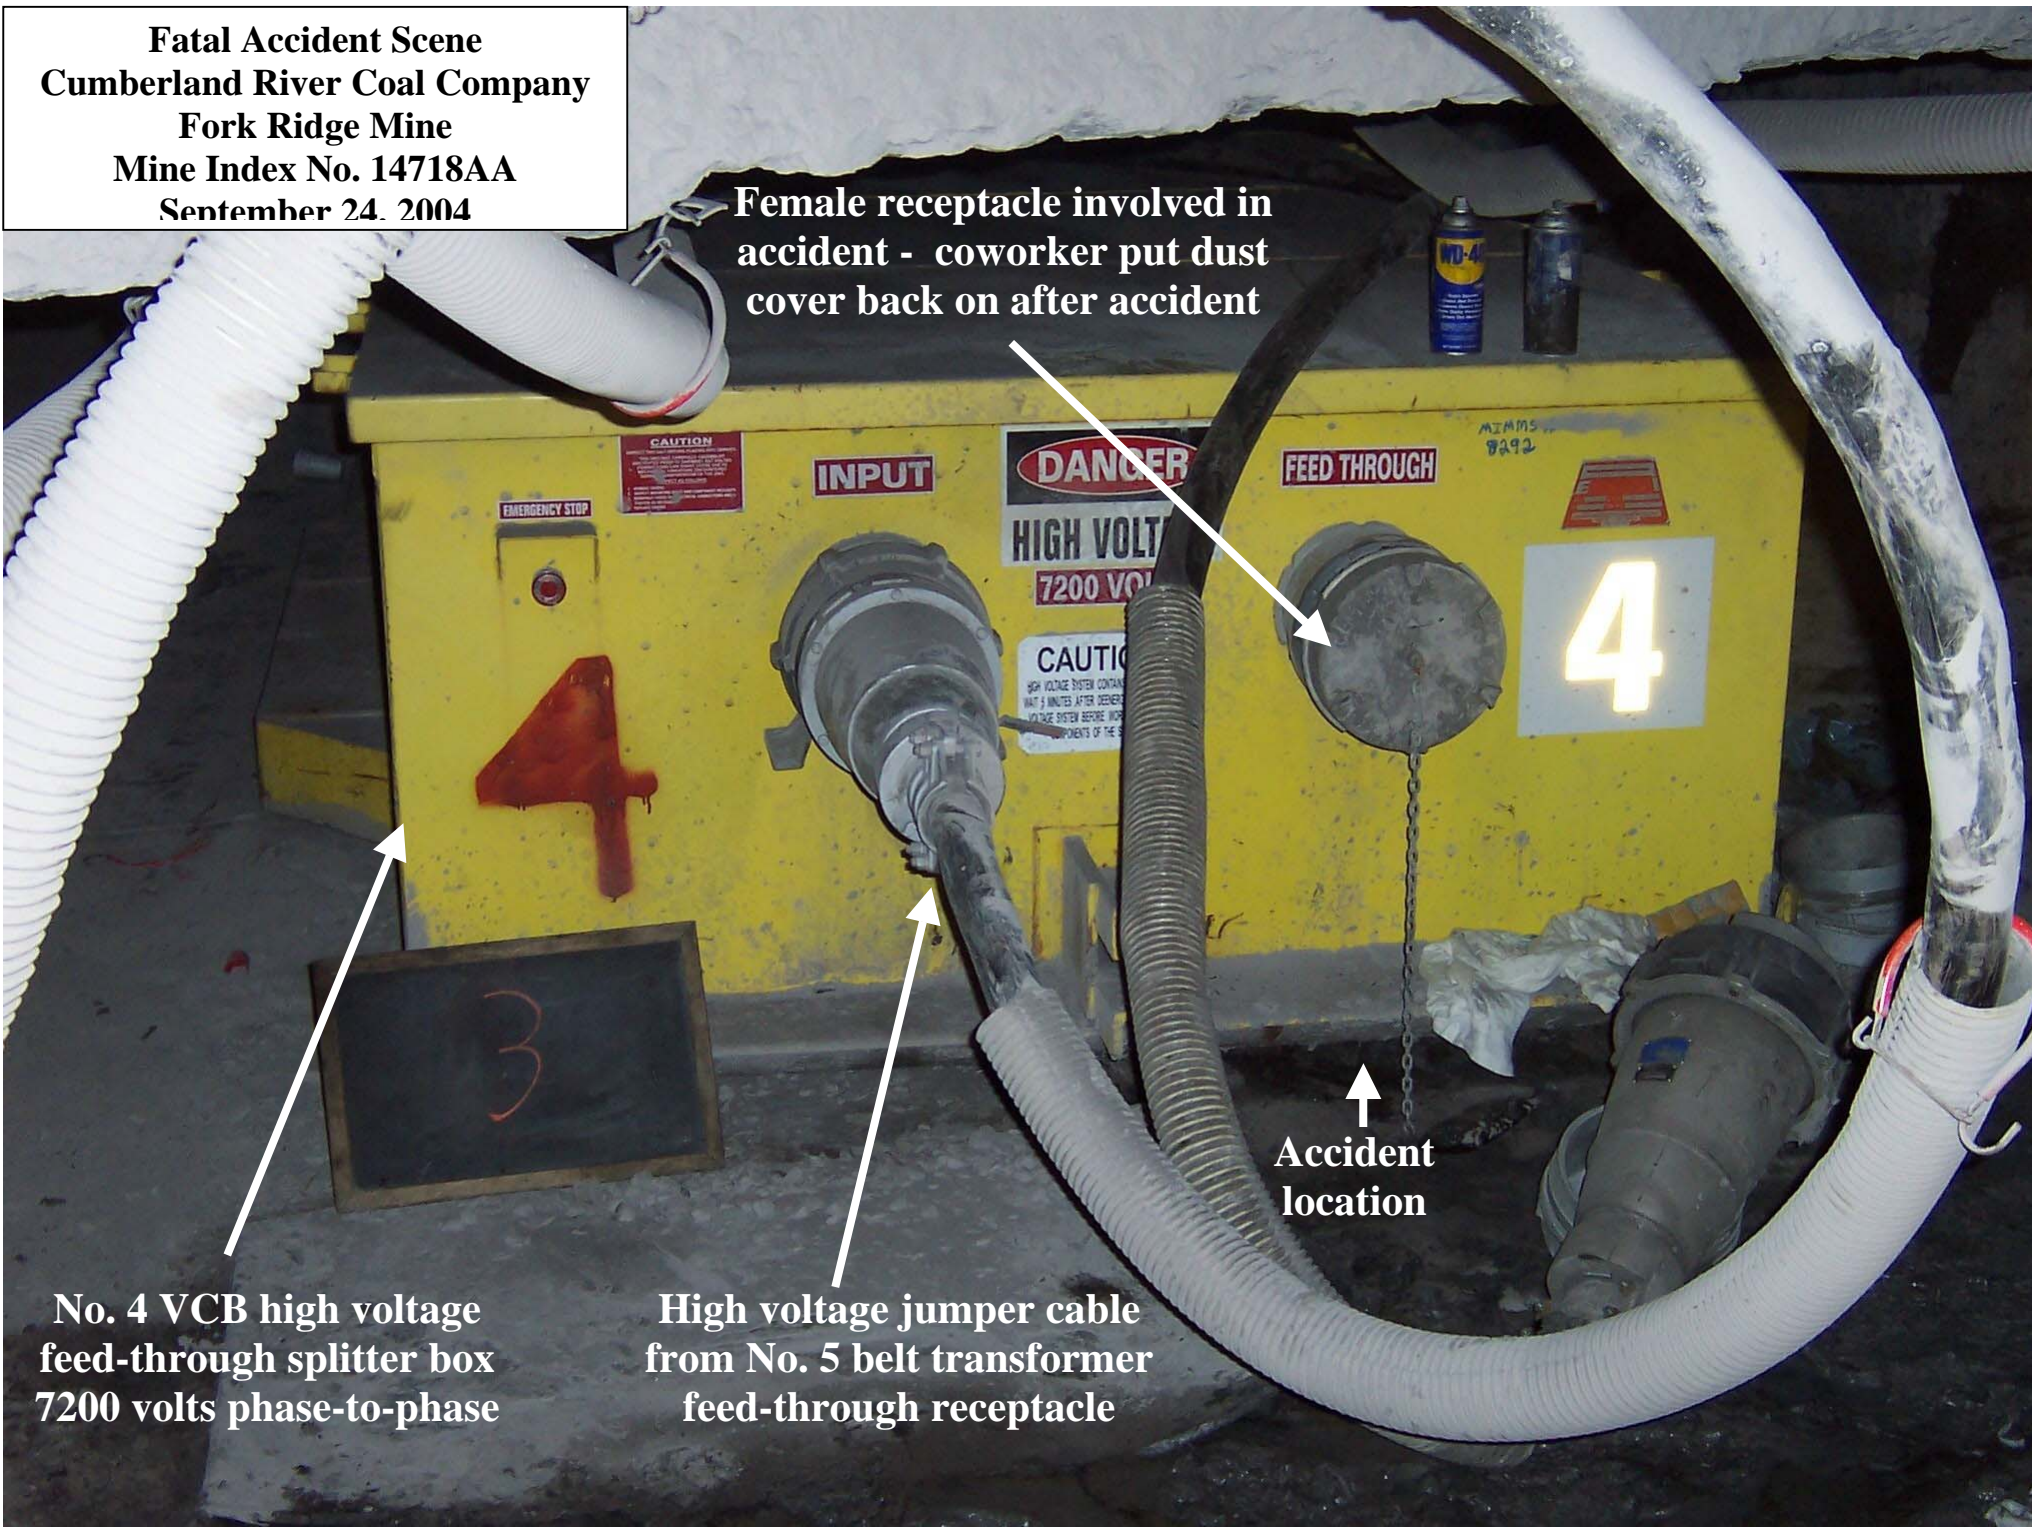
**No. 4 VCB high voltage feed-through splitter box 7200 volts phase-to-phase**

**High voltage jumper cable from No. 5 belt transformer feed-through receptacle**

**↑  
Accident location**

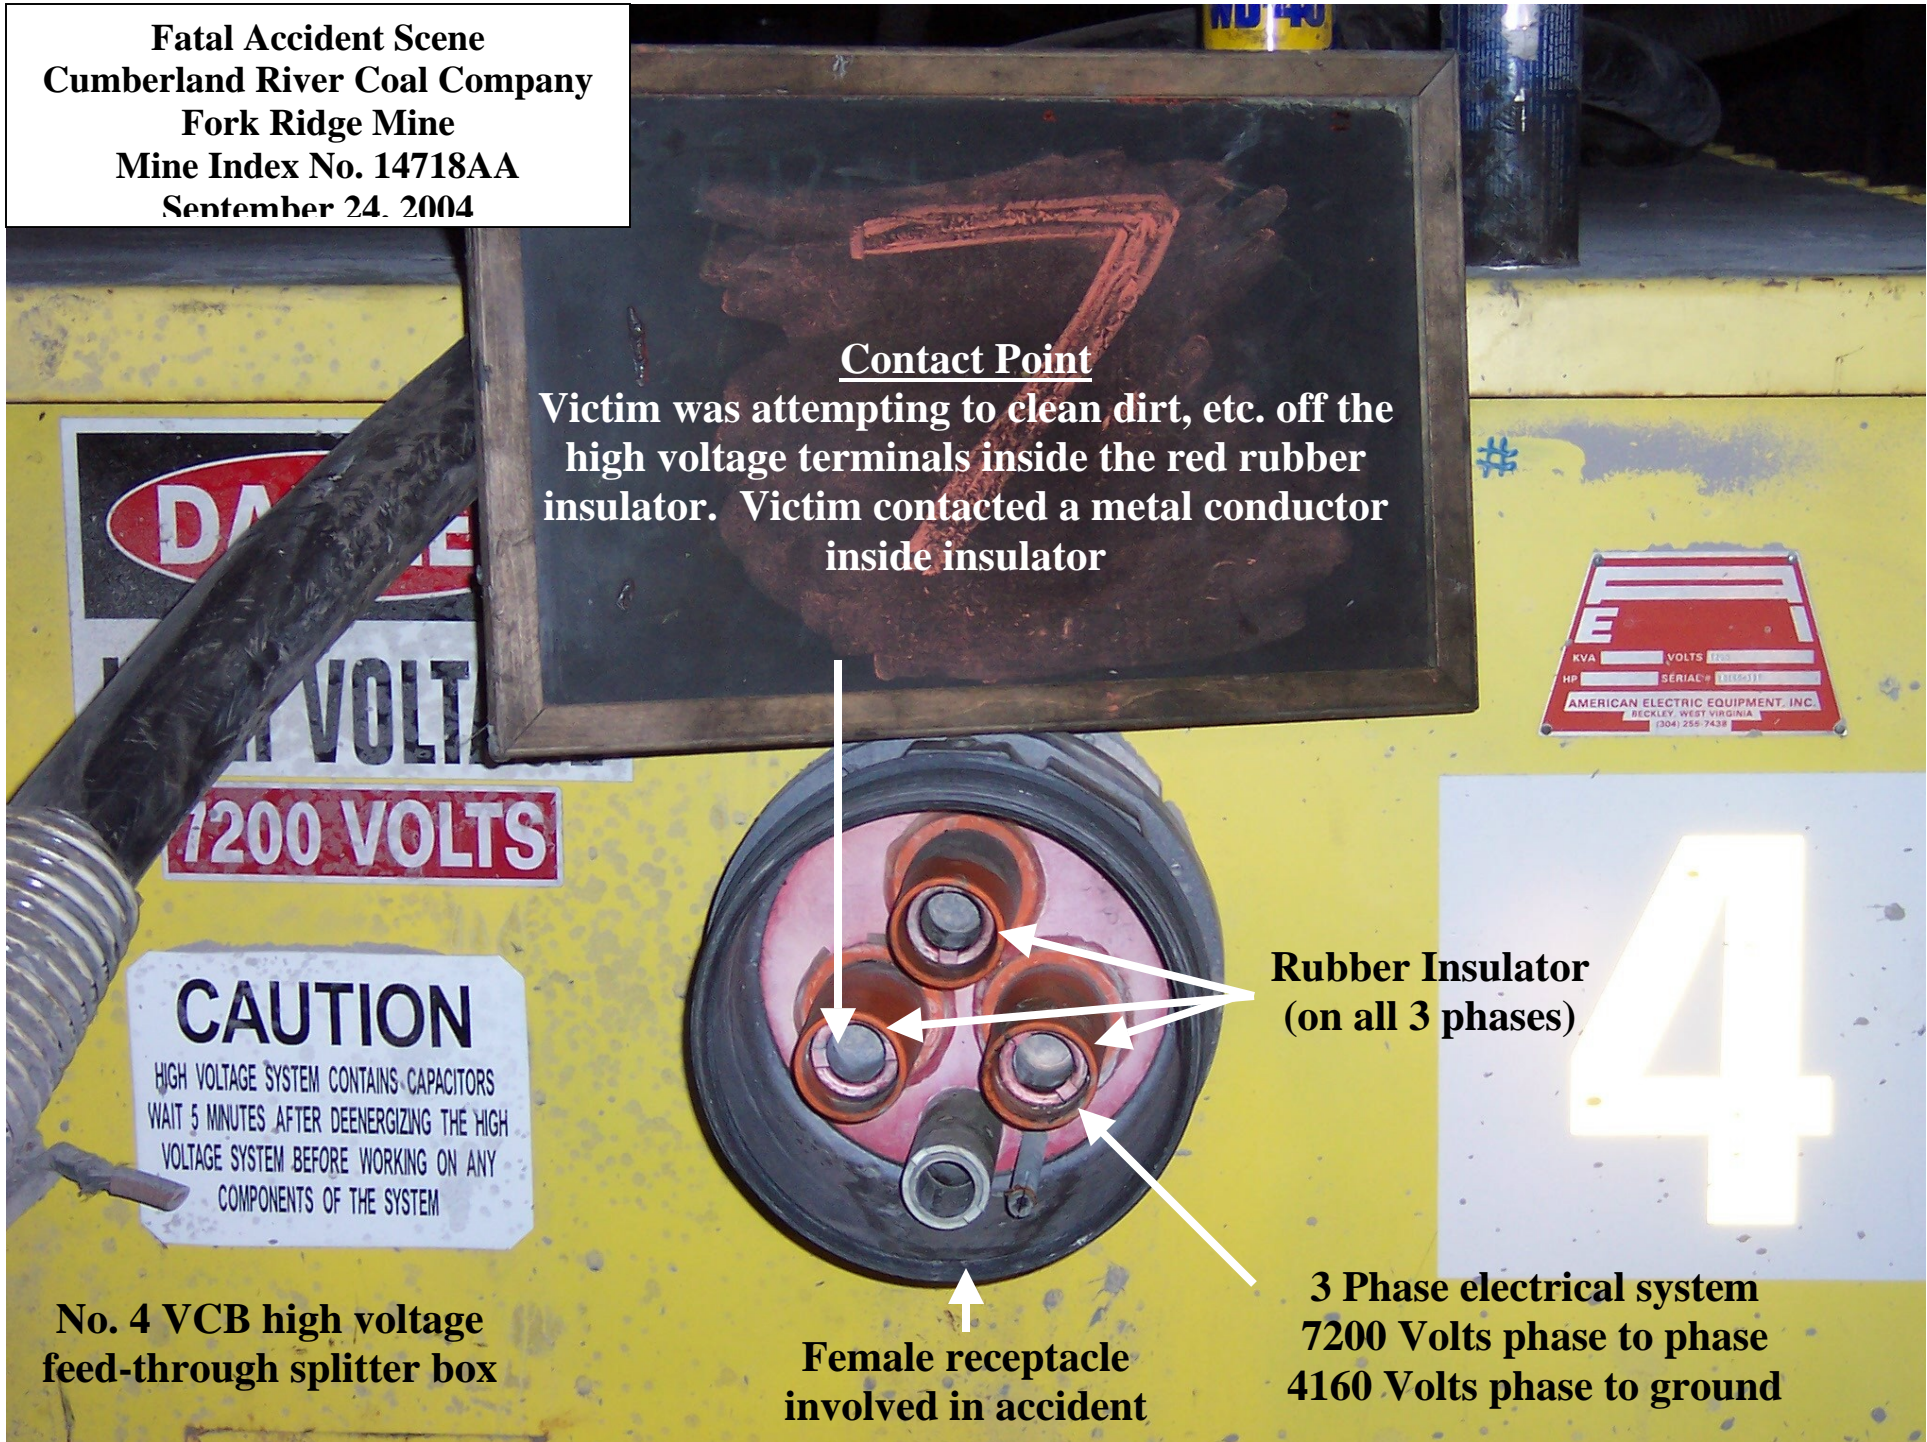
**Contact Point**

**Victim was attempting to clean dirt, etc. off the high voltage terminals inside the red rubber insulator. Victim contacted a metal conductor inside insulator**

**Rubber Insulator  
(on all 3 phases)**

**No. 4 VCB high voltage  
feed-through splitter box**

**Female receptacle  
involved in accident**

**3 Phase electrical system  
7200 Volts phase to phase  
4160 Volts phase to ground**

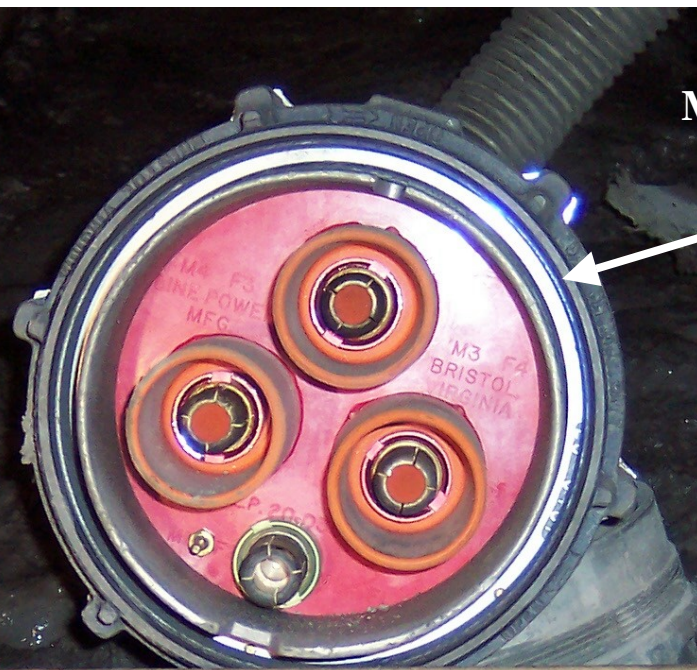
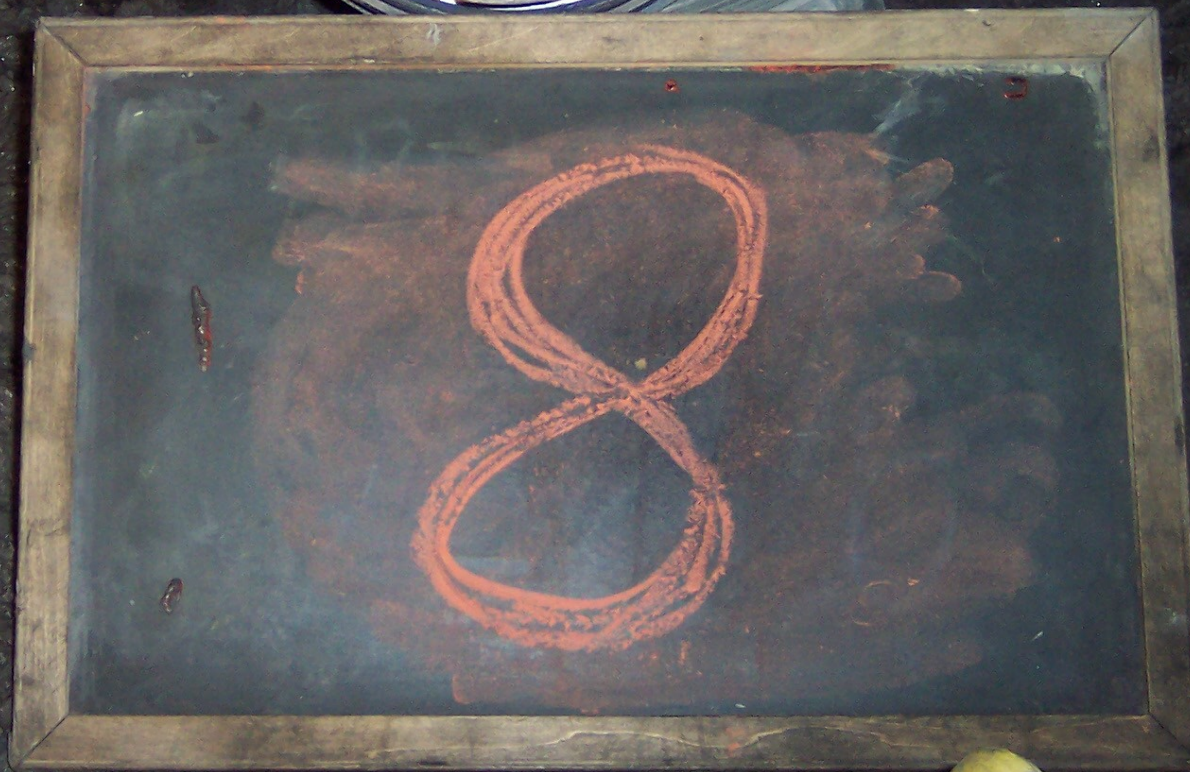
**Male coupler that would  
be connected to the  
female receptacle  
involved in accident**

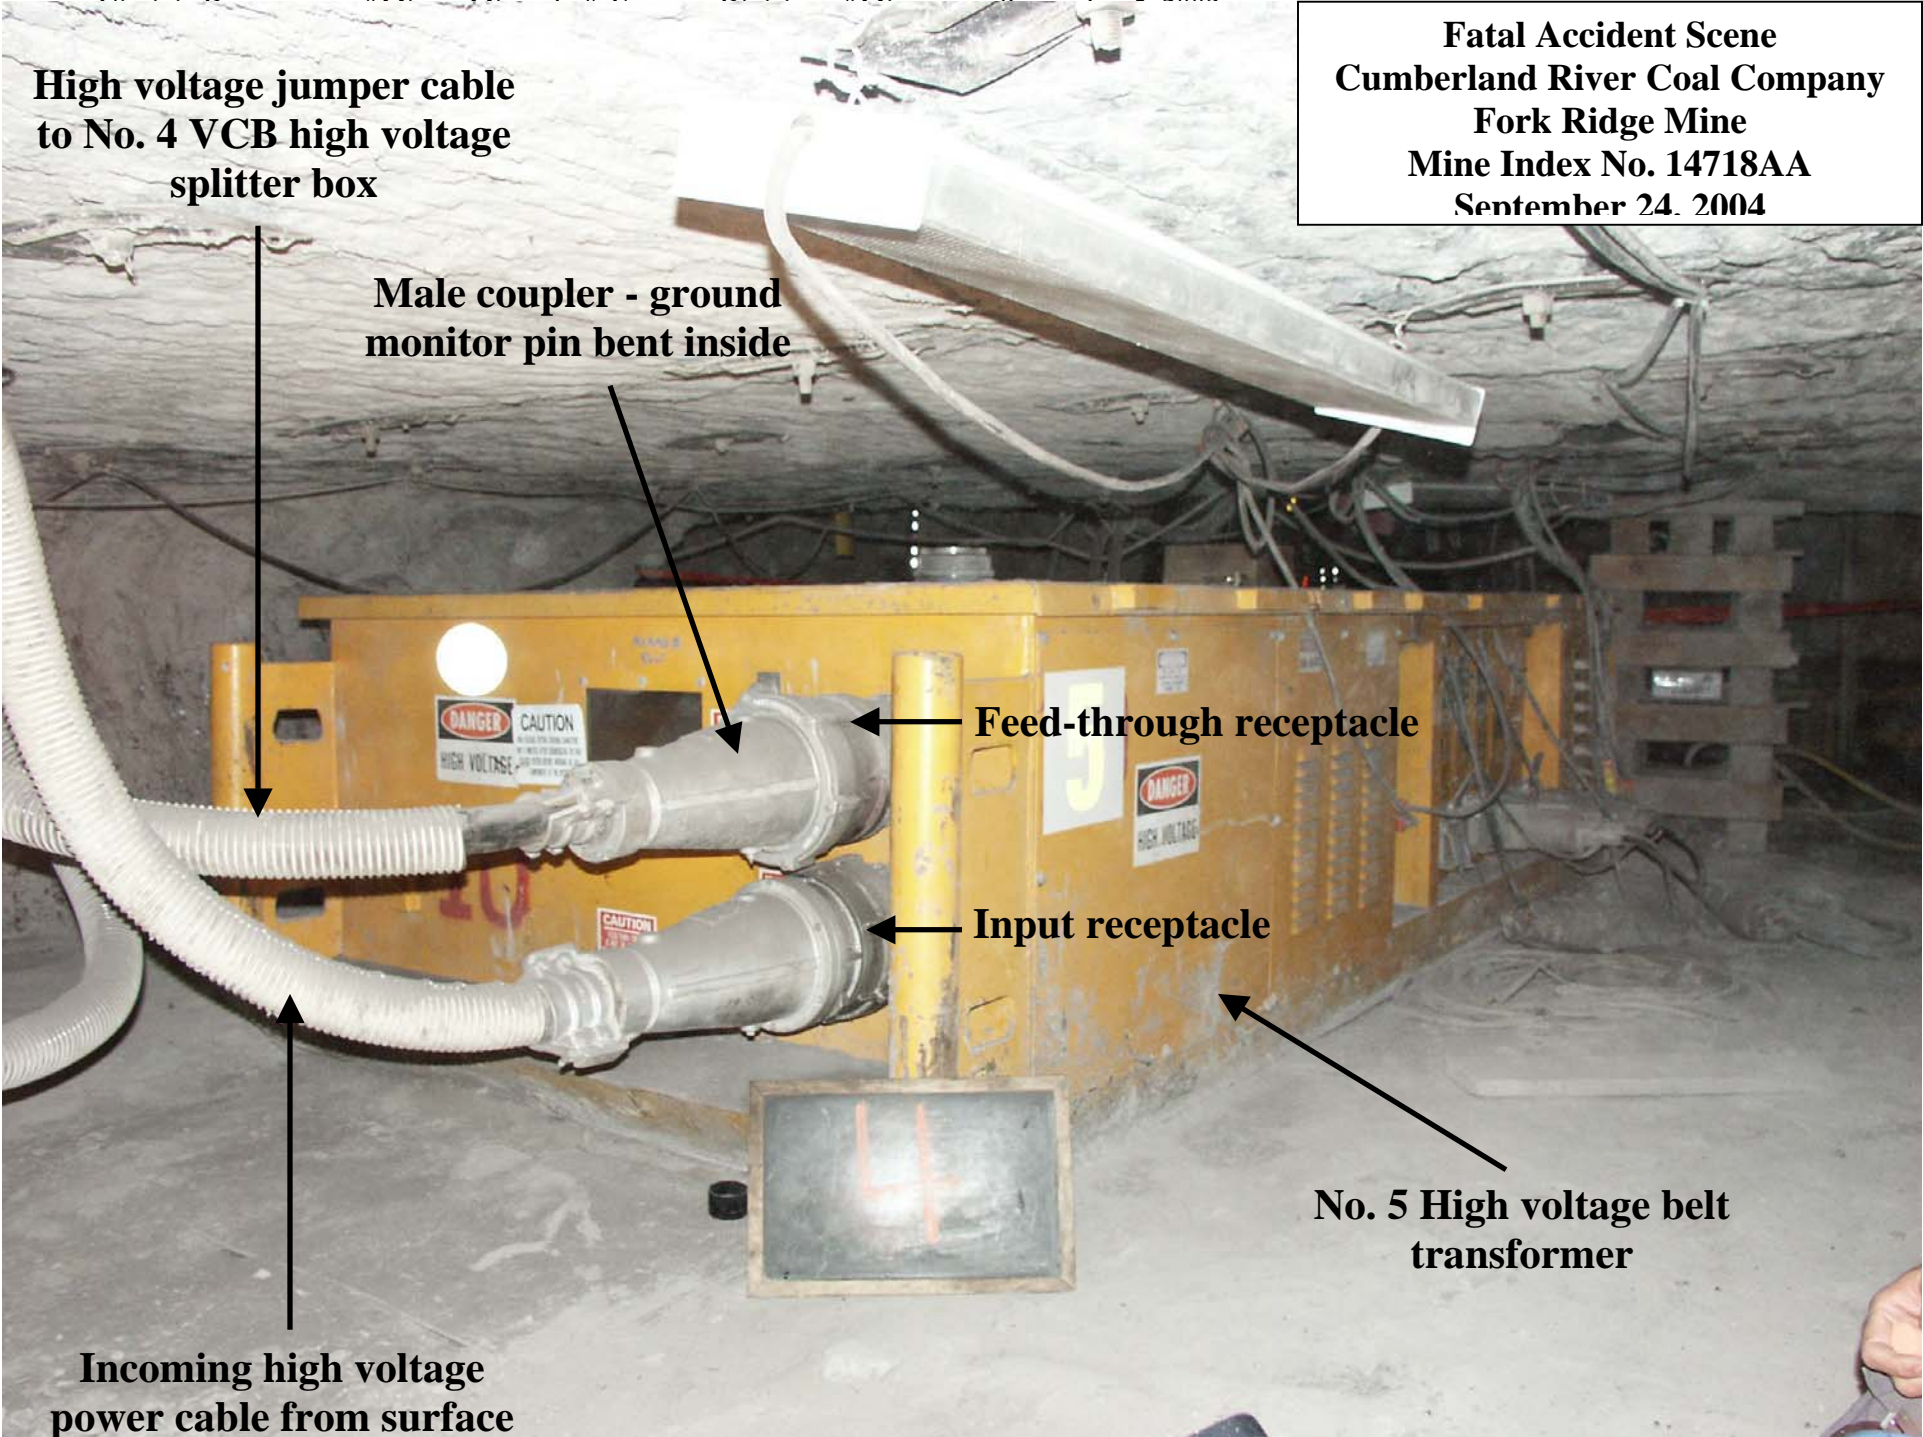
**High voltage jumper cable  
to No. 4 VCB high voltage  
splitter box**

**Male coupler - ground  
monitor pin bent inside**

**Feed-through receptacle**

**Input receptacle**

**No. 5 High voltage belt  
transformer**

**Incoming high voltage  
power cable from surface**

- The investigation team observed the problem with the ground/ground monitoring circuit for the No. 4 VCB high voltage splitter box. The ground monitor pin located in the No. 5 high voltage belt transformer feed-through male coupler was bent against the coupler housing, which resulted in a “short circuit” of the ground/ground monitoring circuit at this point. This “short circuit” caused a failure of the ground/ground monitoring system in the No. 4 VCB high voltage splitter box;

- The bent ground monitor pin was repaired and the male coupler was reconnected;
- A “terminator cover” was installed over the No. 4 VCB high voltage splitter box feed-through female receptacle where the accident occurred;

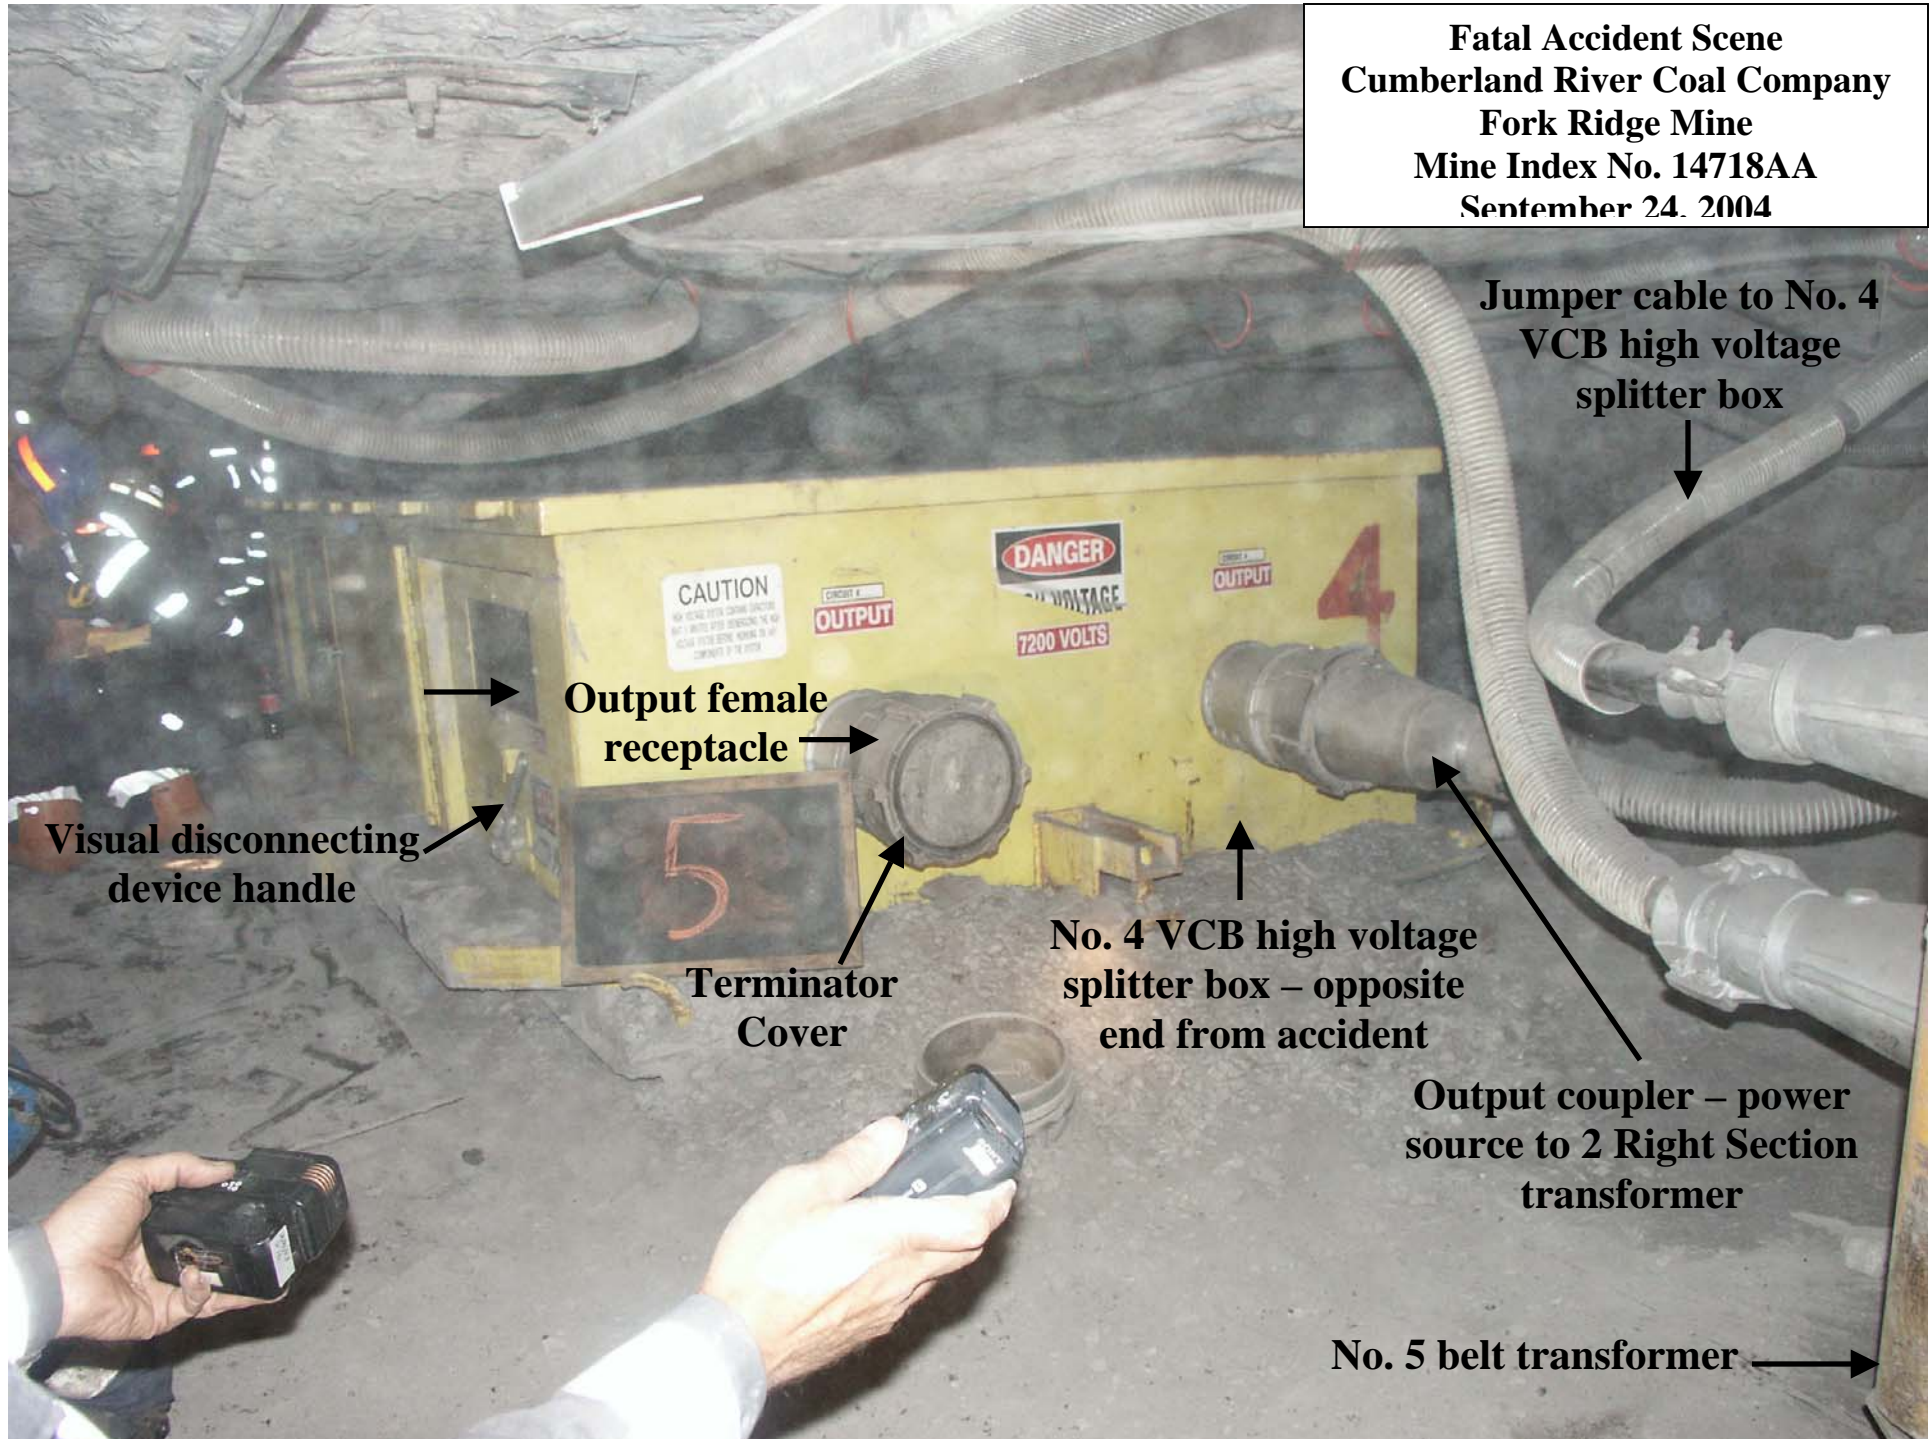
**Jumper cable to No. 4  
VCB high voltage  
splitter box**

**Output female  
receptacle**

**Visual disconnecting  
device handle**

**Terminator  
Cover**

**No. 4 VCB high voltage  
splitter box – opposite  
end from accident**

**Output coupler – power  
source to 2 Right Section  
transformer**

**No. 5 belt transformer**

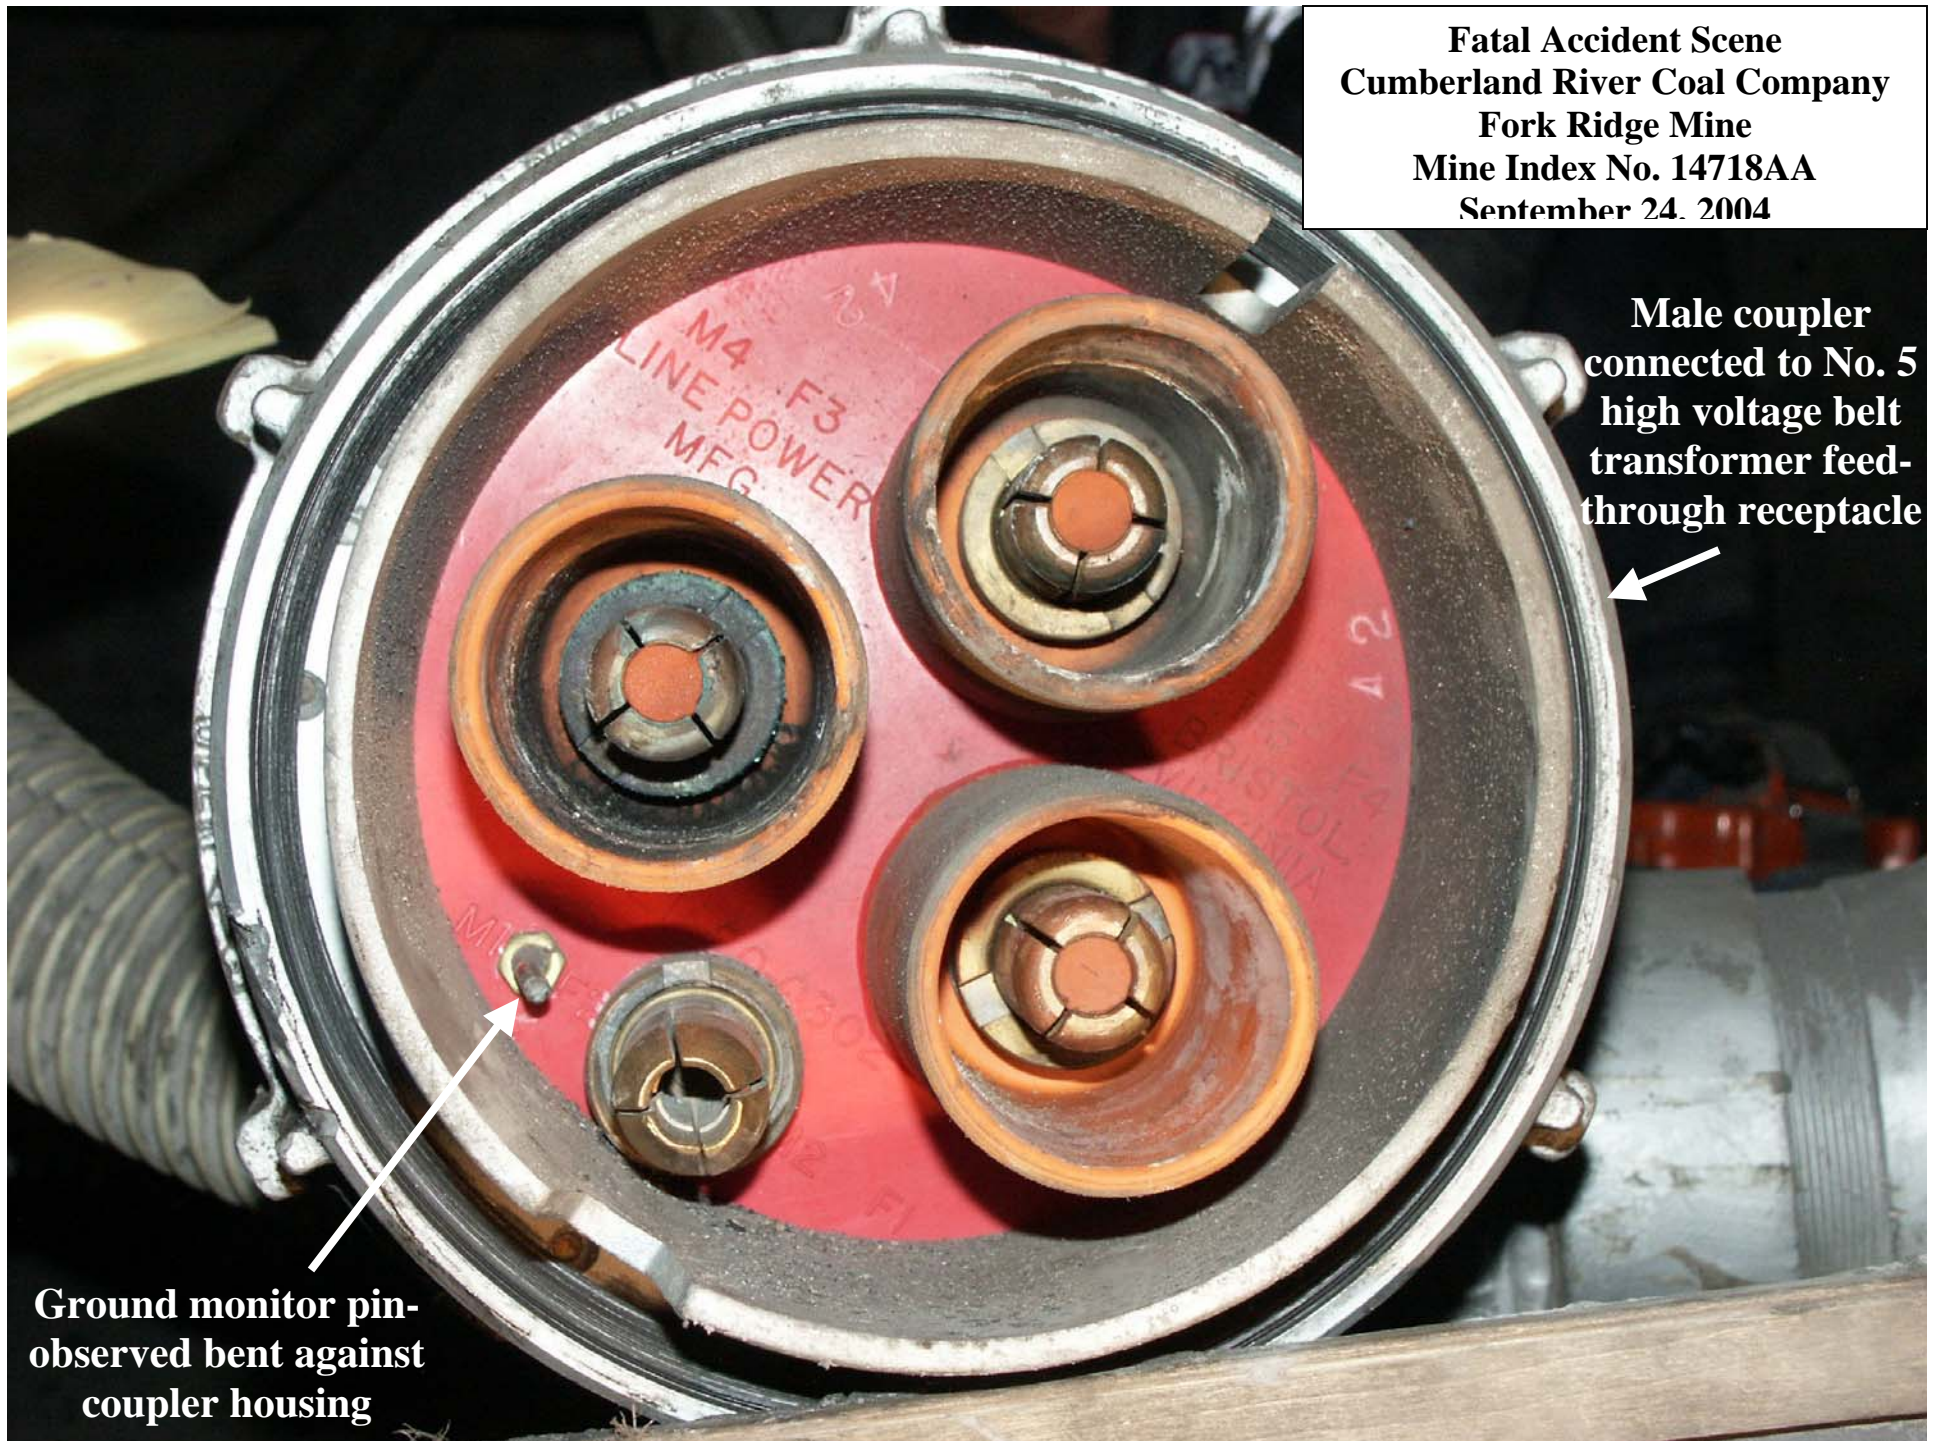
**Male coupler  
connected to No. 5  
high voltage belt  
transformer feed-  
through receptacle**

**Ground monitor pin-  
observed bent against  
coupler housing**

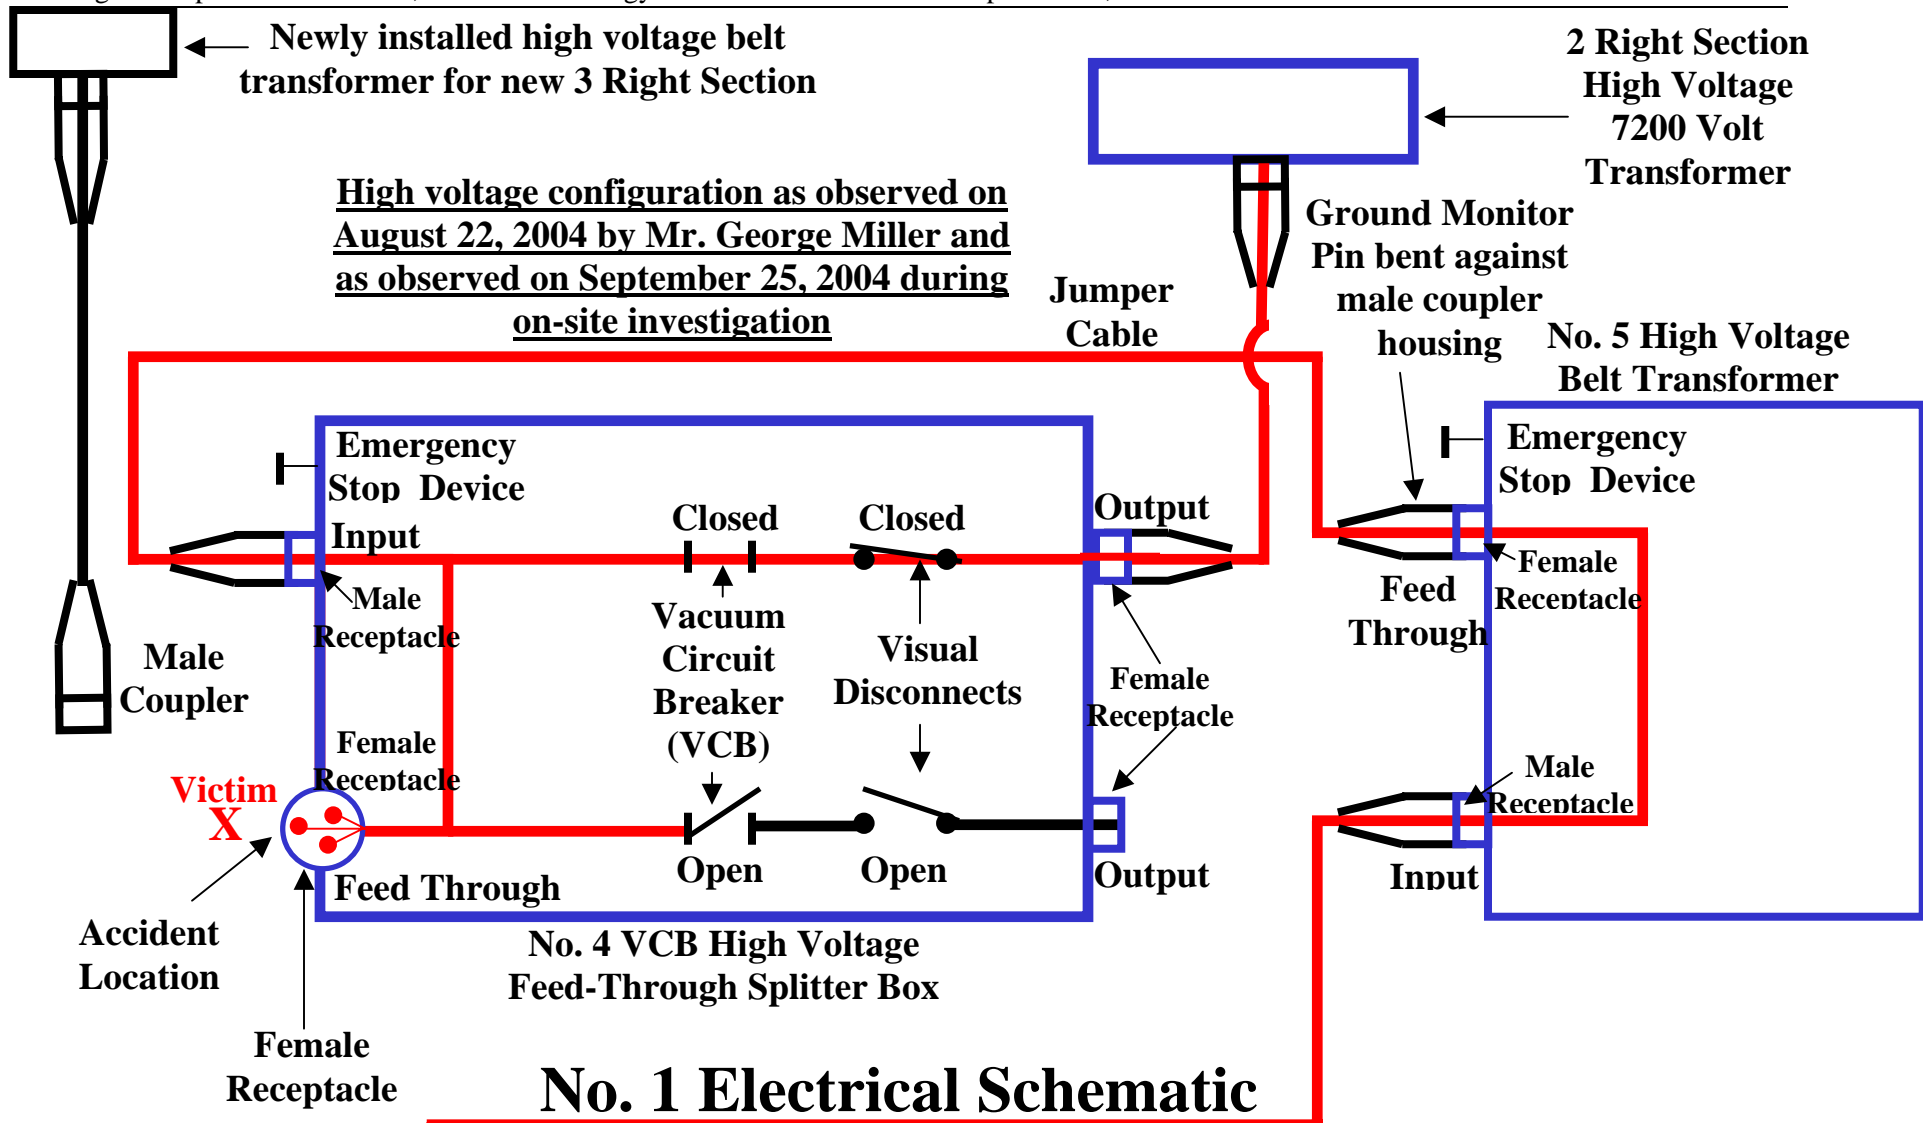
**RED** – Energized power when accident occurred  
 7200 Volts Phase to Phase  
 4160 Volts Phase to Ground

**Incoming High Voltage Power Cable From Surface**

**High voltage configuration as originally installed on July 21, 2004 by Mr. George Miller - 3<sup>rd</sup> shift electrical repairman**

17. The configuration of electrical connections of the incoming high voltage power from the surface to the No. 4 VCB high voltage splitter box and the No. 5 high voltage belt transformer had been changed sometime after July 21, 2004 (installation date) and before August 22, 2004, when Mr. Miller conducted the last monthly examination of high voltage circuit breakers at this location. The configuration of electrical connections that Mr. Miller observed on August 22, 2004, was the same configuration that was in place when the accident occurred. The following is an electrical configuration description of how the high voltage connections were made on July 21, 2004, when Mr. Miller made the high voltage electrical connections at the No. 4 VCB high voltage splitter box and the No. 5 high voltage belt transformer:

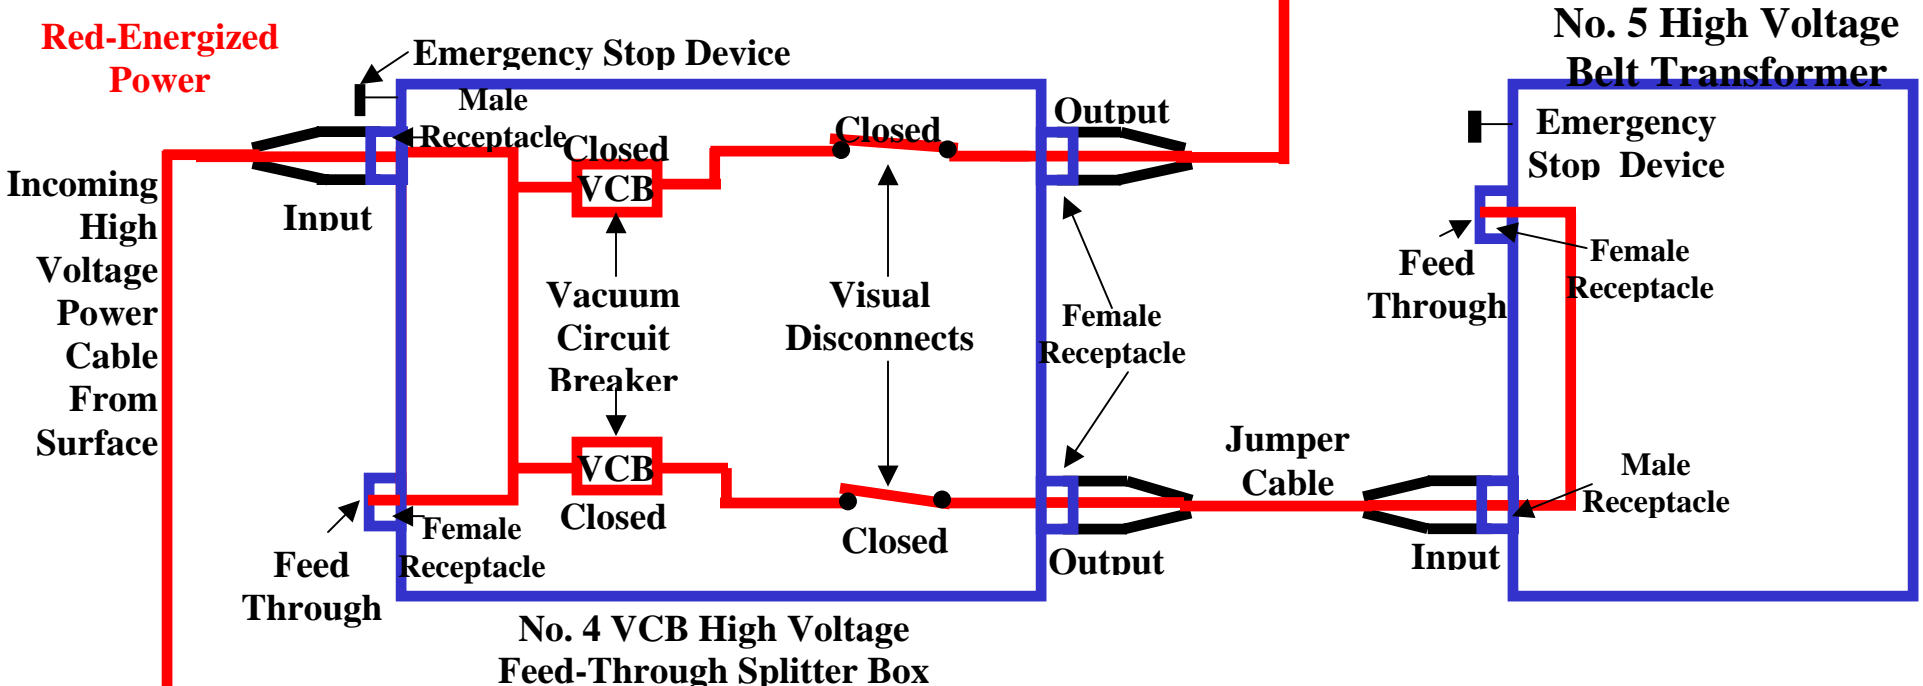
**No. 2 Electrical Schematic**

To No. 2 Right Section High Voltage 7.200 Volt Transformer
