### **Accident Investigation Report Underground Coal Mine**

#### **Powered Haulage Fatal Accident September 26, 2004**

#### **Consolidation Coal Company Buchanan Mine No. 1 Mine Index No. 11912AA Buchanan County, Virginia**

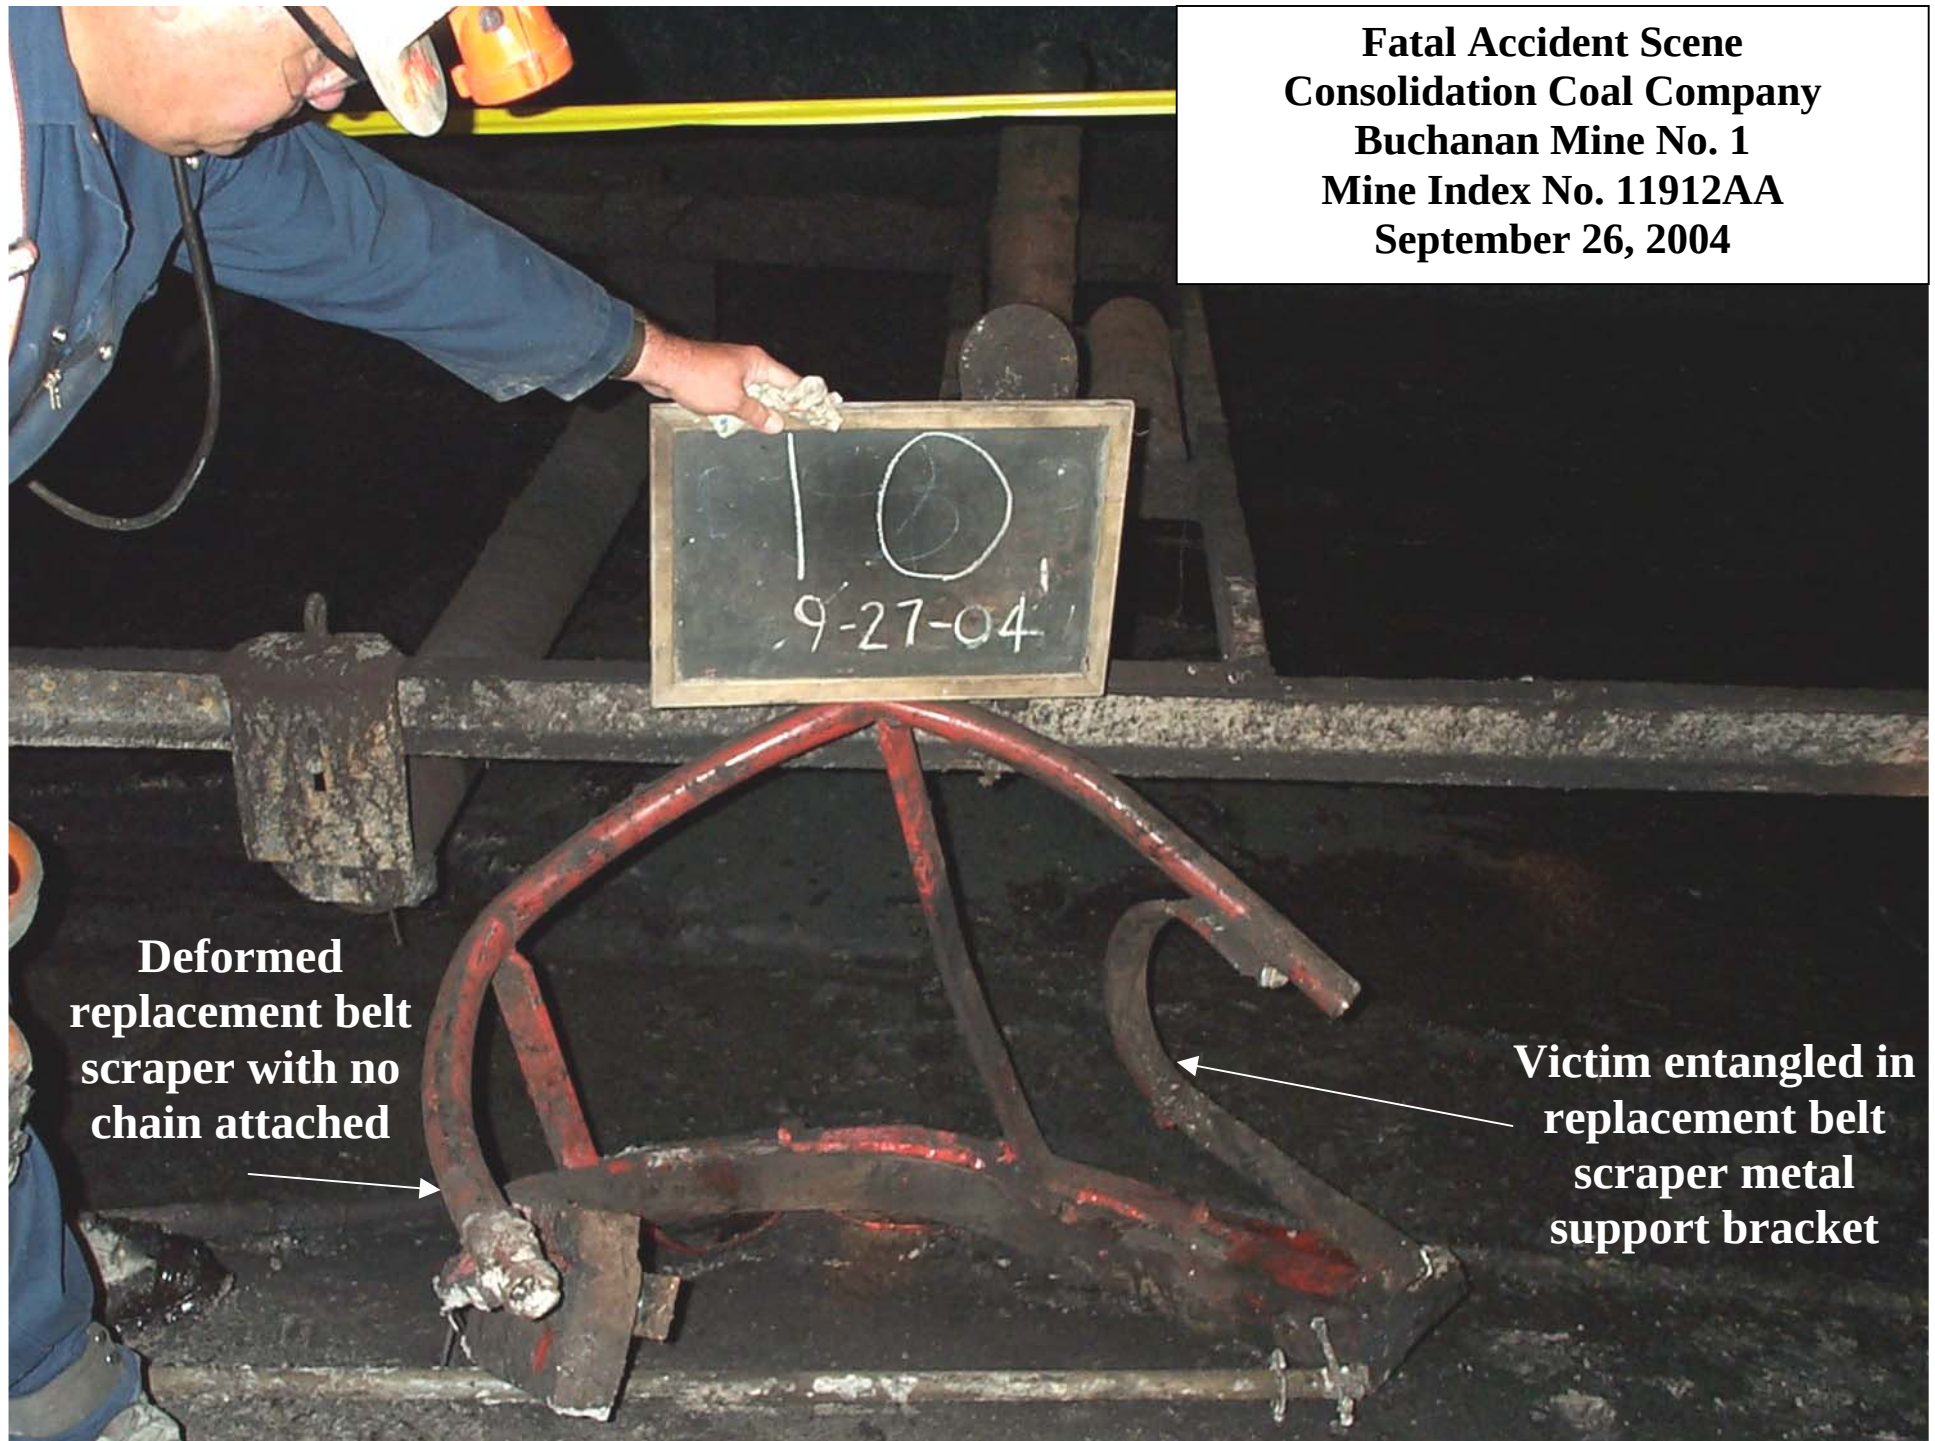
**Deformed  
replacement belt  
scraper with no  
chain attached**

**Victim entangled in  
replacement belt  
scraper metal  
support bracket**

14. The replacement bottom belt scraper involved in the accident was extremely deformed and conformed to the shape of the 3 East Mains No. 1 belt conveyor tail roller. There was no belt chain attached to the scraper. The scraper support bracket located on the trackside of the tailpiece was bent inward toward the belt. The scraper mounting brackets were located approximately 78 inches from the 3 East Mains No. 1 belt conveyor tail roller. The tailpiece structure, tail roller guard measured approximately 96 inches from the scraper mounting bracket on the trackside of the tailpiece.

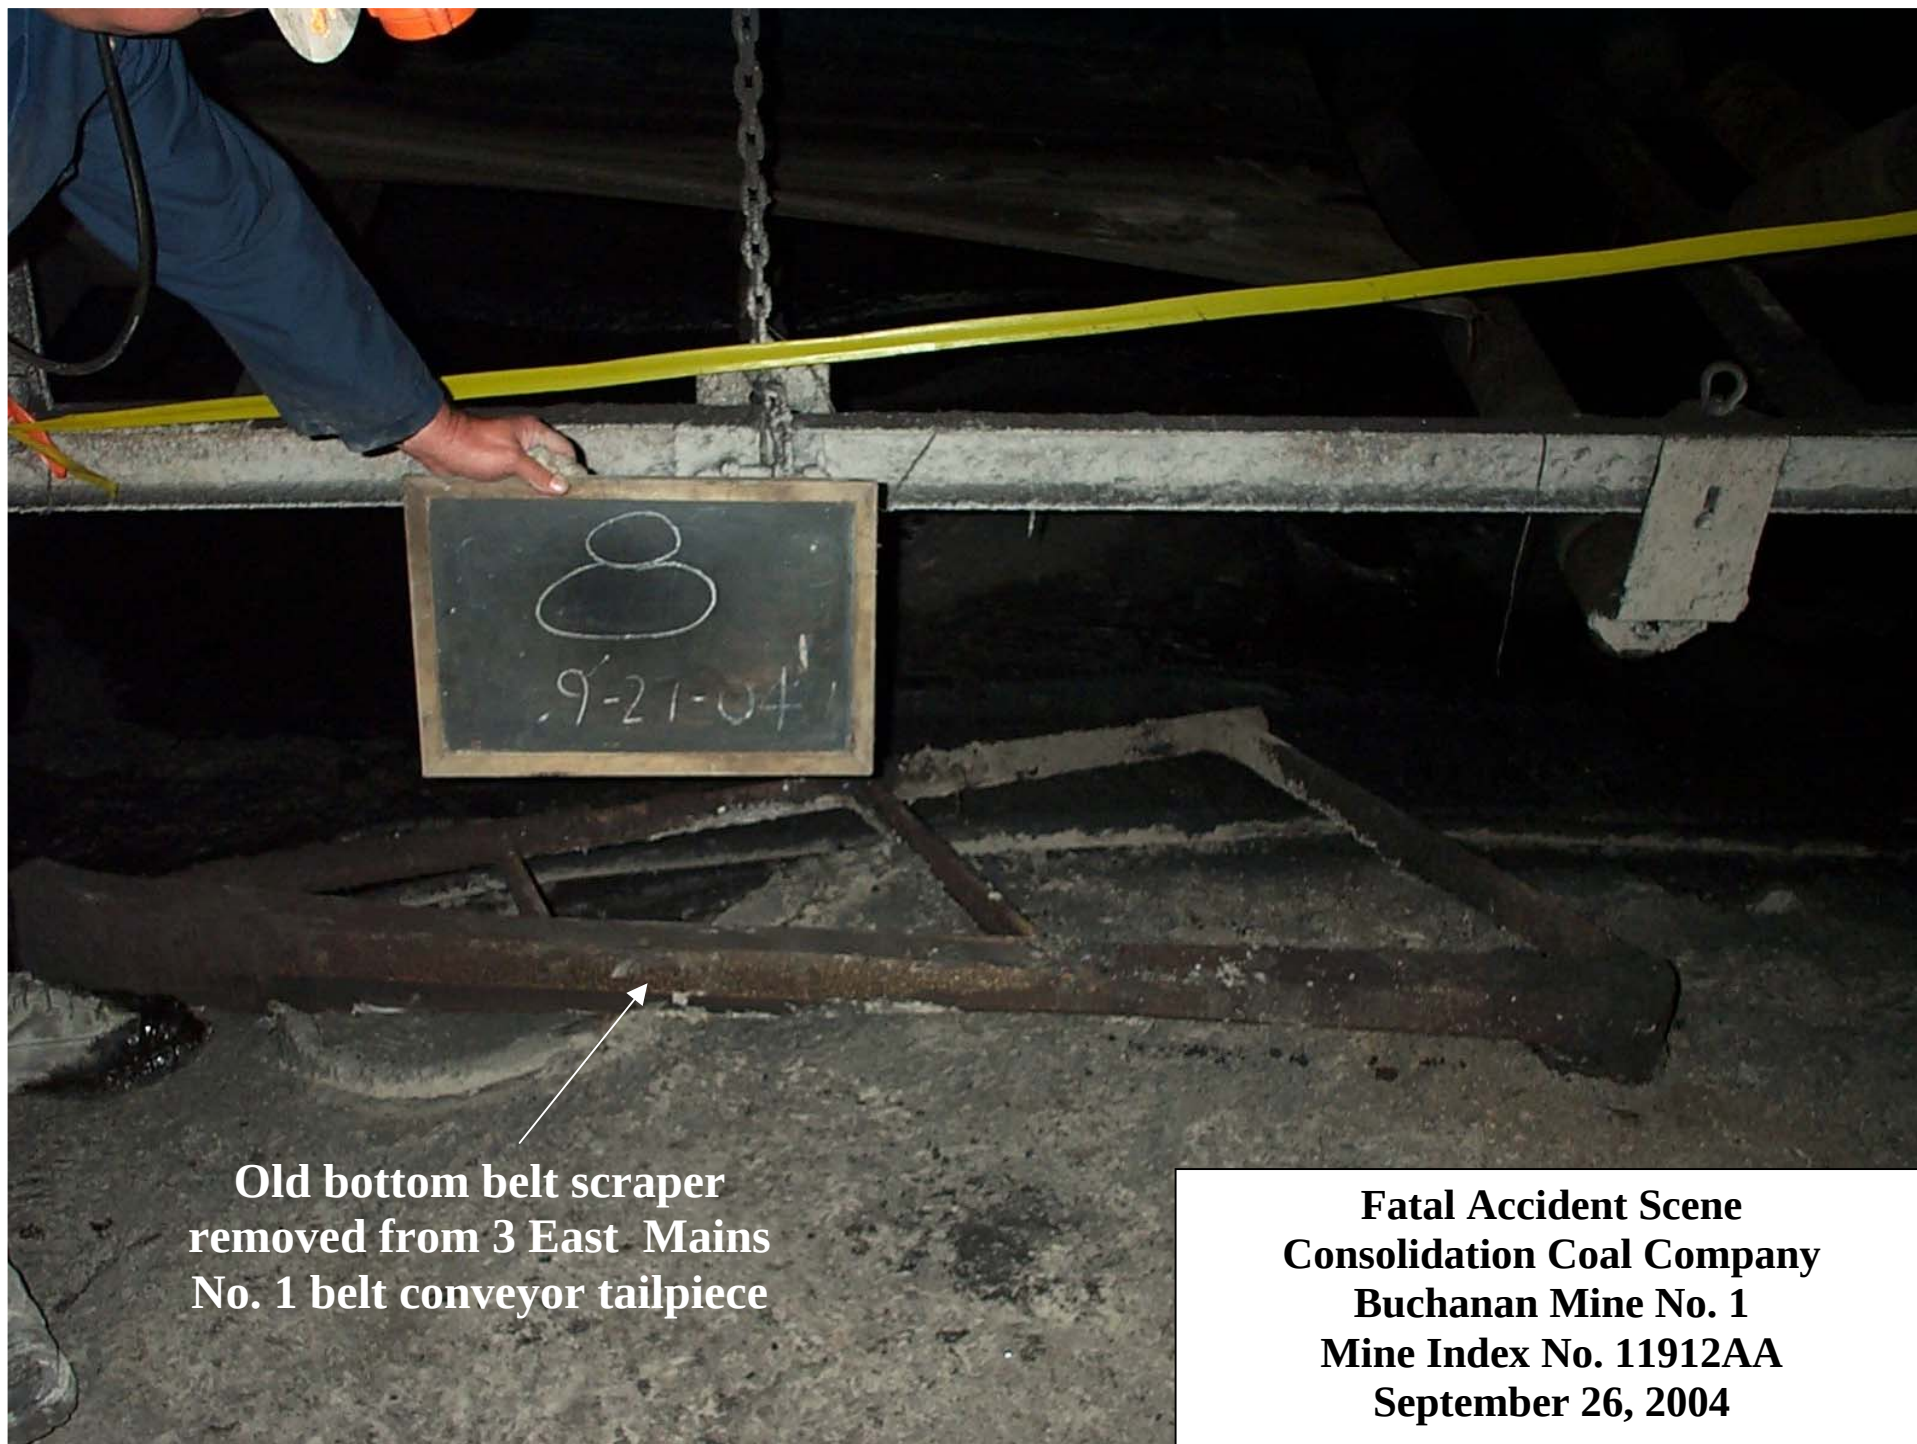
Old bottom belt scraper  
removed from 3 East Mains  
No. 1 belt conveyor tailpiece

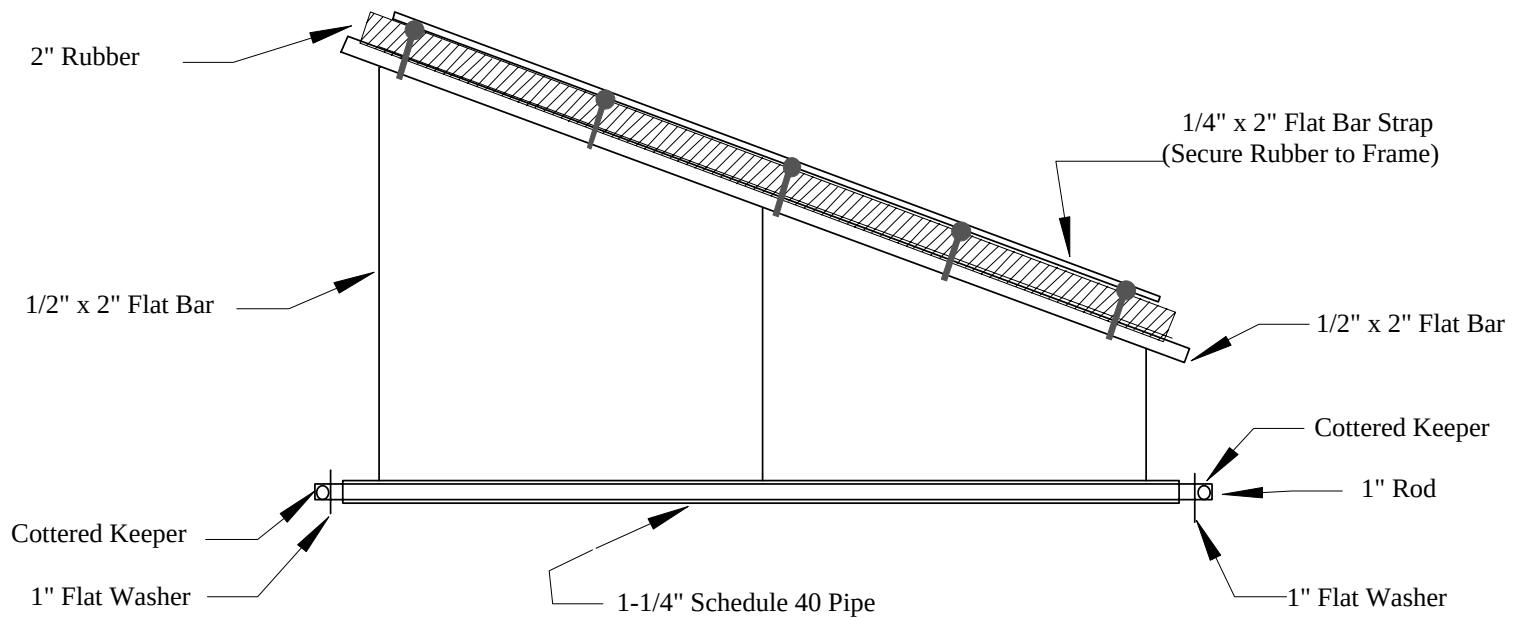
**S and T Welding Company, Inc.**  
**Angled wiper for 54" belt**

13. The replacement bottom belt scraper involved in the accident was manufactured by S and T Welding Company, Inc. The scraper, identified by the manufacturer as an “angled belt wiper”, was constructed specifically to accommodate a belt conveyor 54 inches in width. The scraper / wiper measured 66 inches in length and was attached to metal brackets mounted on the 3 East Mains No. 1 belt conveyor tailpiece, using a one inch by sixty-six inch steel attachment rod. The attachment rod secured the angled scraper / wiper to the tailpiece mounting brackets by using a flat washer and a cottered key fastening system provided on each end of the attachment rod.
