Accident Investigation Report
Underground Coal Mine

Machinery Fatality Investigation Report
October 22, 2003

Paramont Coal Company Virginia, LLC
VICC No. 7 Mine

Mine Index No. 13980AC
Wise County, Virginia

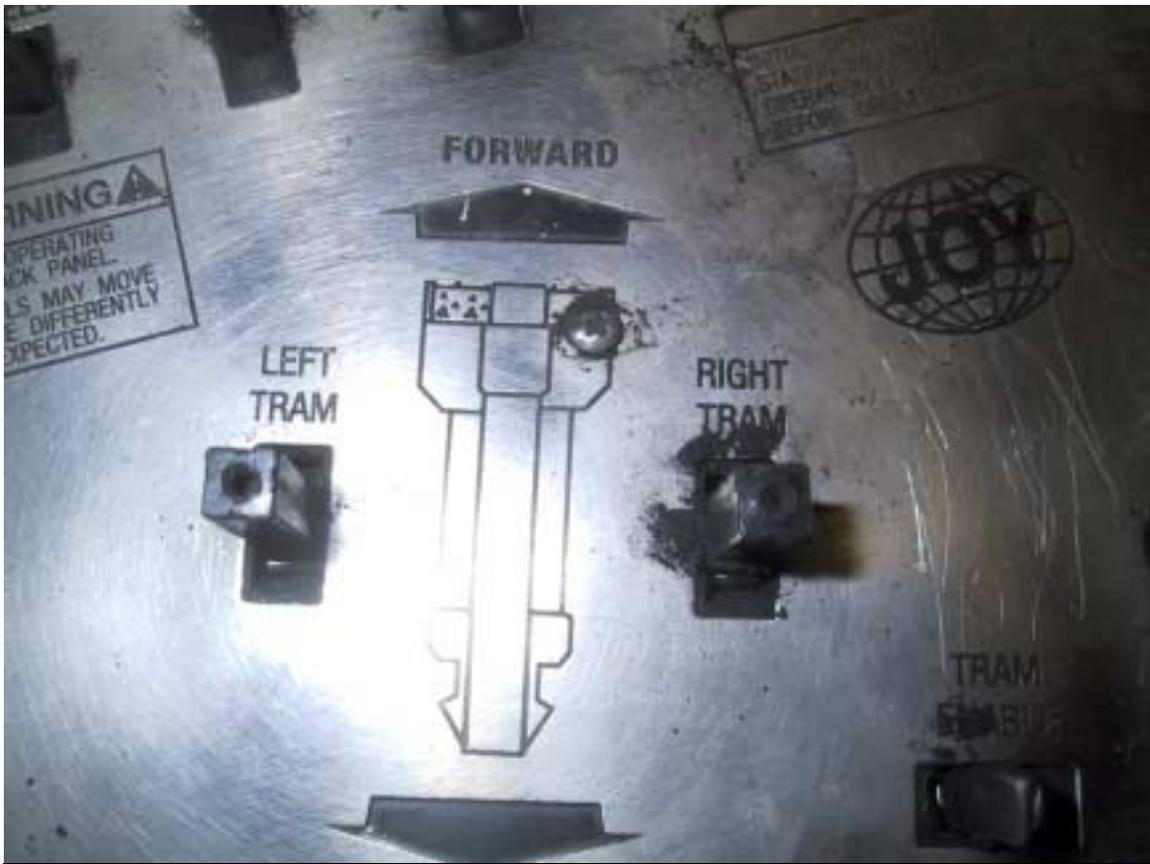
Figure 2, PE-1 Transmitter, tram levers with knobs removed

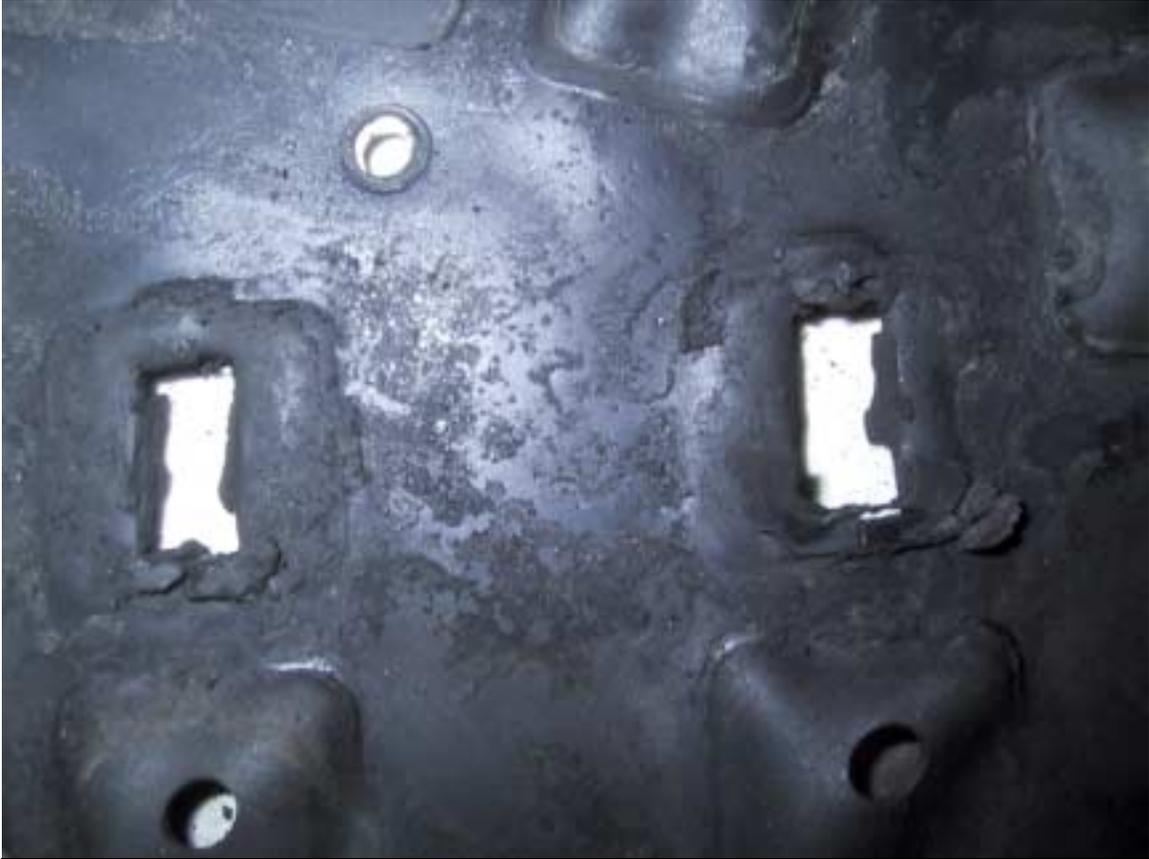
The inspection and testing of the control components revealed that one fault which could have allowed the left tram function to continue upon release of the tram lever. A rubber gasket was found between the cover plate over the switch actuators and the case of the remote control transmitter seen in Figure 1 in Attachment 4. The areas of the gasket around the tram levers, as shown in Figure 2 in Attachment 4, did not conform to the actuator stems. The tram levers measured 6.25 mm x 6.25 mm, and the openings in the cover plate were 15.65 mm x 7.93 mm. As shown in Figure 3 of Attachment 4, the margins of the gasket material at the opening for the tram levers were uneven and did not occupy the space between the lever and cover plate. This allowed an accumulation of dust in the sockets for the tram levers, as shown in Figure 4 of Attachment 4. The socket for the left tram lever was nearly full of dust and dirt, restricting its free travel. The results of the switch calibration test seemed to verify this, as the full range of the output of the left tram switch was only 78% of that of the right tram switch. This accumulation could have also caused the left tram lever to fail to return to its centered position. This could have then caused a forward signal to continue to be transmitted to the continuous mining machine after the tram lever was released.

Figure 3. PE-1 Transmitter, Front Panel cover plate, gasket side view, detail, tram lever openings

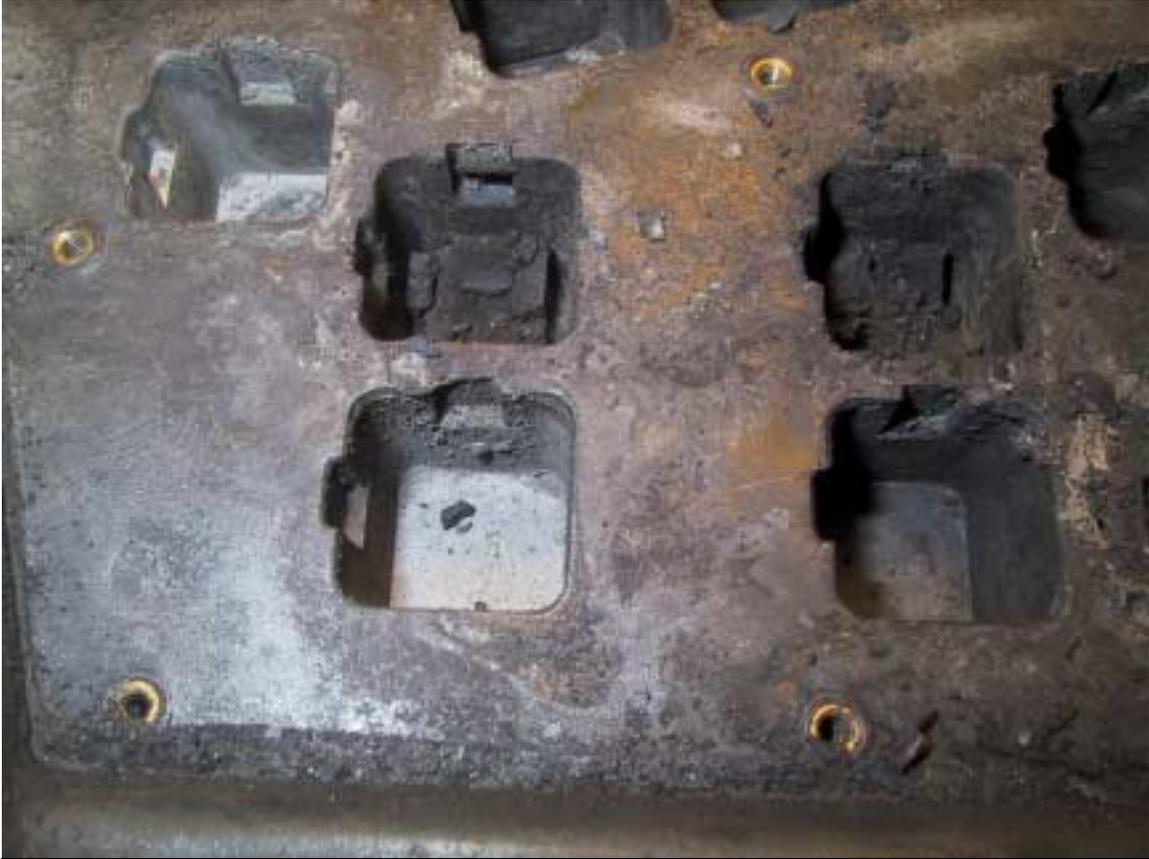
Inspection of the knob and left tram lever revealed no damage to the internal threads of the lever or to the screw hole through the knob. Additionally, the inspection revealed that the socket for the left tram lever was packed with coal dust, as was the socket for the right tram lever, albeit to a lesser extent. A rubber gasket was found between the cover plate over the switch actuators and the case. The areas of the gasket around the tram levers, and especially the left tram lever, were not tight against the actuator stems. The lever measured 6.25 mm x 6.25 mm, and the opening in the cover plate was 15.65 mm x 7.93 mm. The gap between the lever and the cover plate allowed an accumulation of dust in the sockets for the tram levers. The gasket material was not effective for excluding dust and other contamination at the area of the tram levers.

Figure 4. PE-1 Transmitter, tram lever sockets (two in center top)

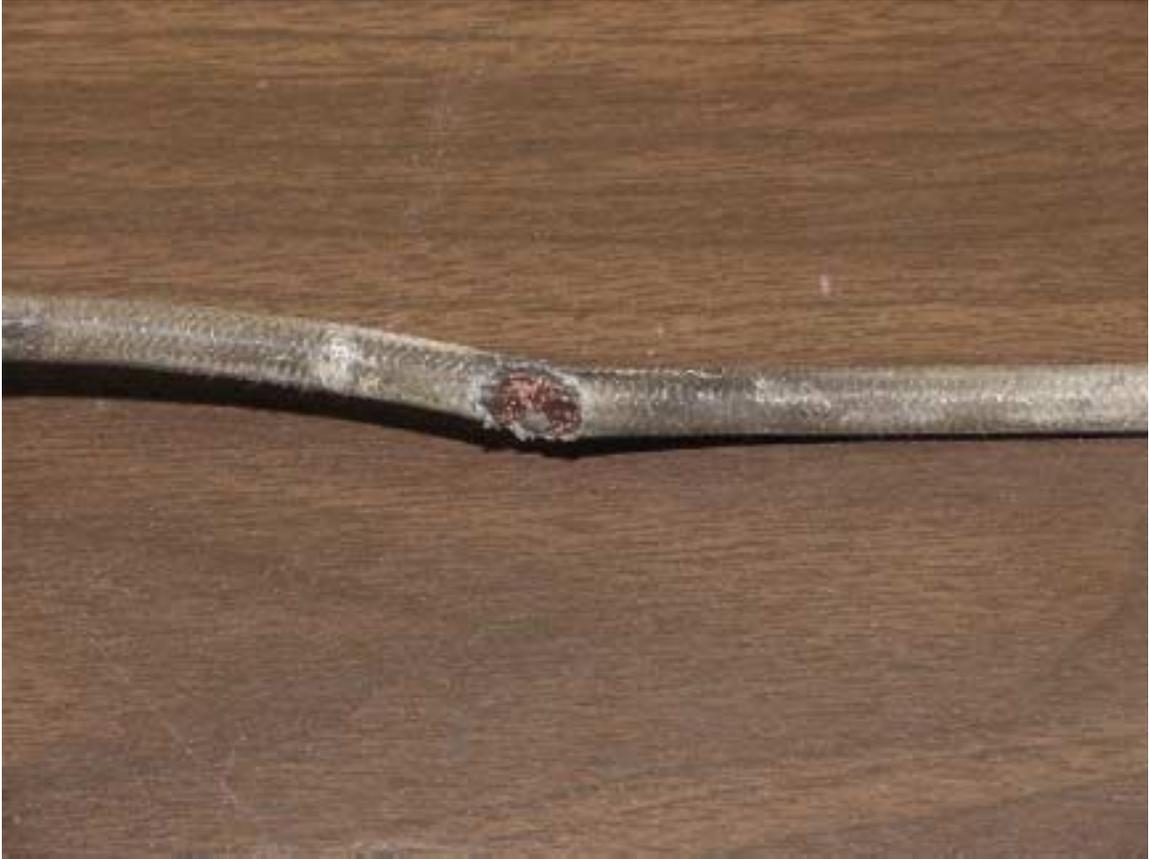
- 3.4 Antenna, PE-19. The housing for the antenna was damaged, but the antenna was not.
 - 3.5 B-Phase Cable, PE-17. The cable had a damaged area that had conductor strands that appeared to be fused or melted together, having a copper-like appearance. The insulation material in the immediate vicinity of the damaged area appeared to be discolored. The effect of grounding the damaged area of the cable was tested by bringing it into continuous contact, and intermittent contact, with the grounded machine frame at the mine site. The left tram function did not continue to operate after the tram levers were released during this testing. Tests were also conducted on a similar machine, with the PE-8 firing package, and the PE-13 and PE-14 SCR bridges installed, by intermittently grounding using controlled contacts at higher frequencies, with no continuation of left tram function.

Figure 5. Damaged Area of B-Phase Power Cable

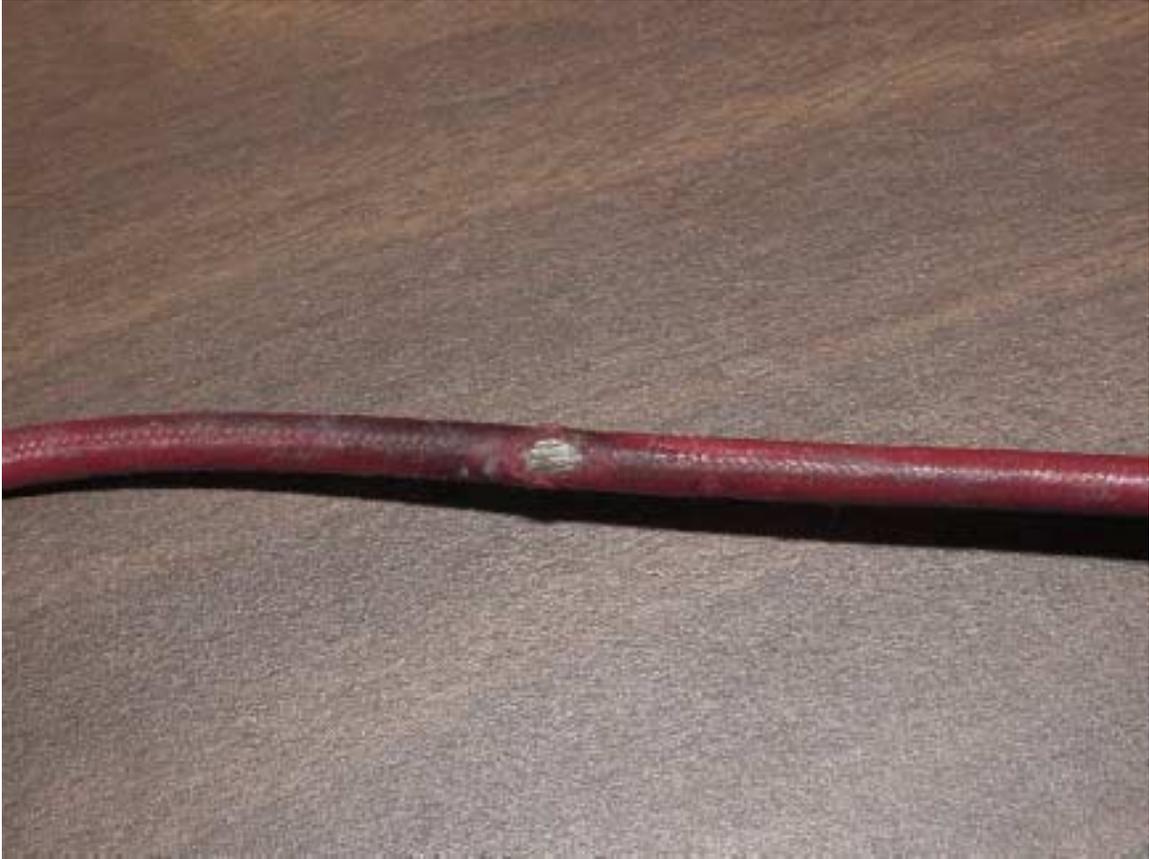
- 3.6 C-Phase Cable, PE-18. The cable had insulation damage in one area. The conductor strands did not appear to be fused. The wire strands had a silver-like appearance. The insulation material in the immediate vicinity of the damaged area did not appear to be discolored.

Figure 6. Damaged Area of C-Phase Power Cable
