Virginia Department of Mines, Minerals & Energy
Division of Mines

Accident Investigation Report
Surface of Underground Coal Mine

Fatal Electrical Accident
October 23, 2004

Omega Mining, Inc.
Southern Crescent Mine
Mine Index No. 14333AC
Russell County, Virginia

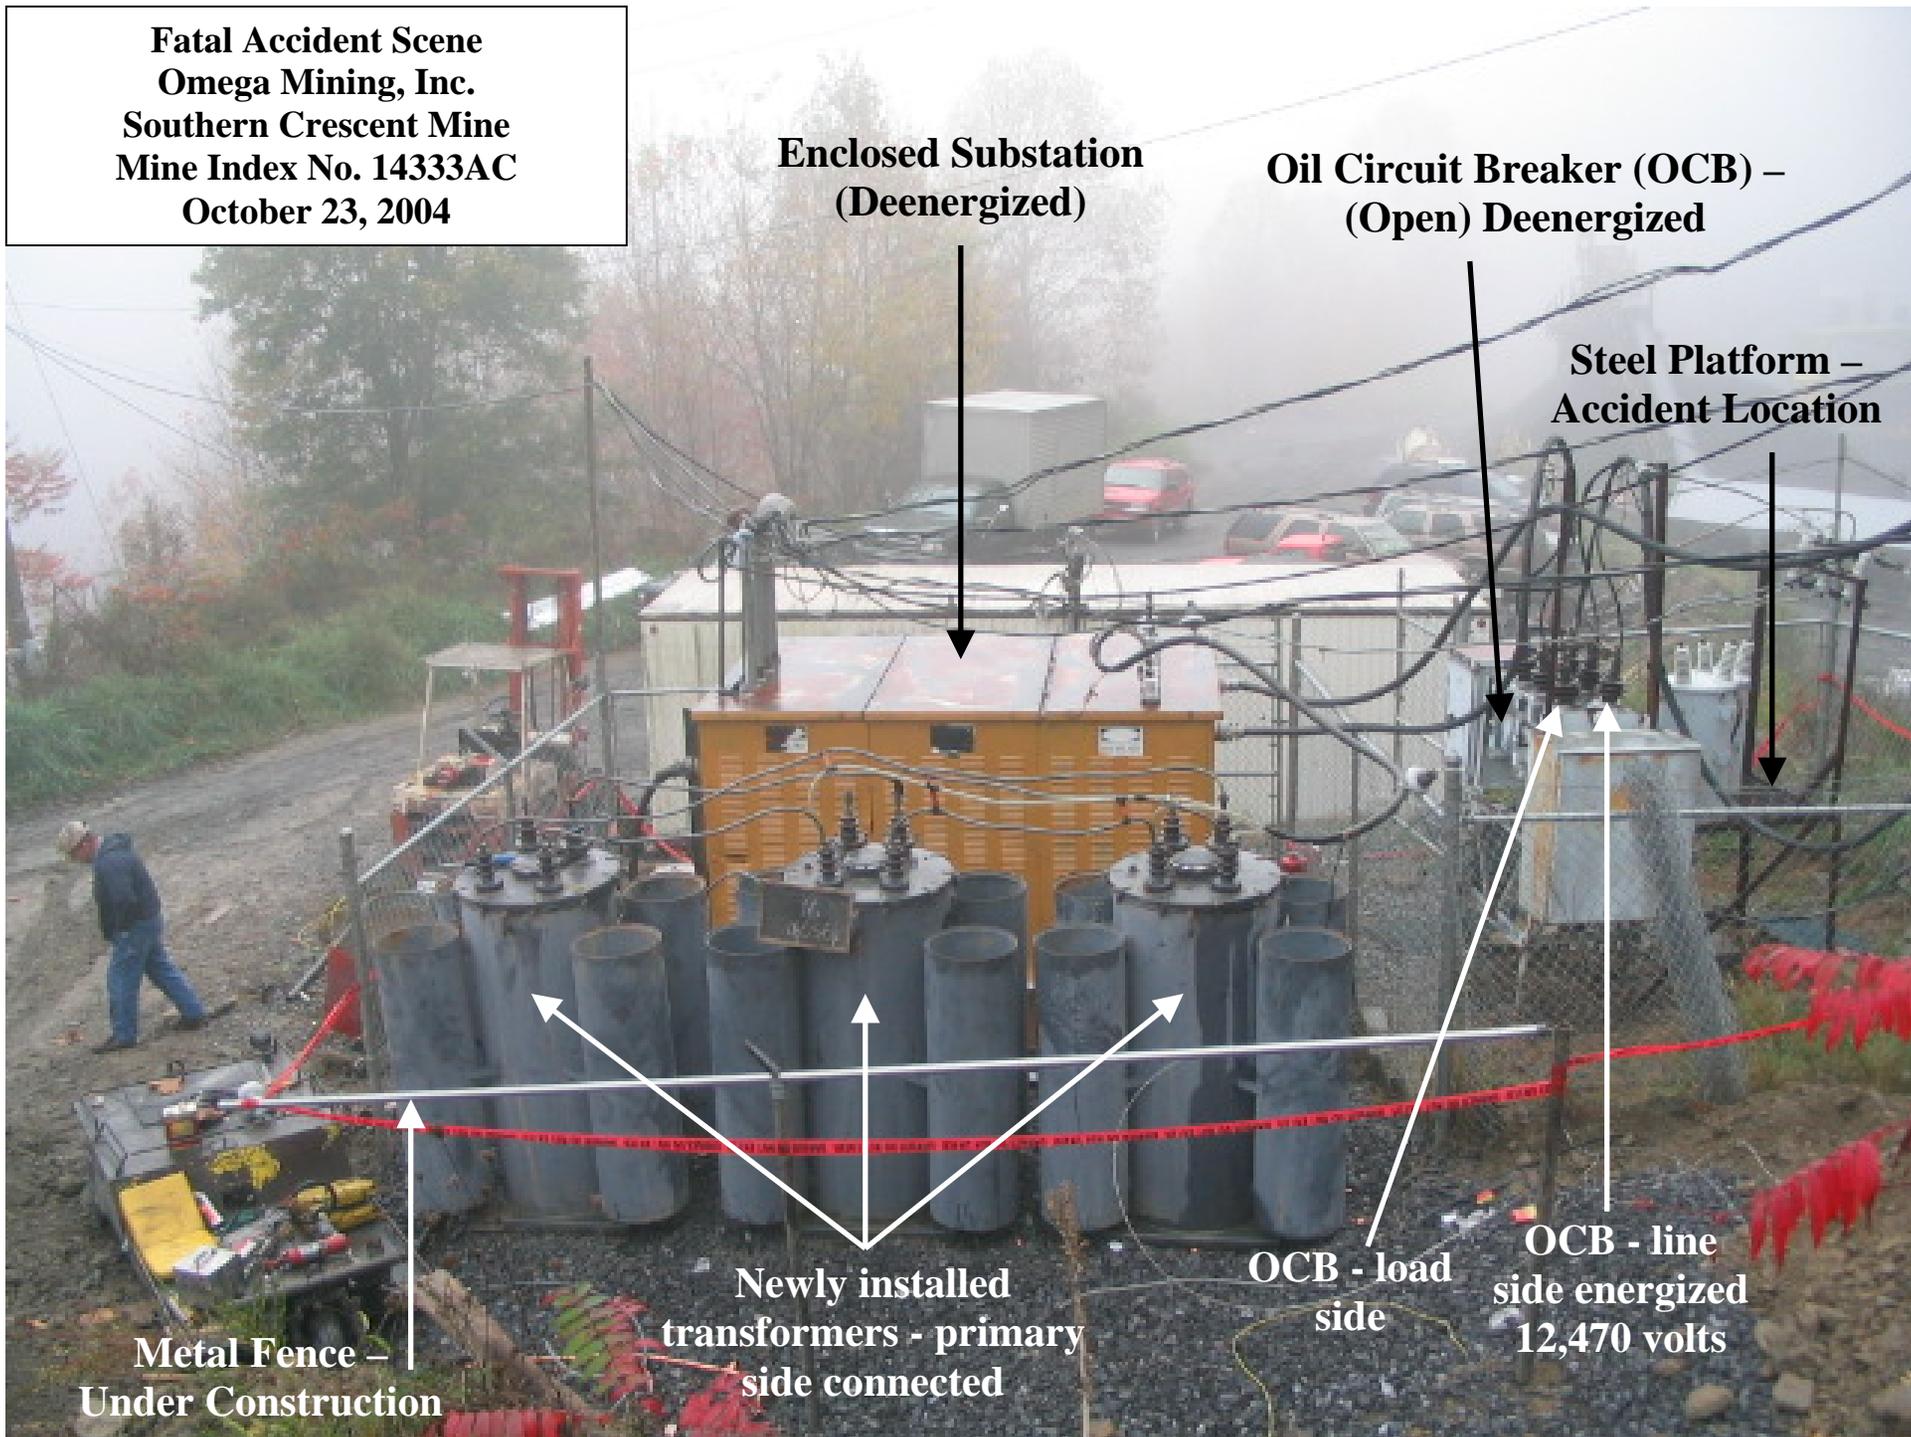
**Metal Fence –
Under Construction**

**Newly installed
transformers - primary
side connected**

**OCB - load
side**

**OCB - line
side energized
12,470 volts**

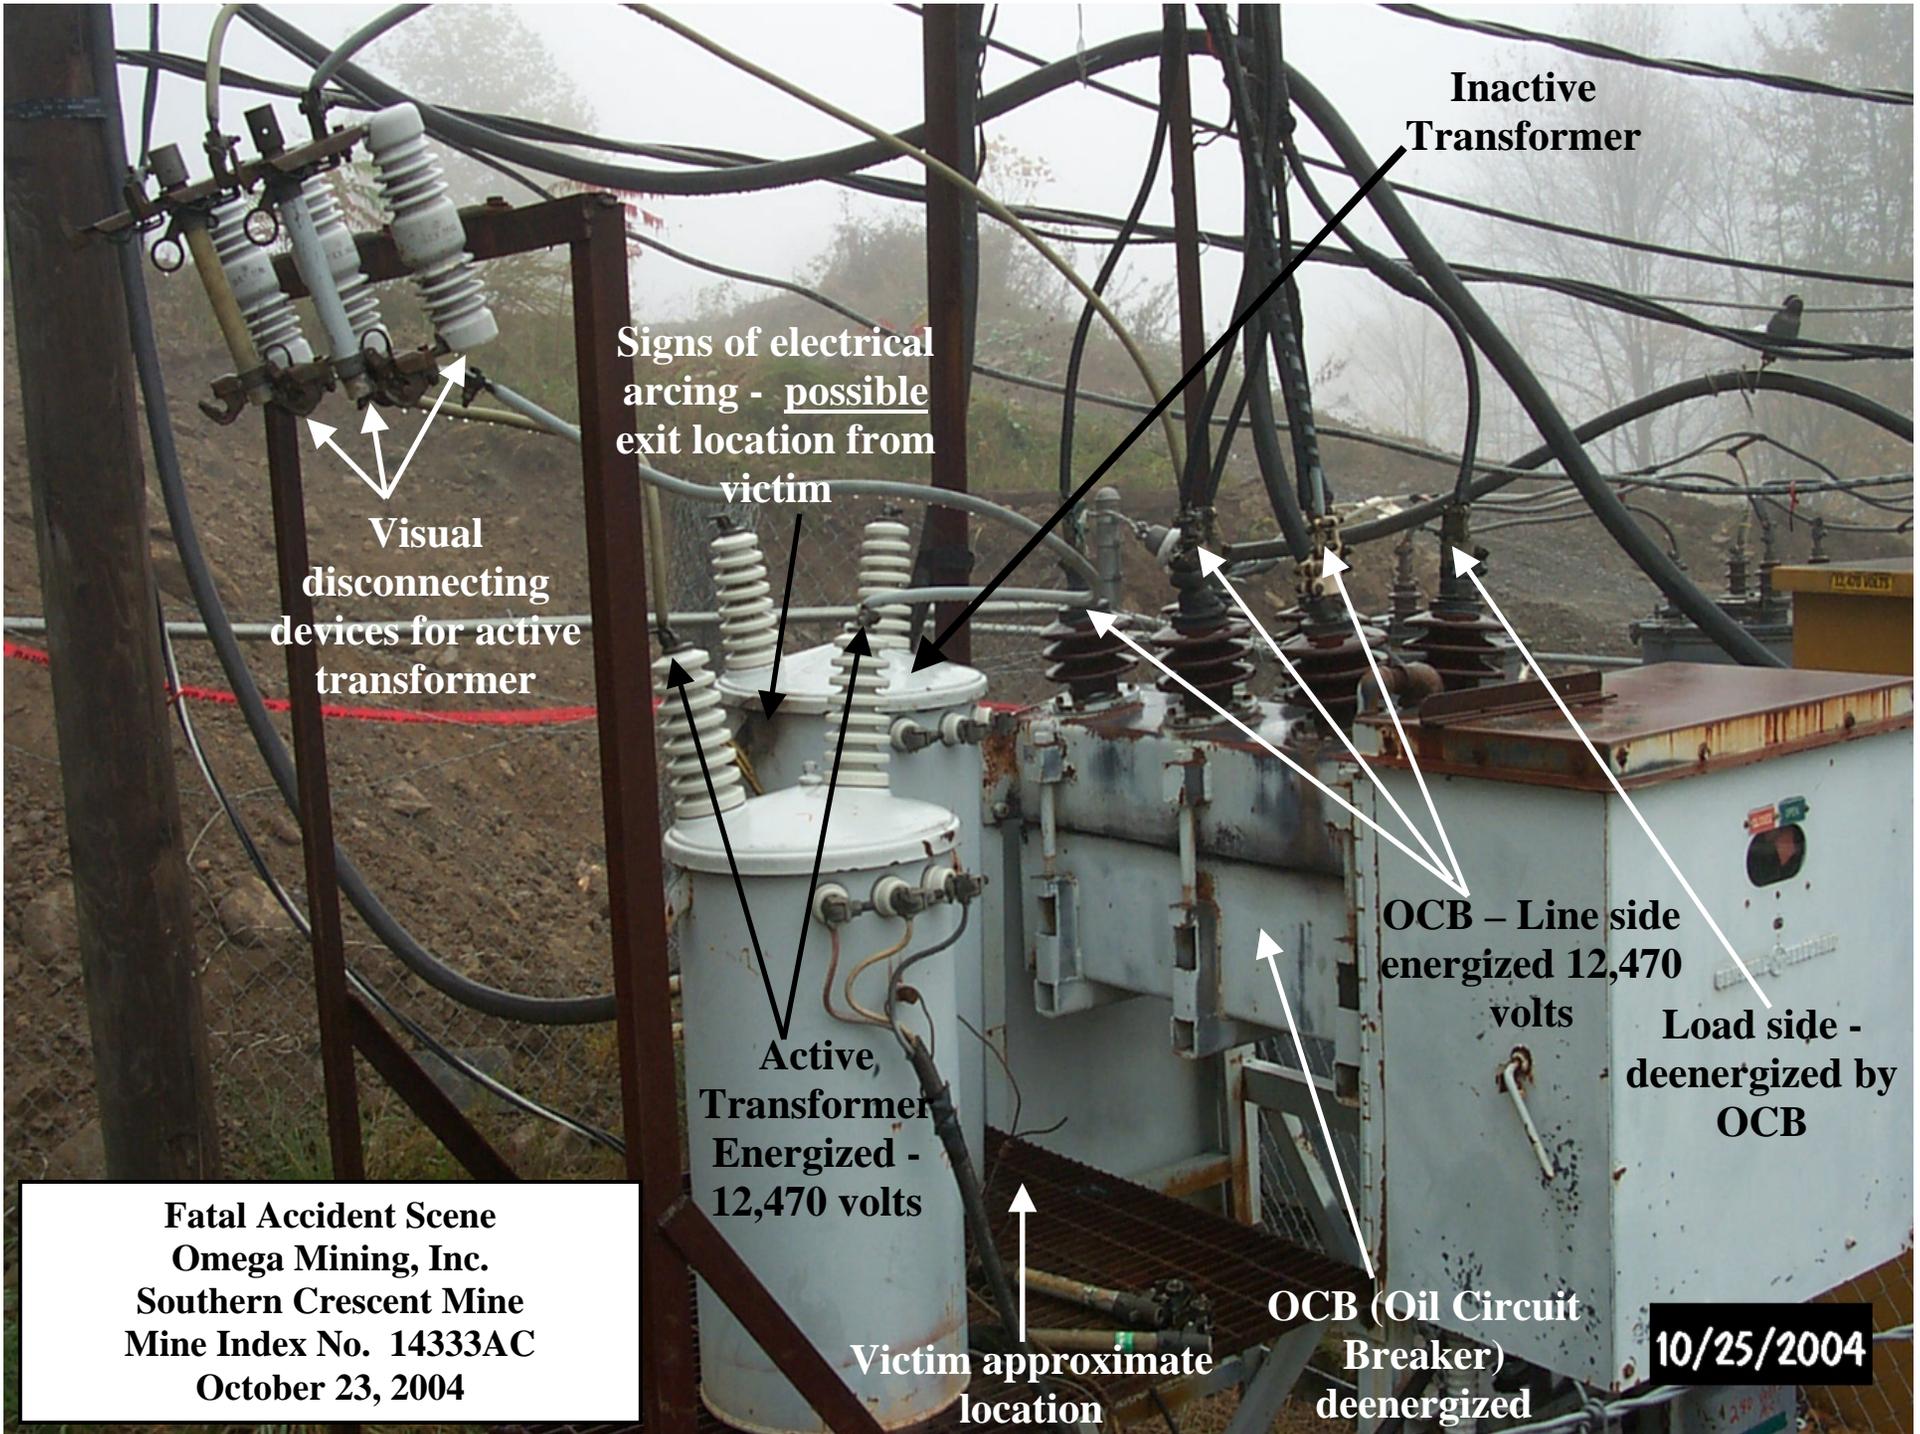
**Inactive 30 KVA
Transformer –
(Out of Service)**

**Active 25 KVA
Transformer
Energized –
12,470 volts**

**Possible exit
location from
victim**

**Possible entrance
locations to victim**

**Grounding
clamp leads**

**Victim approximate
location**

**Inactive
Transformer**

**Signs of electrical
arcing - possible
exit location from
victim**

**Visual
disconnecting
devices for active
transformer**

**Active,
Transformer
Energized -
12,470 volts**

**OCB - Line side
energized 12,470
volts**

**Load side -
deenergized by
OCB**

**OCB (Oil Circuit
Breaker)
deenergized**

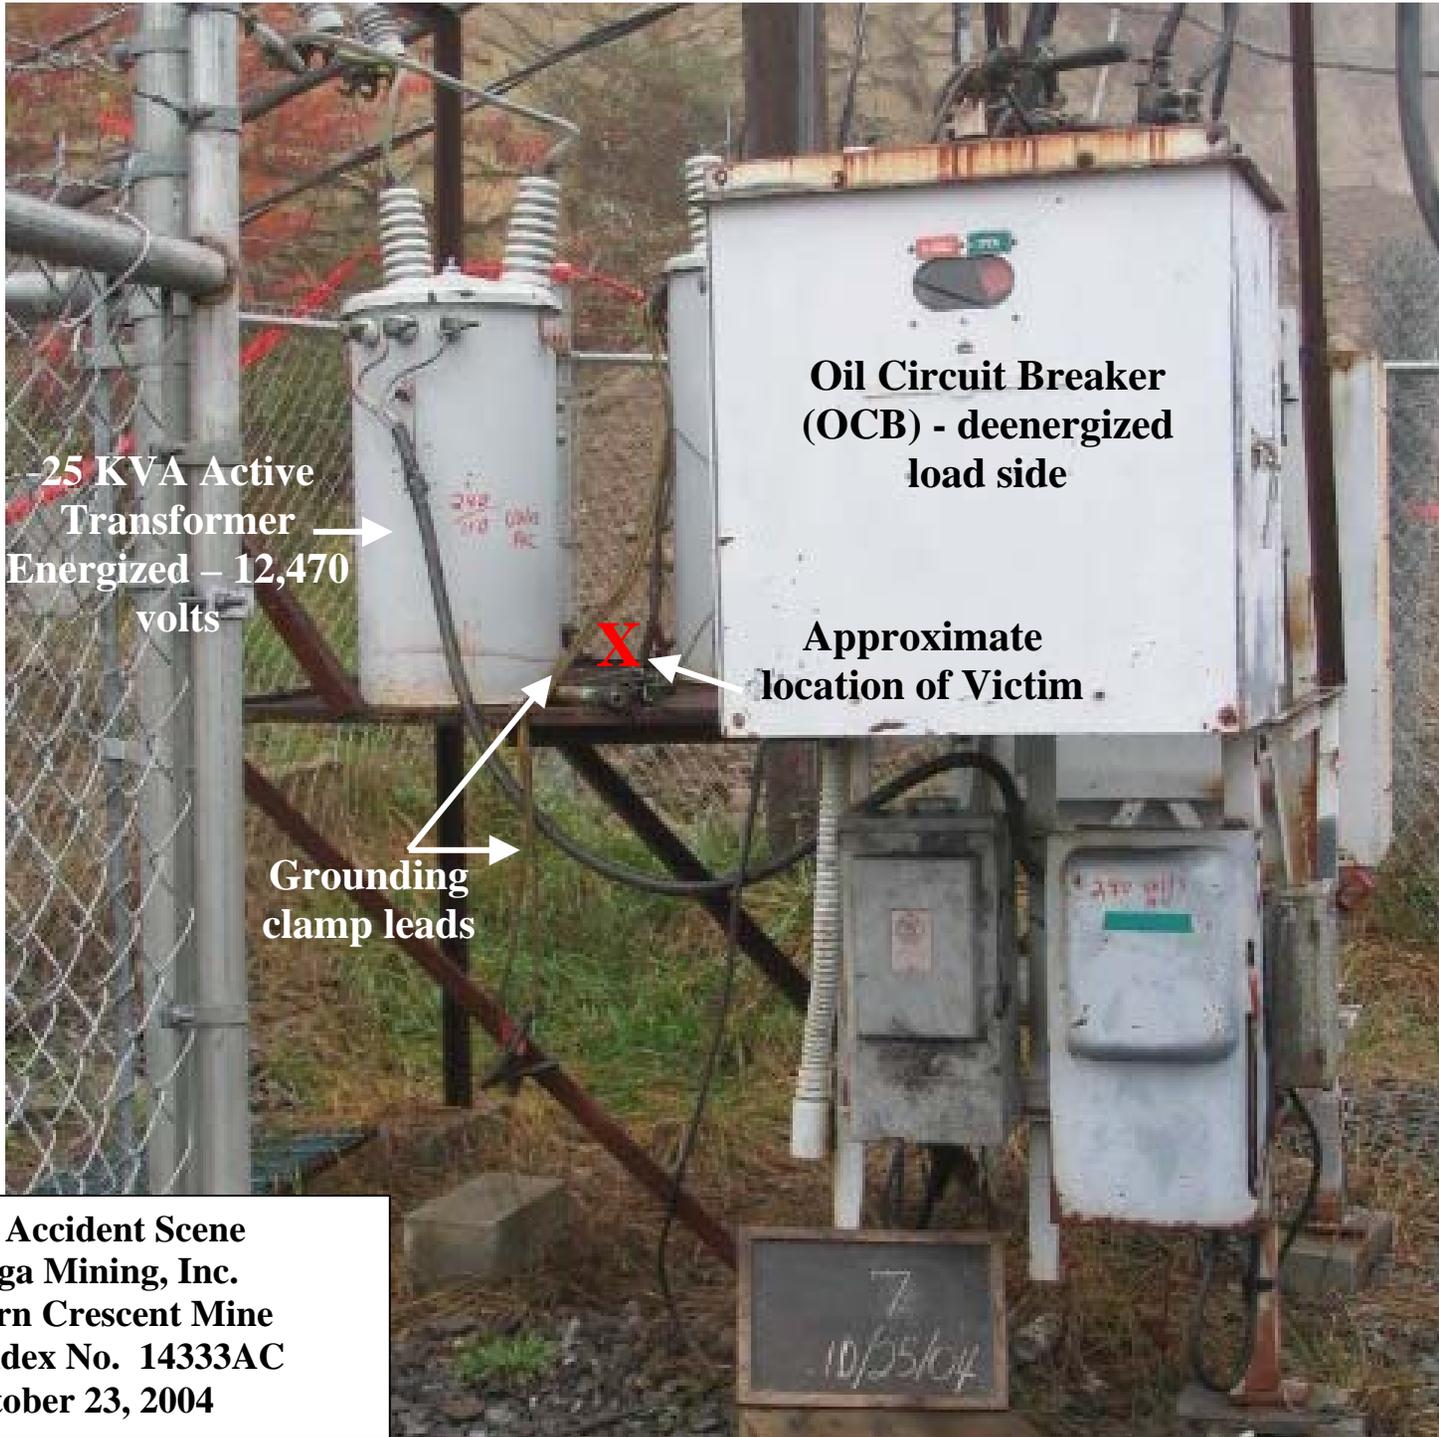
-25 KVA Active
Transformer →
Energized – 12,470
volts

**Oil Circuit Breaker
(OCB) - deenergized
load side**

**Approximate
location of Victim**

**Grounding
clamp leads**

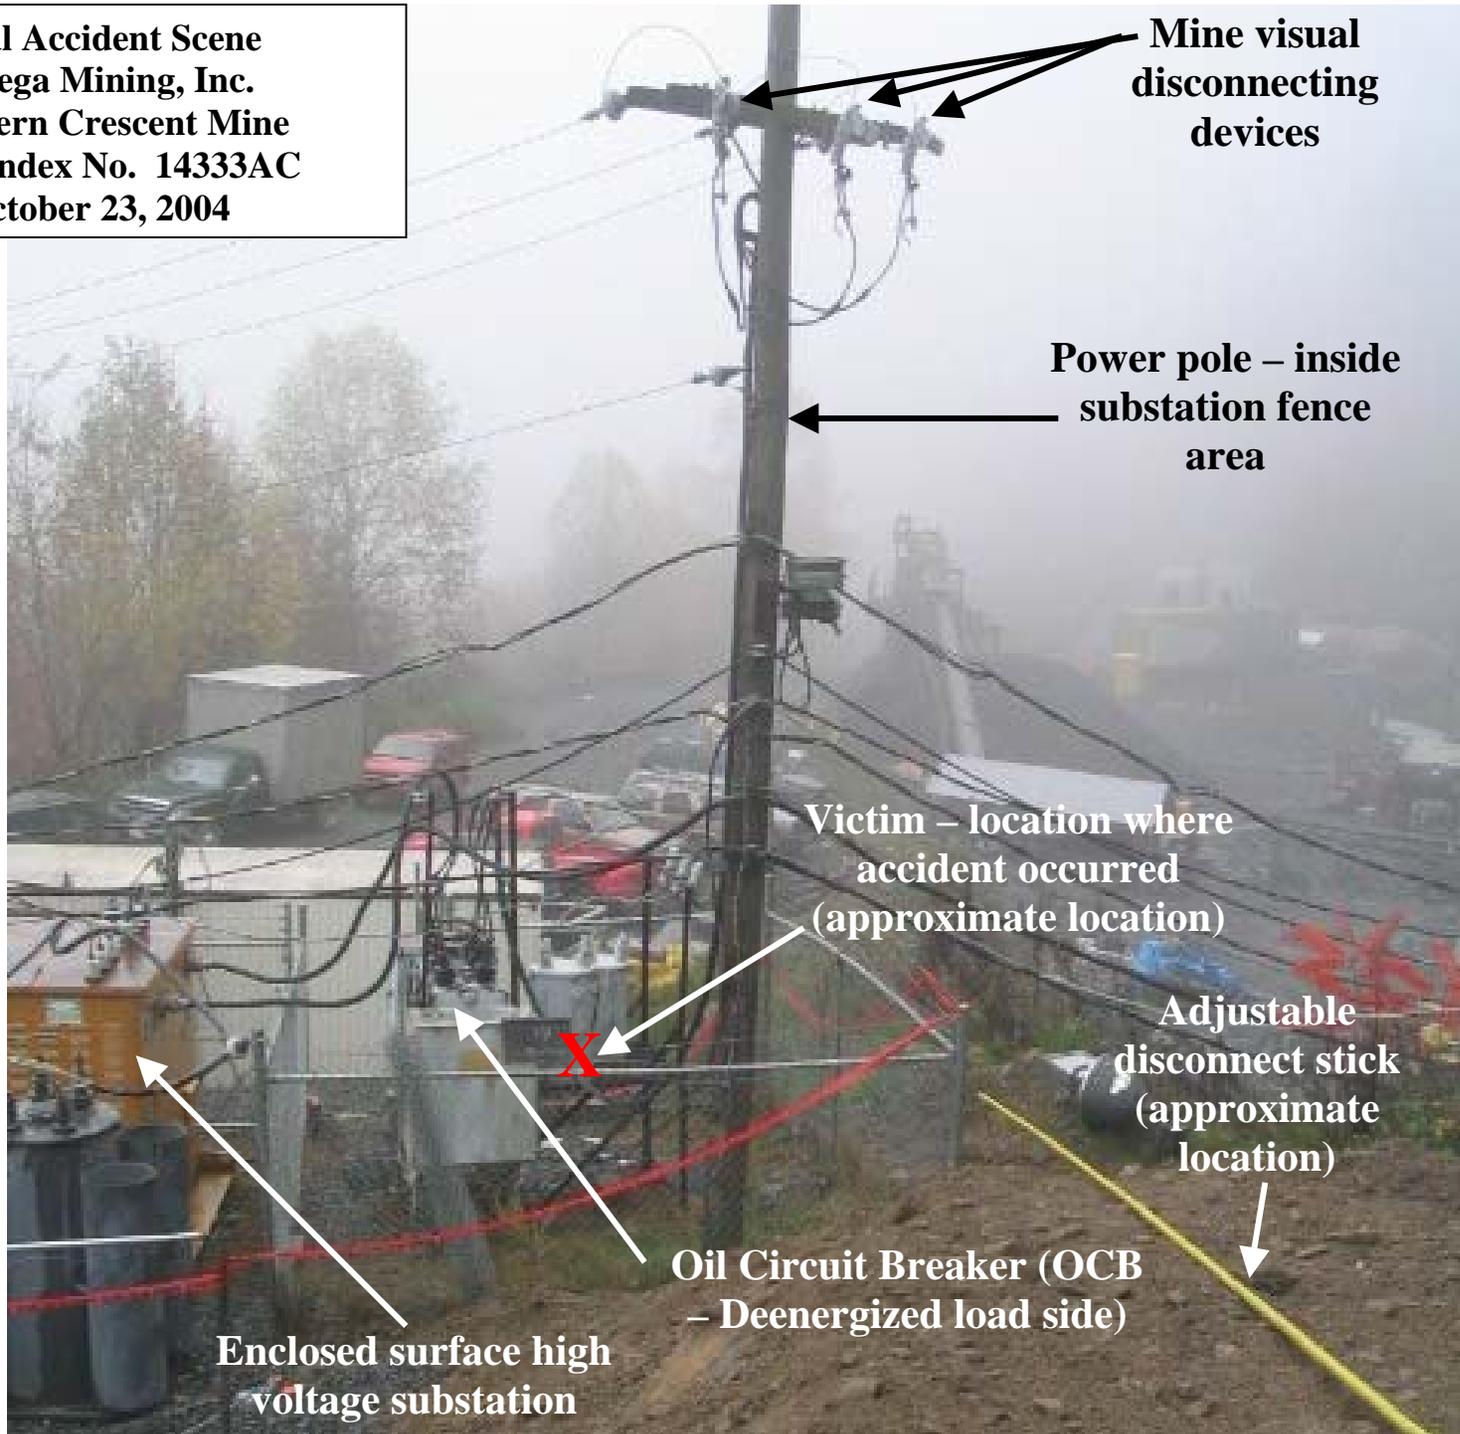
**American Electrical Power (AEP)
disconnecting devices**

**Mine visual
disconnecting devices**

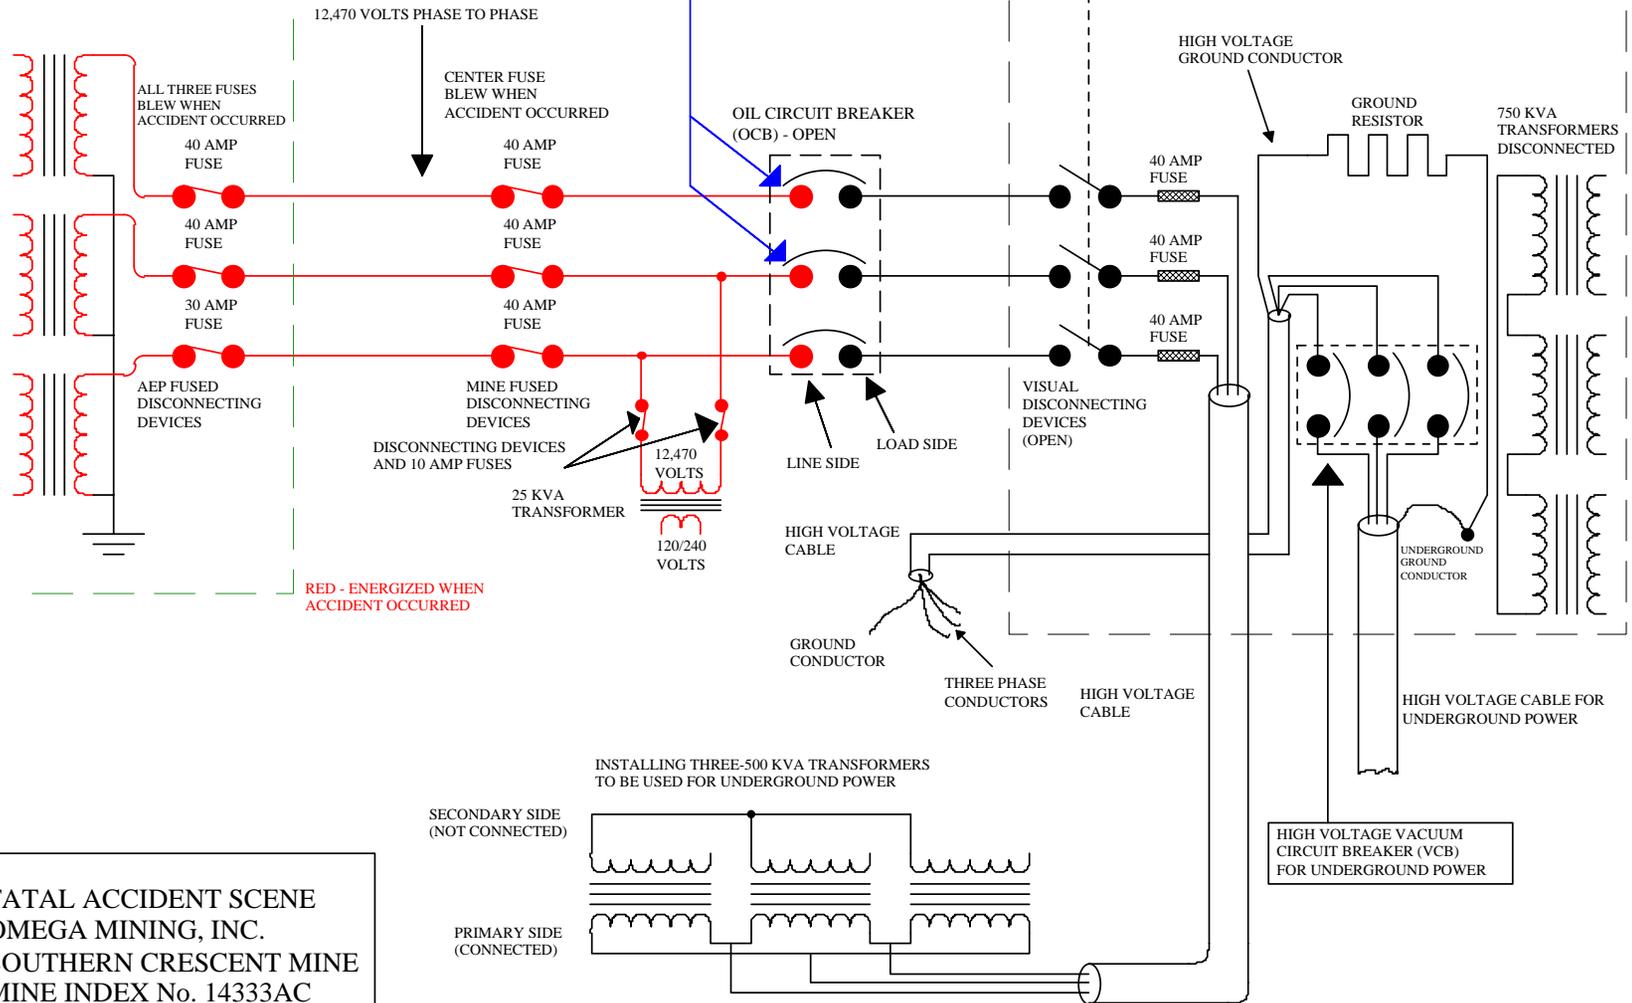
VICTIM CONTACTED ENERGIZED
12,470 VOLTS PHASE TO PHASE

ENCLOSED SUBSTATION

RED - ENERGIZED WHEN
ACCIDENT OCCURRED

INSTALLING THREE-500 KVA TRANSFORMERS
TO BE USED FOR UNDERGROUND POWER

SECONDARY SIDE
(NOT CONNECTED)

PRIMARY SIDE
(CONNECTED)

HIGH VOLTAGE VACUUM
CIRCUIT BREAKER (VCB)
FOR UNDERGROUND POWER
