Fatality Investigation Report

Fatal Roof Fall Accident

May 31, 2024

Buchanan #1 Mine

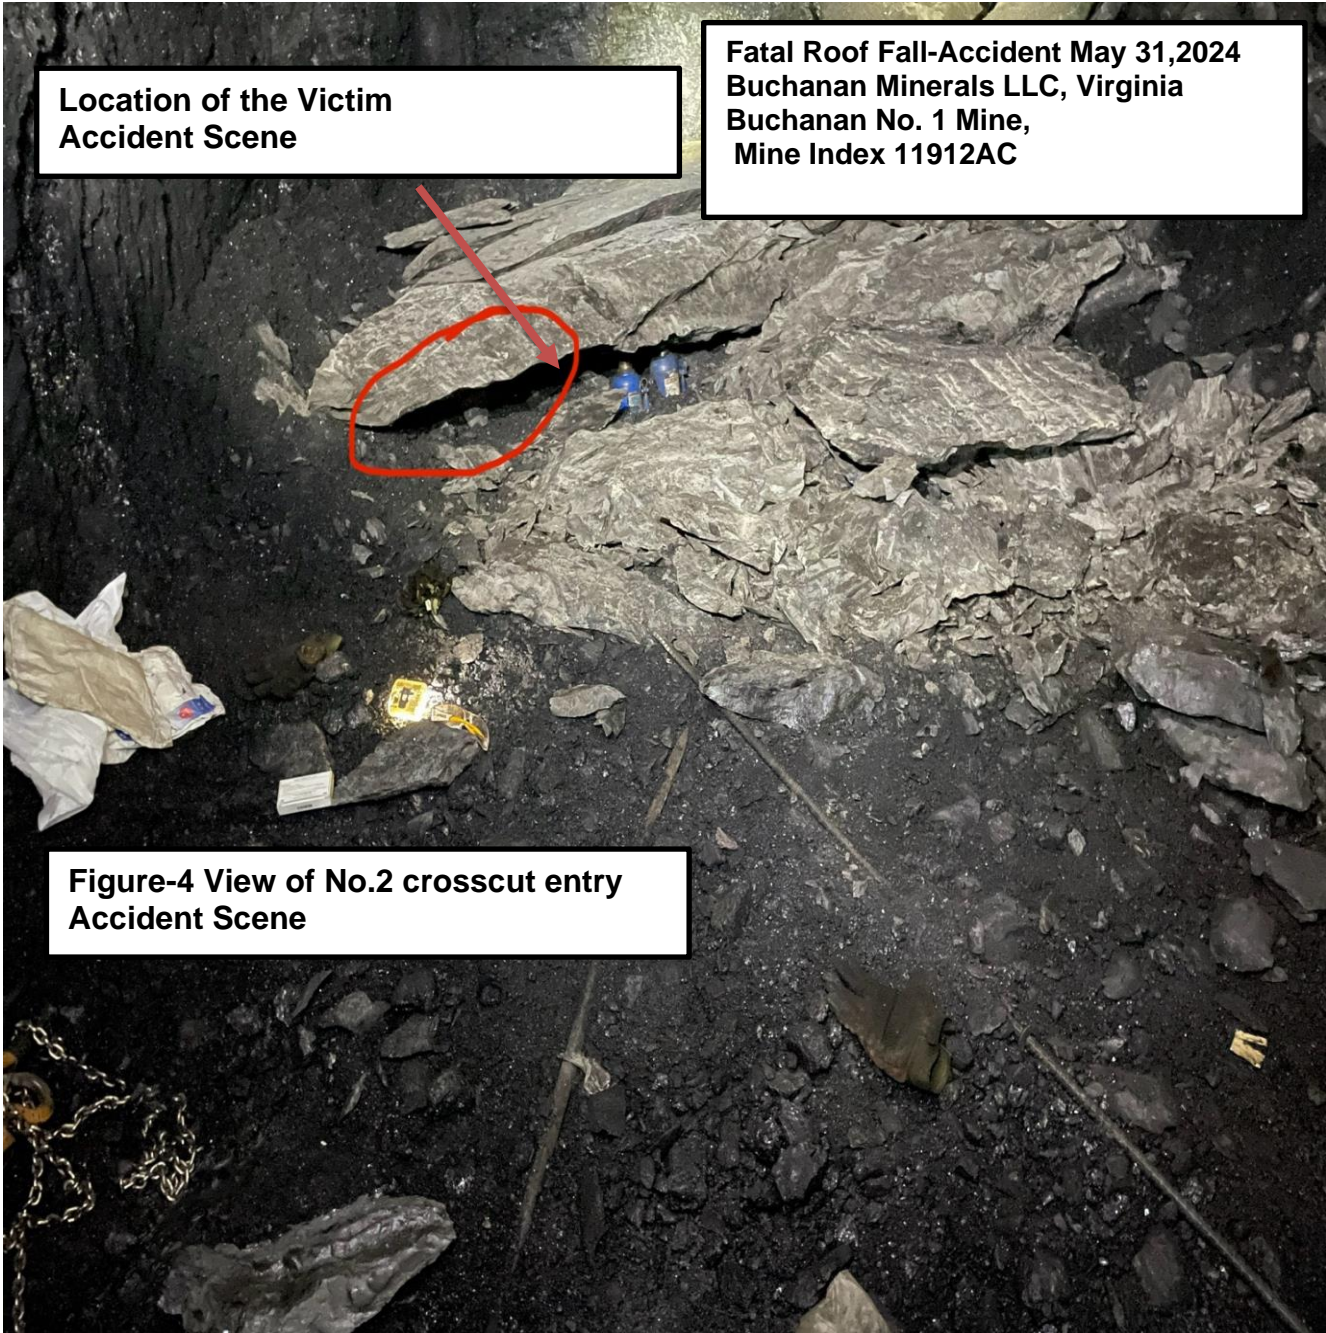
**Figure-4 View of No.2 crosscut entry
Accident Scene**

**Location of the Victim
Accident Scene**
