## Geotechnical Quick Report on the Affected Region of the 23 August 2011 M5.8 Central Virginia Earthquake near Mineral, Virginia

EDITOR: James R. Martin, II, Team Leader (Virginia Tech, Blacksburg, VA)

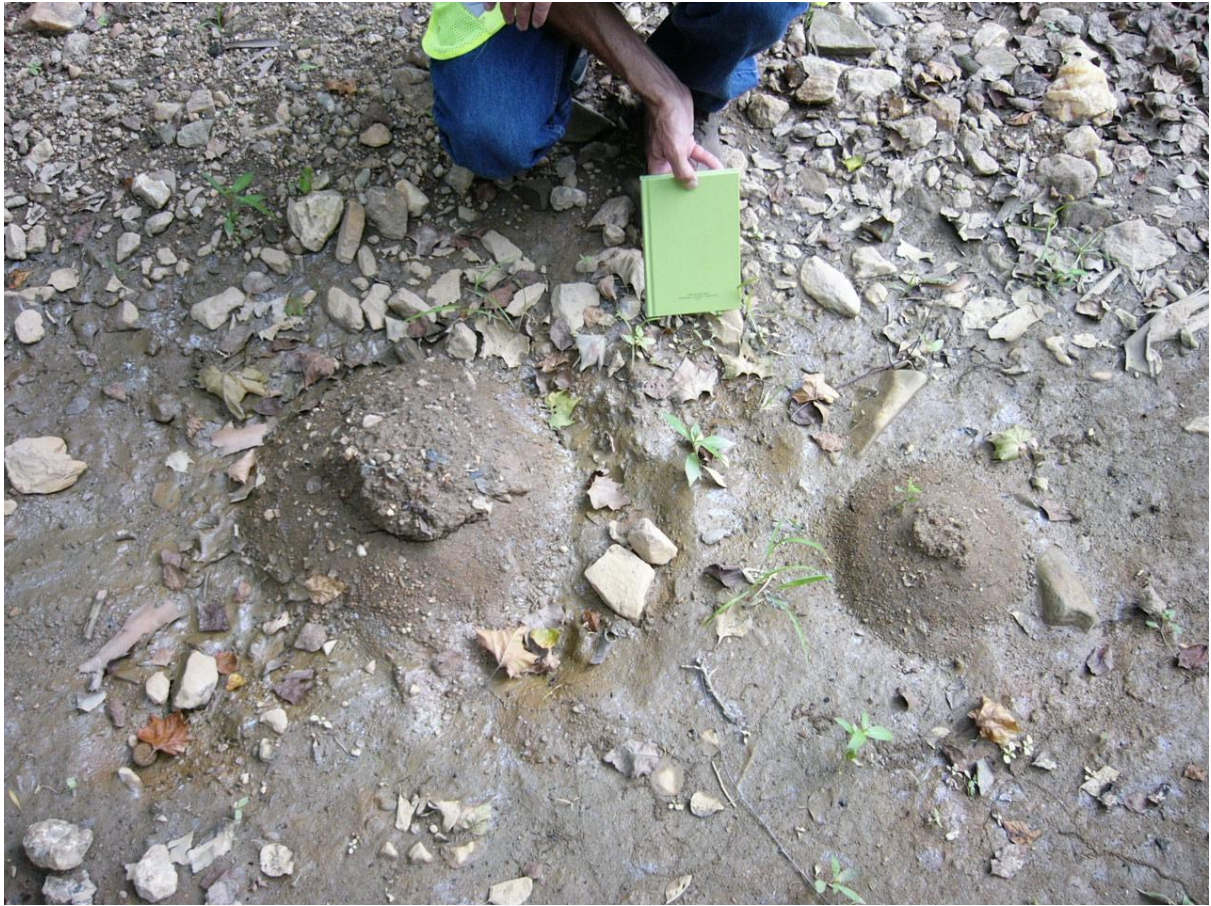
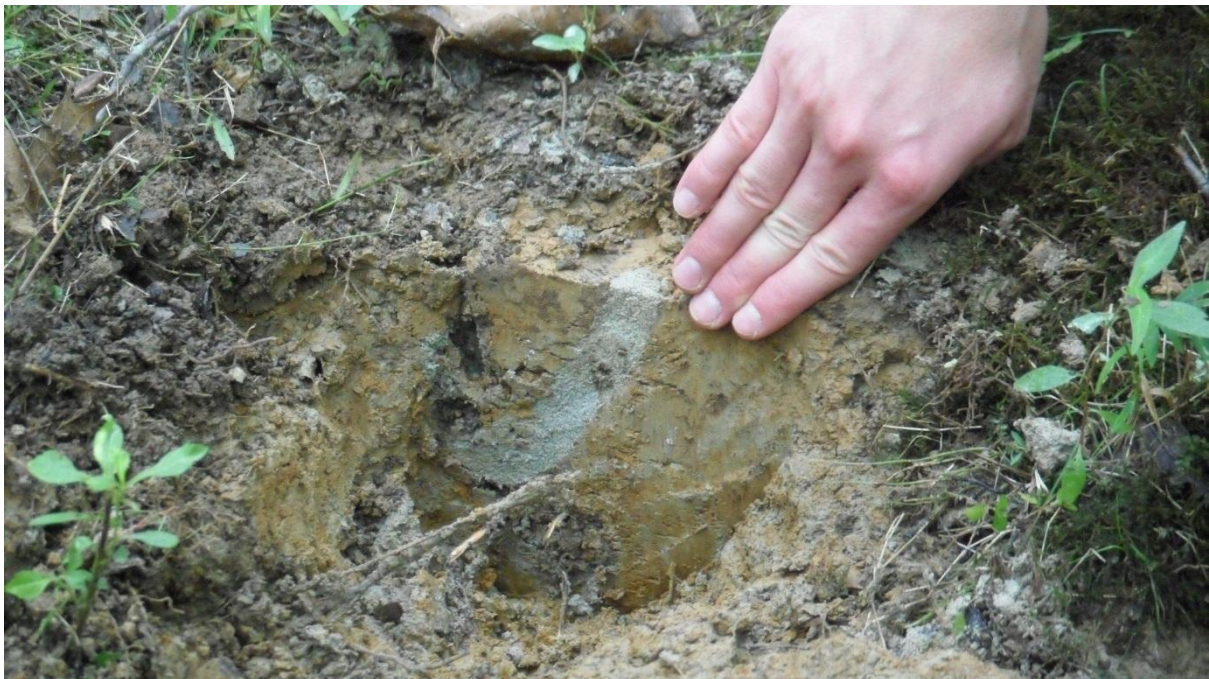
The liquefied soil was coarse sand, with the feature in the drainage channel containing some plasticity. No feeder dikes could be found for the features in the S. Anna River riverbed (Figure 2b), but the riverbed was very gravelly and the water table was only an inch or two below the ground surface. As a result, a clean cut could not be made vertically through the feature and the cut quickly filled with water. The features on the roadside (Figures 2c,d) and the feature in the drainage channel in the woods (Figures 2e,f) both appeared to have vented through existing animal holes or burrows.

Figure 2. Liquefaction sand boils found in the epicentral region: (a) two sand boils in the S. Anna River riverbed near Yancy Mill (features found by Jeff Munsey, TVA) (37.93839, 77.98269); (b) cross-sectional cut through one of the sand boils in the S. Anna River riverbed. The trowel points to a layer of leaves, indicating that the blow material was recently placed; (c) sand boil found across the road from the features in the riverbed (feature found by Ed Harp, USGS) (37.93807, -77.98238); (d) horizontal cut through the roadside feature showing a plan view of the feeder dike; (e) sand boil found in a drainage channel in the woods of Bend

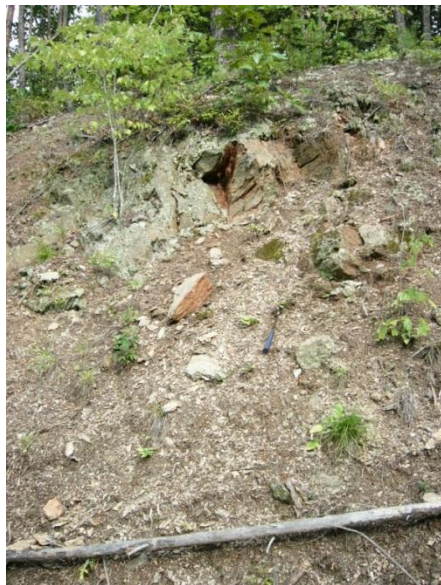
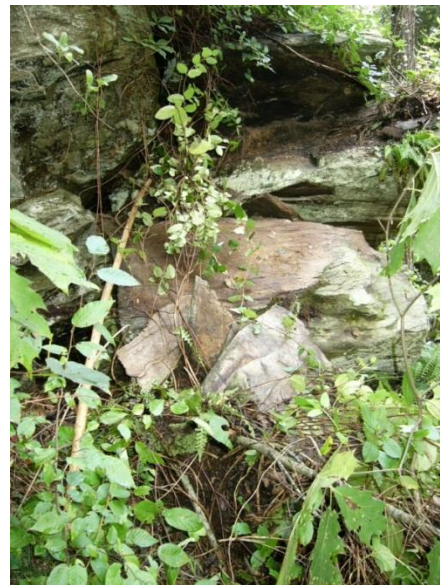
Figure 14. Rock falls found in the epicentral region (source: Mark Carter): (a) rockfall along Shannon Hill Rd (37.93174, -77.96190); and (b) rockfall along Vigor Rd, near the intersection with Yanceyville Rd (37.93802, -77.98245).

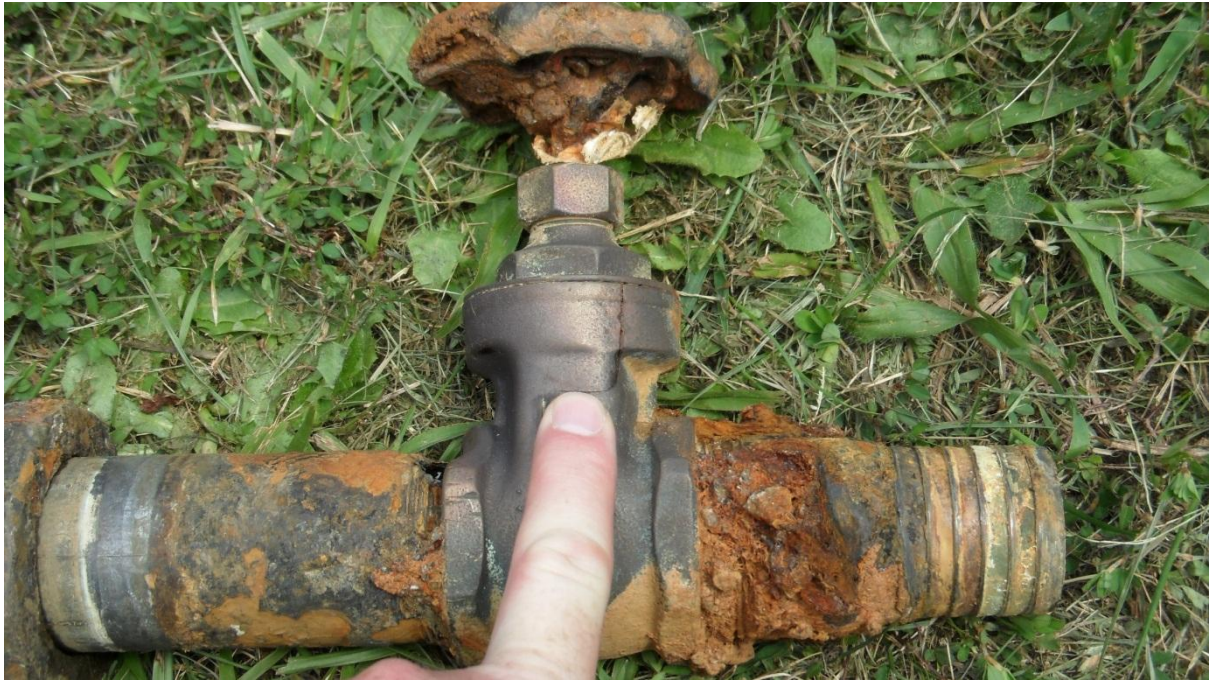
There were no reported gas leaks as a result of the earthquake. However, a 5 cm dia. water main in Mineral broke as a result of the earthquake, the location of which is shown in Figure 21. A photo of the excavated trench used to access the broken main is shown in Figure 22a. As may be observed in Figure 22b, the valve was heavily corroded and would have likely eventually failed even without the occurrence of the earthquake.

Figure 22. Water main break in Mineral (38.01215, -77.90903): (a) trench showing broken water main; and (b) corroded water main valve with a crack that was caused by the earthquake.

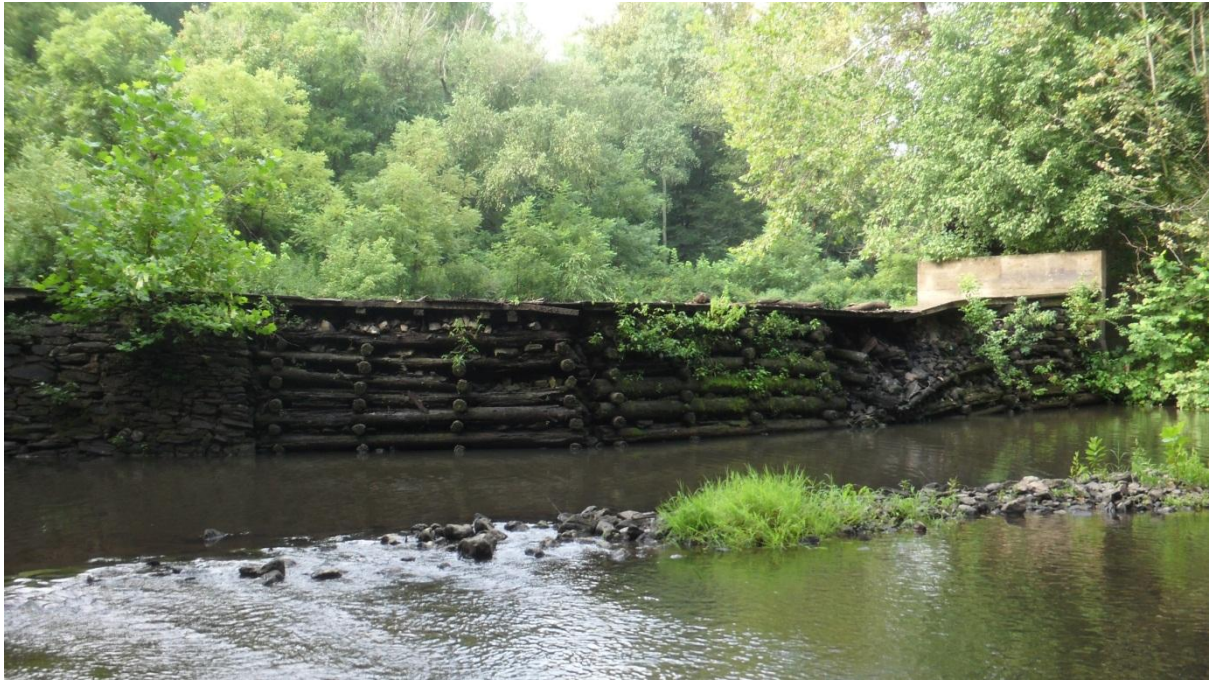
The Yancey Mill Dam is on the S. Anna River and is a few meters upstream of the earthquake-induced sand boils found in the riverbed and nearby roadside ditch. The dam is ~1.5 m high. A photo of the dam is shown in Figure 33, and as shown in this photo, the dam is comprised of log cribs filled with rubble. A few of the cribs on the downstream face of the dam were broken and rubble spilled out. It is uncertain whether this damage was caused by the earthquake or not. A team member contacted the owner of the dam, and he said he wasn't aware of any pre-earthquake damage to the dam.

Figure 33. Yancy Mill Dam. It is unknown whether the damage shown in this photo resulted from the earthquake, but the owner was not aware of any pre-earthquake damage to the dam (37.93825, -77.98300).

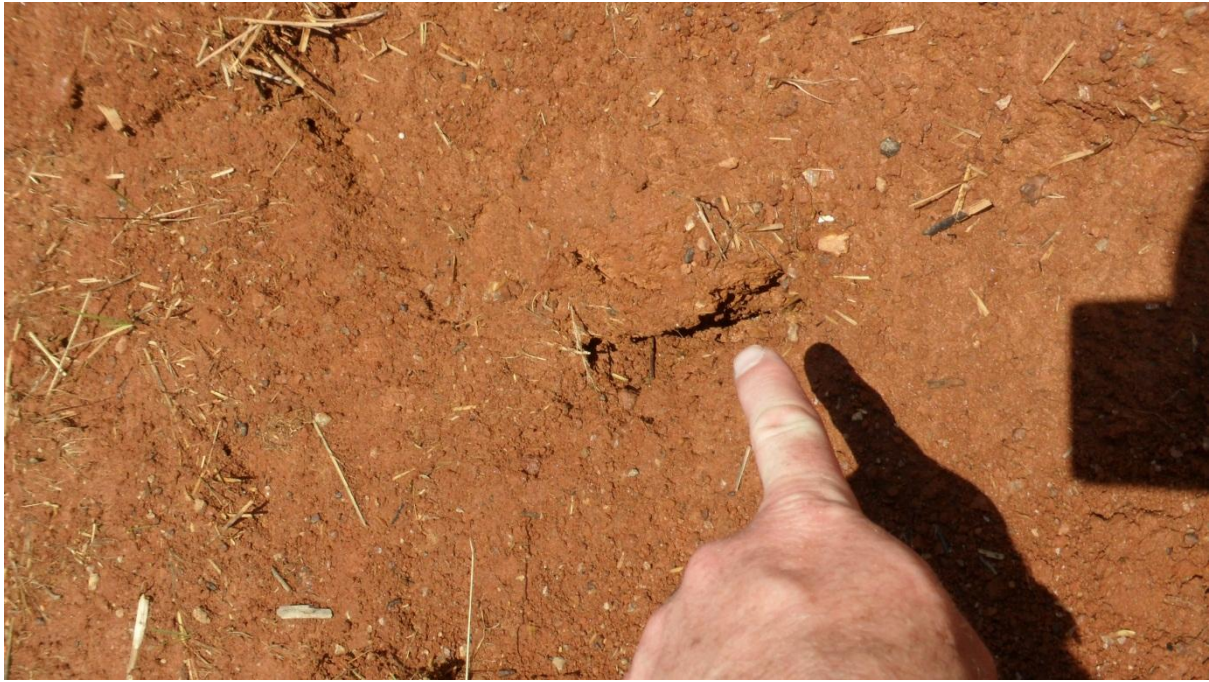
The Louisa County landfill was inspected on 9 September. It is located ~10 km from the epicenter of the main shock as shown in Figure 35. A team member talked with R. Petty, who is the operations manager for the landfill and who was present at the landfill during the earthquake. R. Petty said he noticed a small crack on the front slope of the landfill immediately after the earthquake. The crack was ~2.5 cm wide, but R. Petty was uncertain whether it was there prior to the earthquake. Photos of the front slope of the landfill are shown in Figure 36. By the time R. Green visited the landfill, the crack had largely filled in as a result of the heavy rains from hurricane Irene. However, the crack looked like it was the scarp of a shallow slide in the temporary clay cover; remnants of the crack are shown in Figure 37.

Figure 37. Photos showing the remnants of a crack in the front slope of the landfill that might have formed as a result of the earthquake shaking.

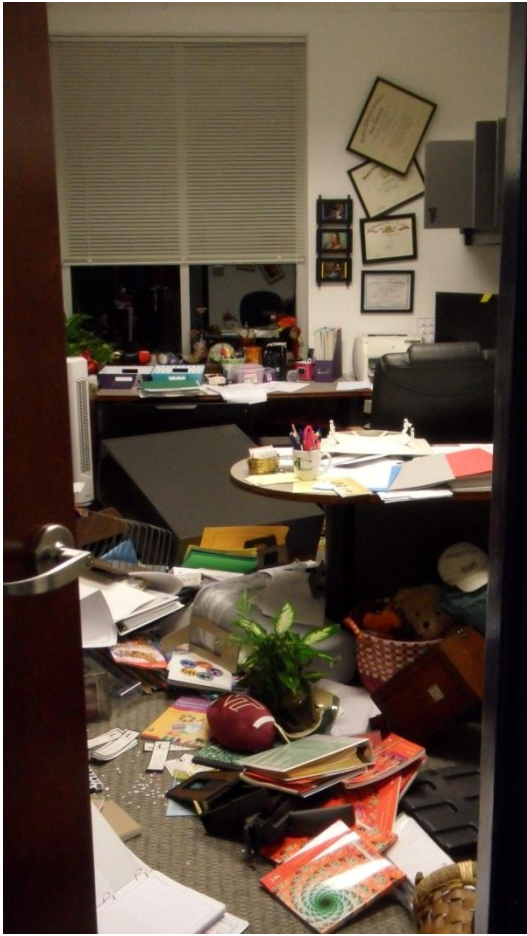
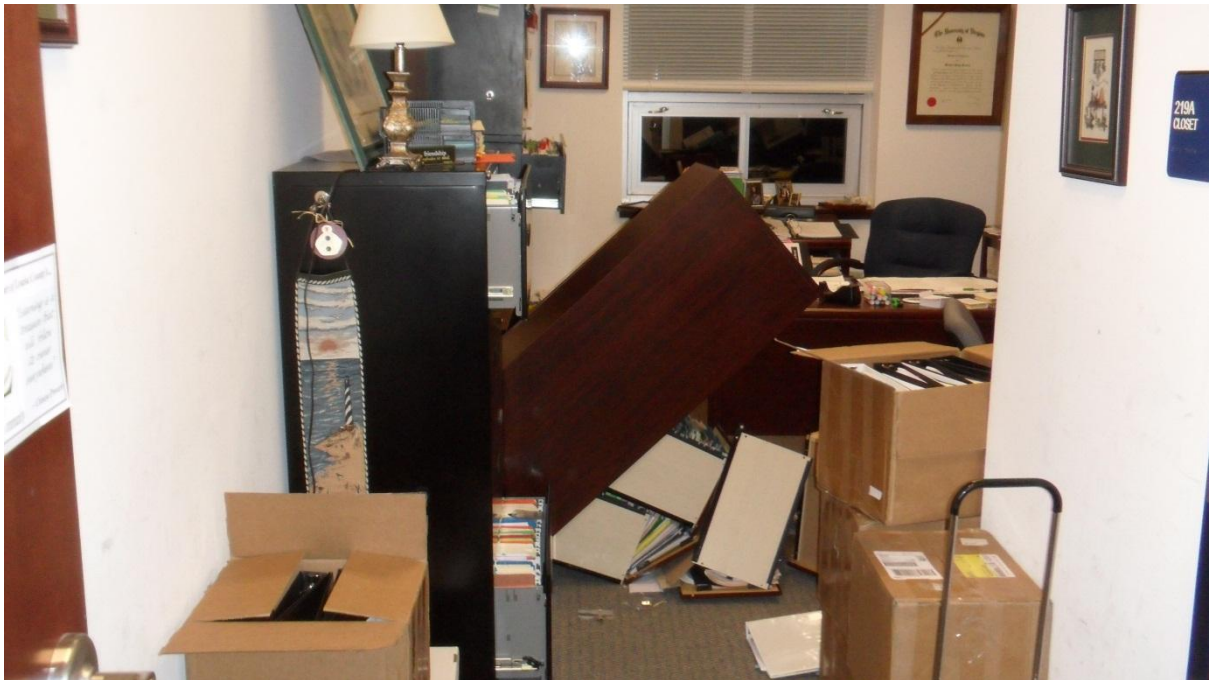
Figure 40. Typical damage to internal contents of offices in the Louisa County Public School Administration Building (38.02066, -77.92373).

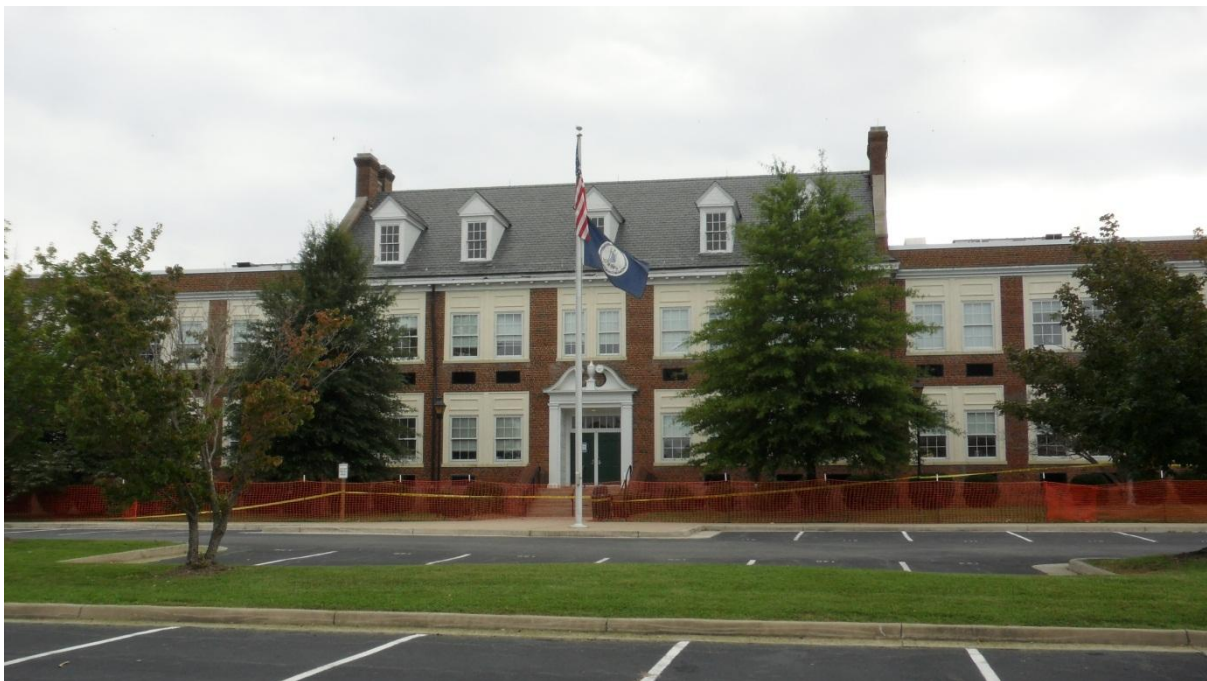
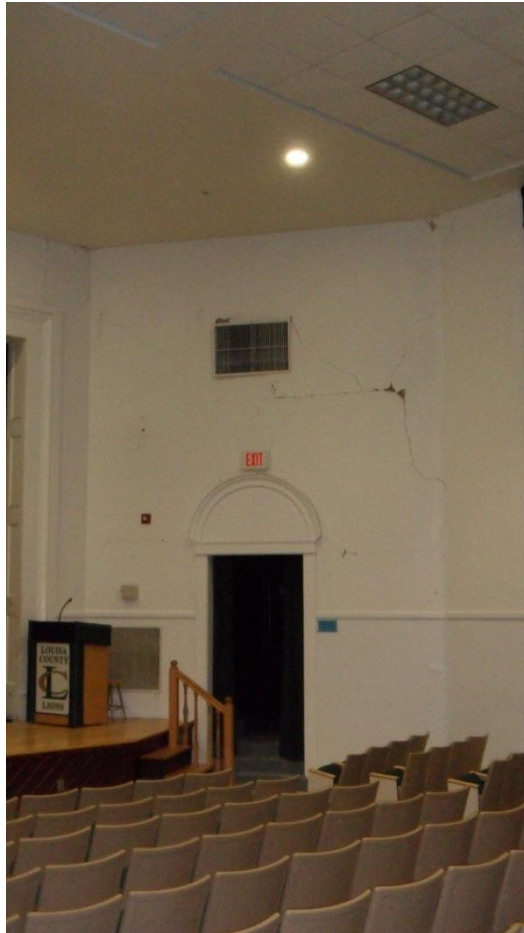
The Louisa County High School building was built in sections over a period of several decades. The most severe damage to the building was in a portion that had a steel frame with concrete block infill walls and a brick façade; it is uncertain whether this same type of structural system was used in all sections of the building. The observed damage included cracks in the infill block walls, with blocks from the top of the walls falling through the dropped ceiling in places. Additionally, in many rooms ceiling tiles along opposite walls fell, indicating a pronounced direction of shaking; unfortunately, the orientations of the walls were not determined. As with the Administration building, the internal contents in many rooms were in disarray. Photos showing some of the damage in the High School building are shown in Figure 41.

Figure 41. Typical damage to the Louisa County High School Building (38.01764, -77.92107).

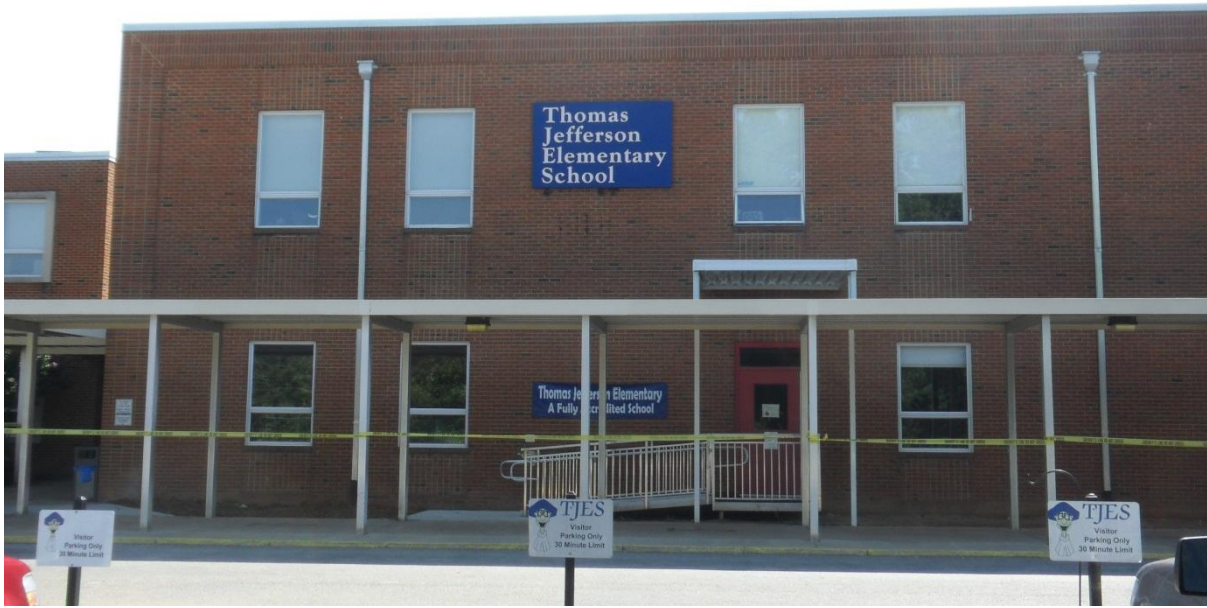
Figure 42. Photo of the outside of Thomas Jefferson Elementary School (37.99468, -77.96233). Along with the LCHS, this building was severely damaged by the earthquake.

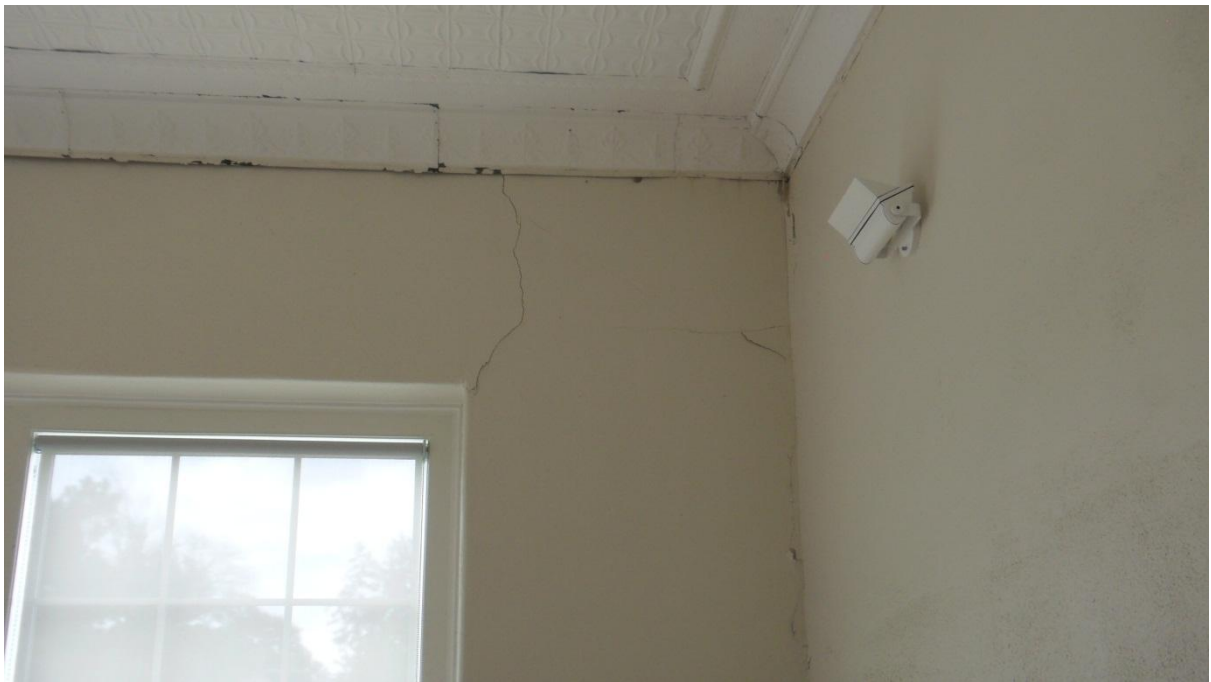
We had received reports on the night of the earthquake that the Louisa Town Hall (Figure 43) had a partial roof collapse. This prompted an inspection of the building on 24 August, the morning after the main shock. The building was constructed in 1907 (Figure 44a) and was damaged by fire in 1924 (Figure 44b); sometime between 1907 and 1924 a second story was added. The reports of damage were grossly exaggerated and most of the damage was cosmetic (e.g., fallen ceiling tiles, cracked plaster); photos of some of the damage are shown in Figure 45. The only structural damage was that the front wall of the building was slightly bowed outward as a result of the earthquake shaking.

Figure 45. Photos showing examples of damage to the Louisa Town Hall.

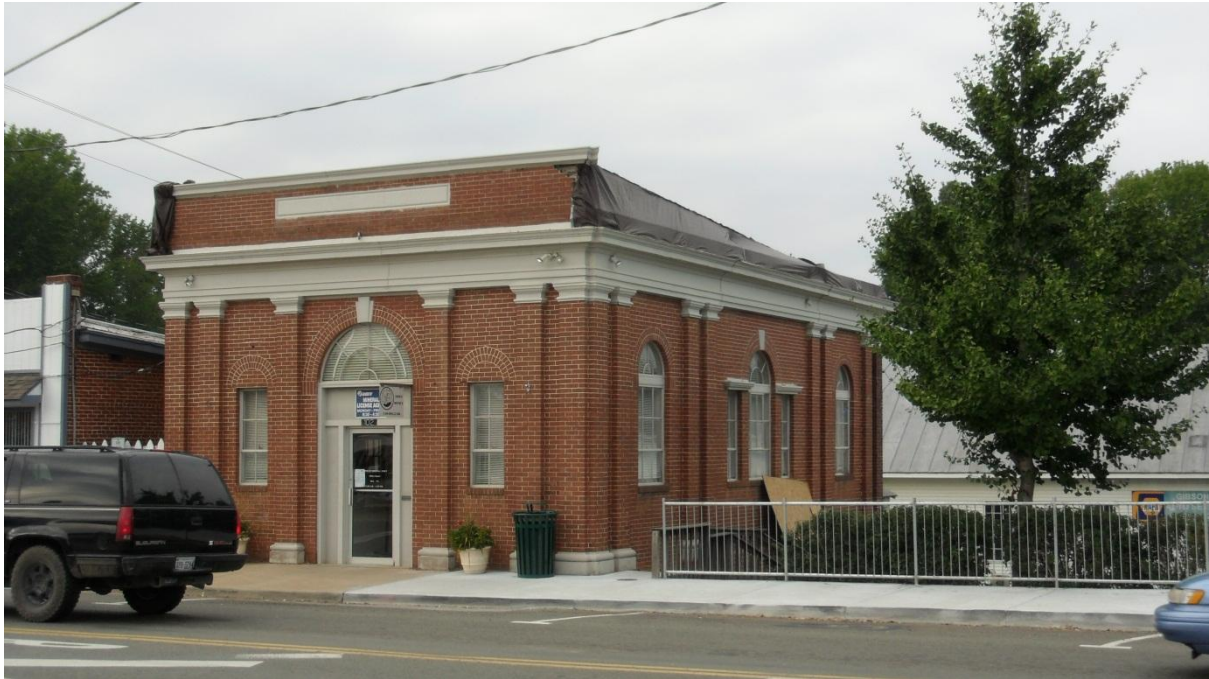
We had received reports on the night of the earthquake that the Mineral Town Hall had completely collapsed during the earthquake. This prompted team members to inspect the building on 24 August, the morning after the main shock. As with the Louisa Town Hall, the initial damage reports for the Mineral Town Hall were grossly exaggerated. A photo obtained from the internet believed to have been taken within hours after the earthquake on 23 August is shown in Figure 46. As shown in this figure, the damage was mainly limited to the brick parapet towards the back of the building. Photos taken by a team member on 24 August are shown in Figure 47. We did not inspect the inside of the building.

Figure 47. Damage to the Mineral Town Hall (38.01090, -77.90848).

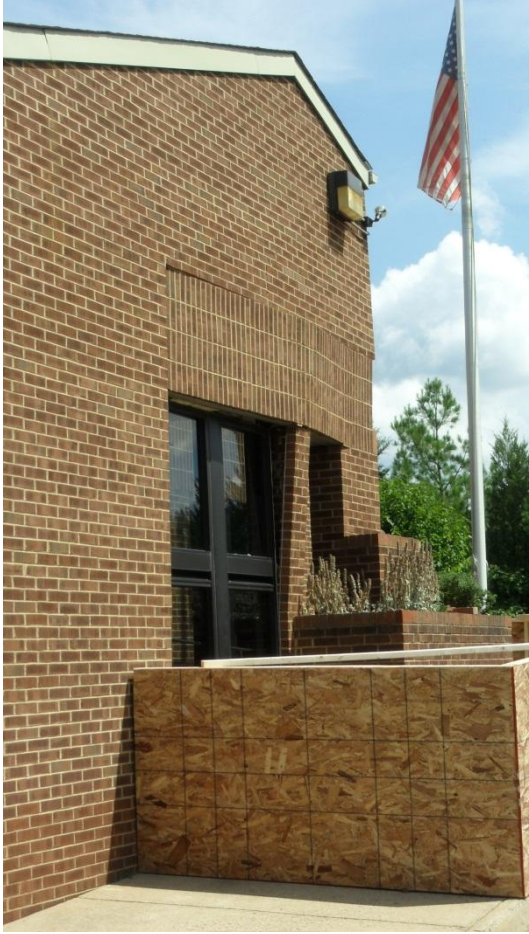
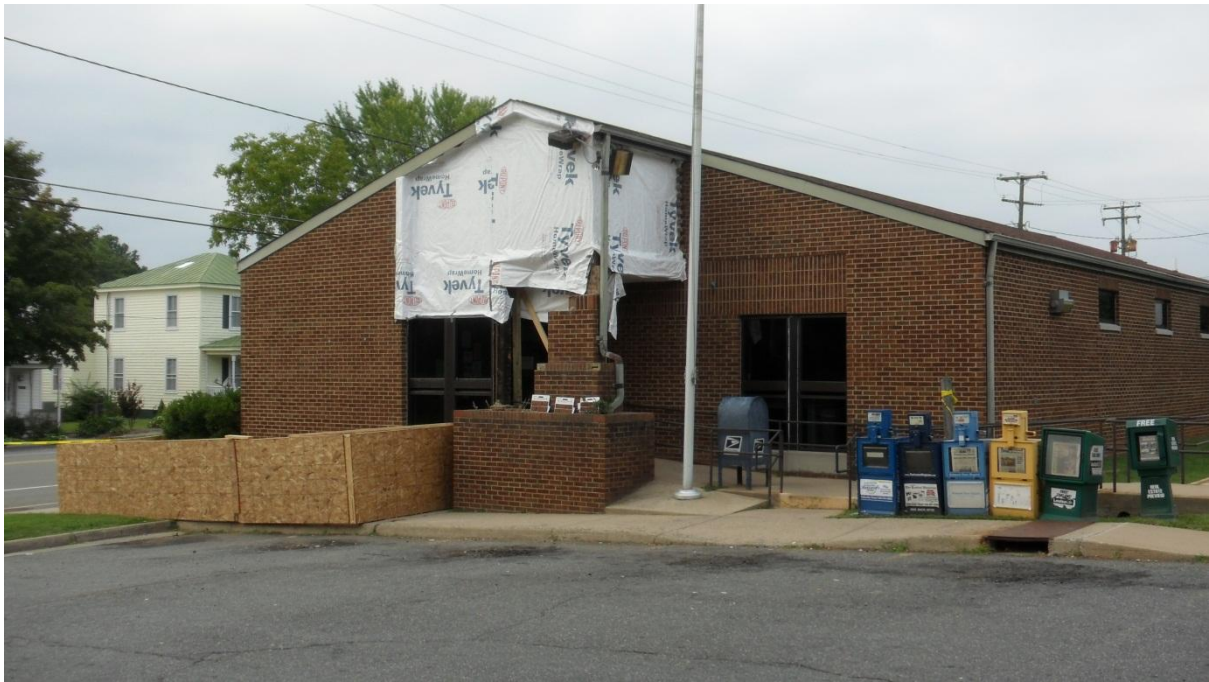
Team members inspected the US Post Office in Mineral on 24 August, the morning after the main shock. The post office was open when we visited, but the main entrance and foyer were closed and residents had to use the backdoor to pick up their mail. Figure 48 shows the damage to the brick façade to the main entrance to the building. As with the Louisa County High School, ceiling tiles along opposite walls fell in the Mineral Post Office. In this case the tiles along the North and South walls fell (Figure 49), indicating a pronounced N-S direction of shaking.

Figure 48. Damage to the main entrance of the Mineral Post Office (38.00669, -77.90859).

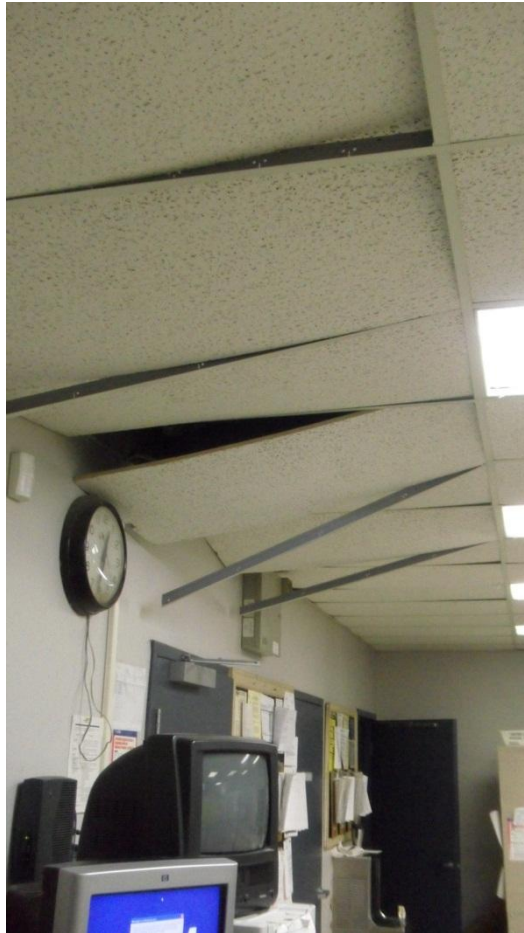
Figure 49. Ceiling tiles that fell along the North wall in the Mineral Post Office (38.00669, -77.90859).

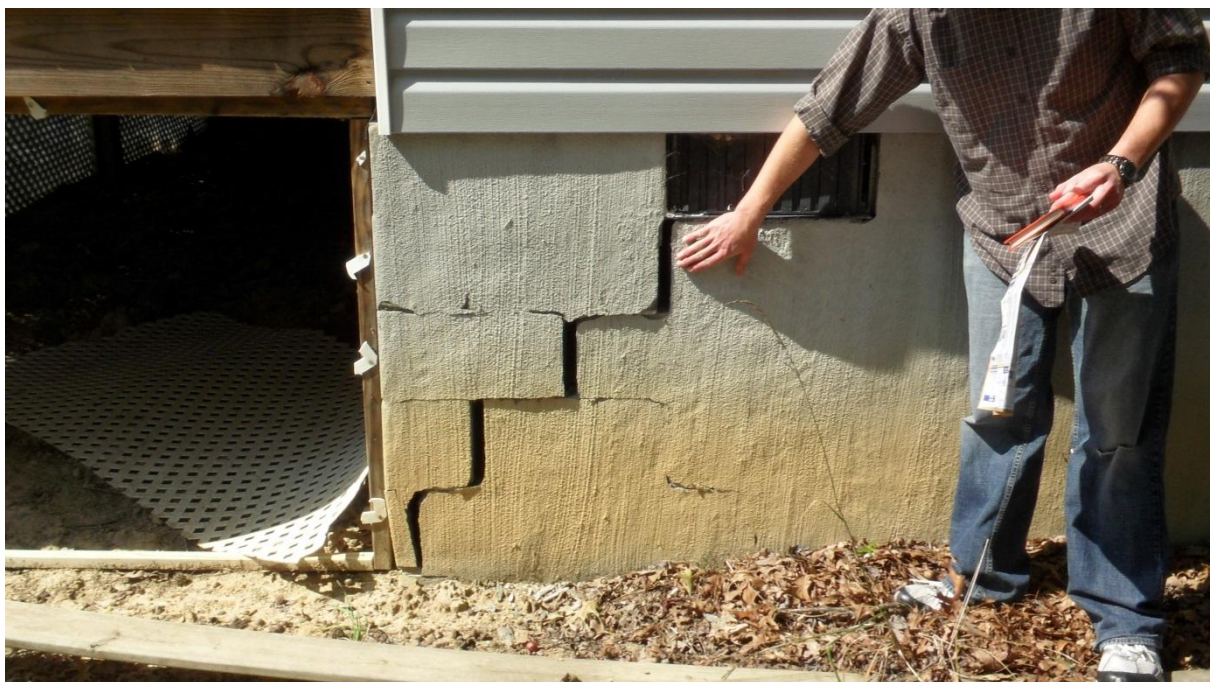
**3290 Mt. Airy Rd, Louisa**

Figure 51. Typical damage to block foundation walls (37.9790, -77.9692).

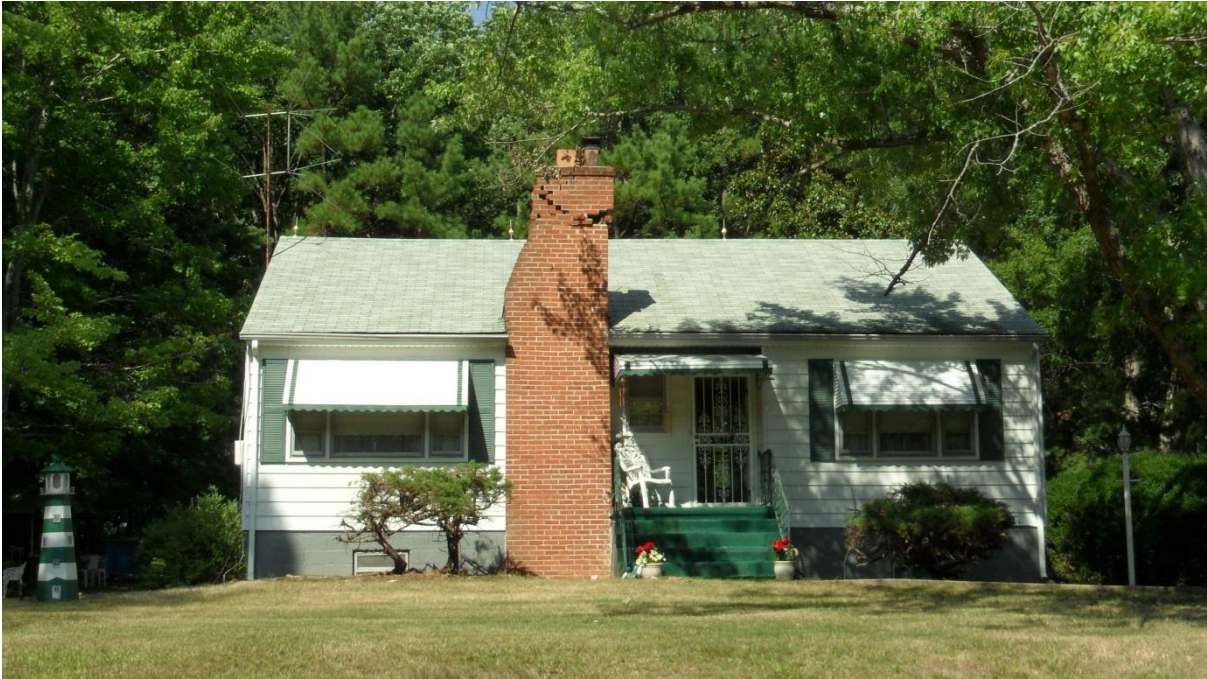
Figure 52. Typical damage to brick chimneys (37.9966, -77.9631).

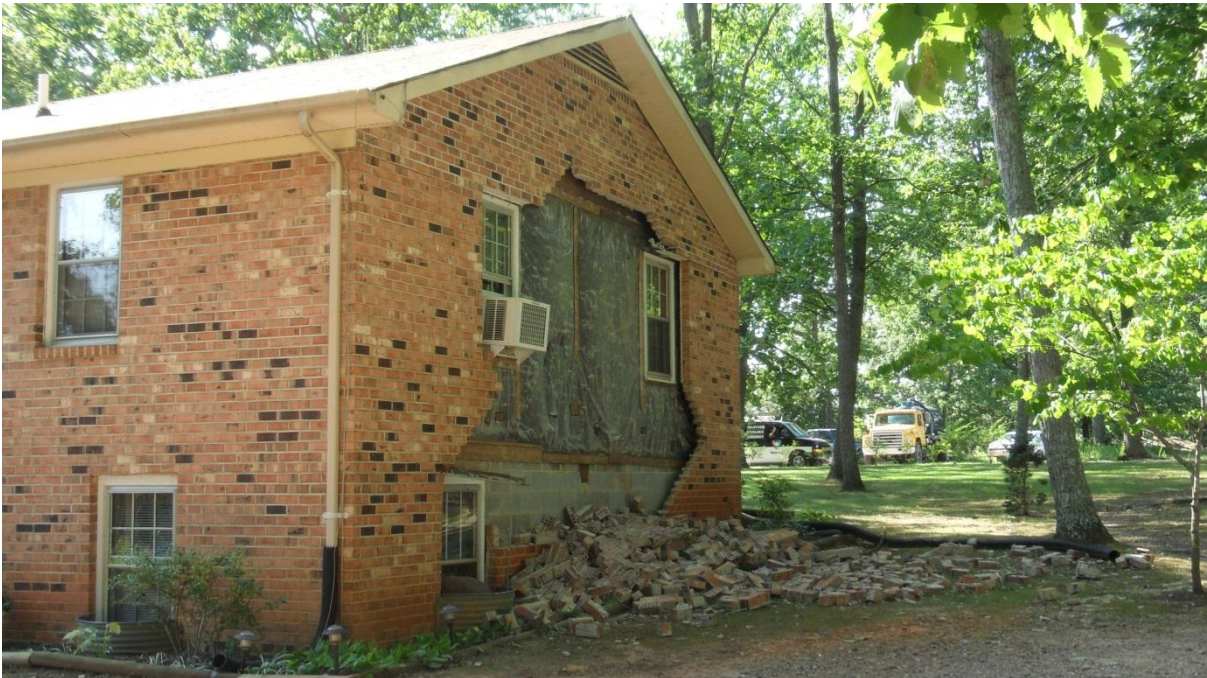
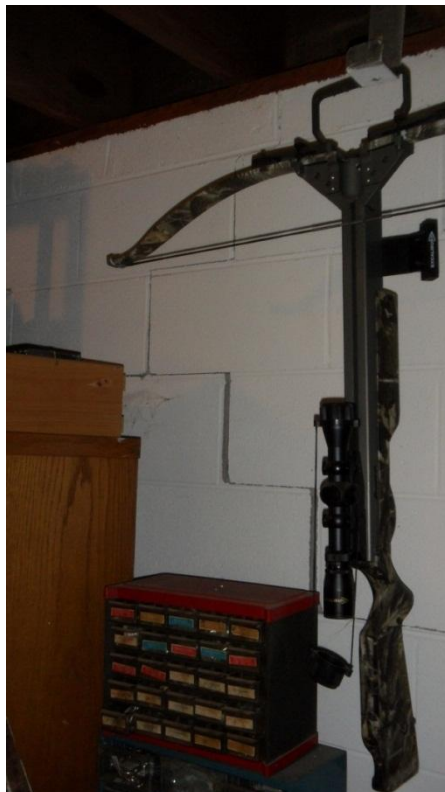
*156 Hwy 789, Mineral*

Figure 53. Representative severe damage to brick façade and block foundation walls (37.9923, -77.9513).

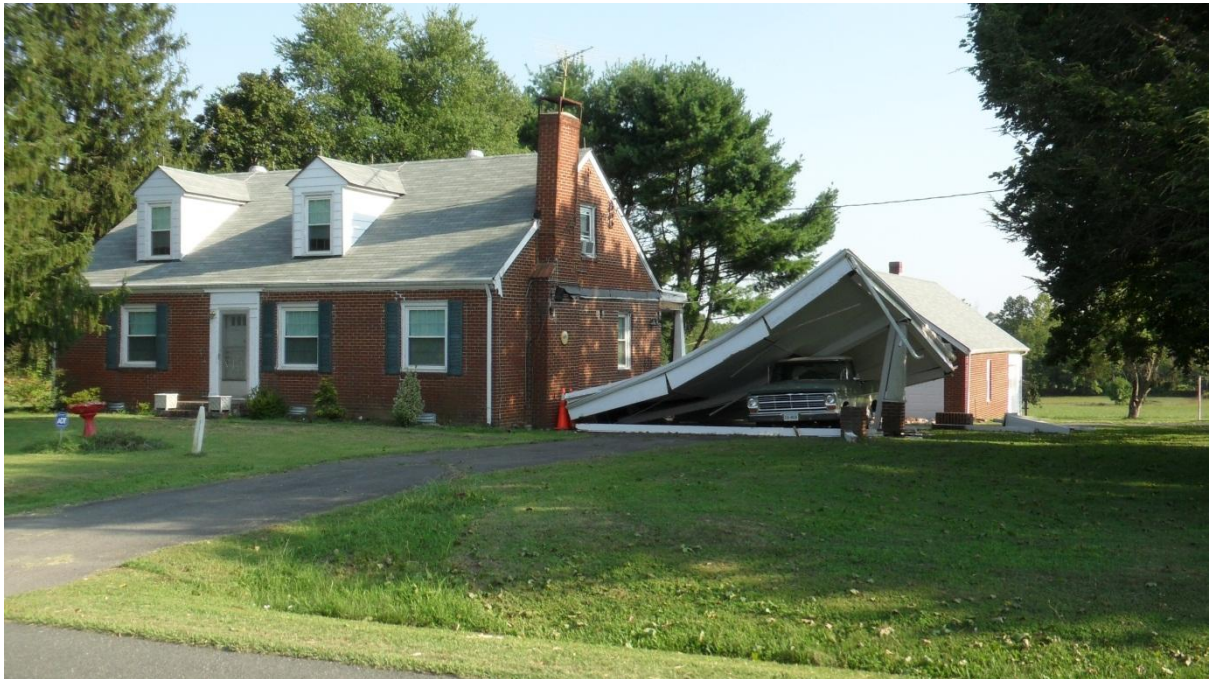
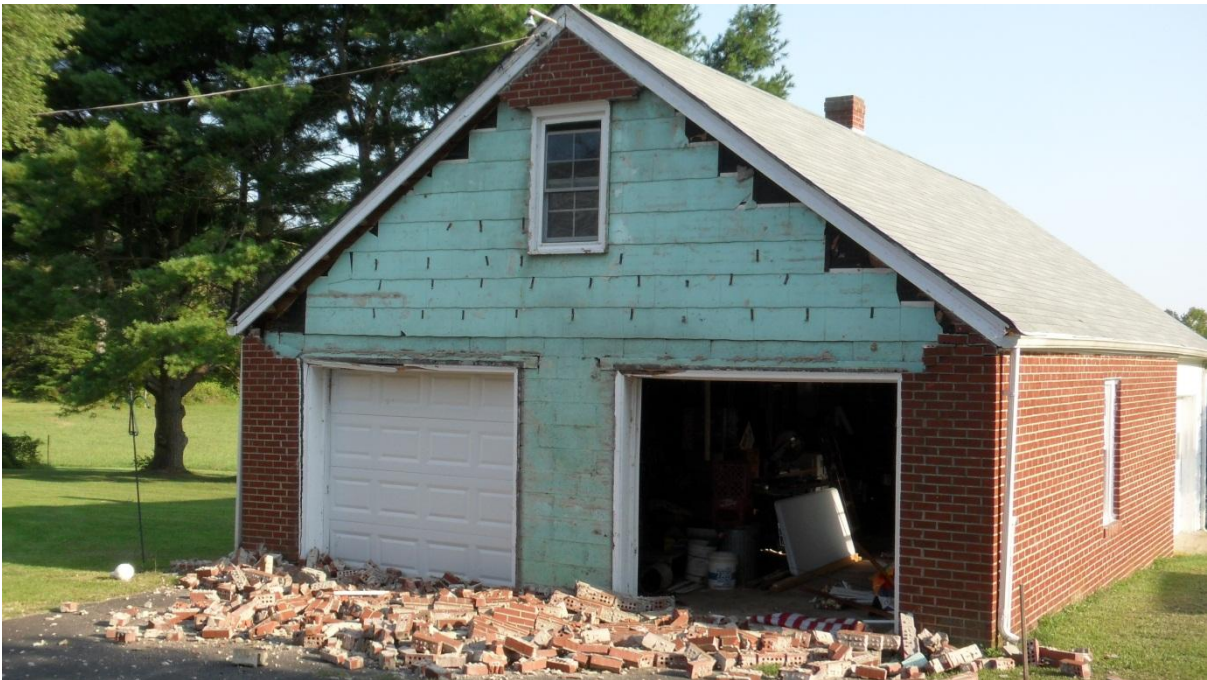
Figure 54. Representative severe damage to brick façade (37.9229, -78.0033).

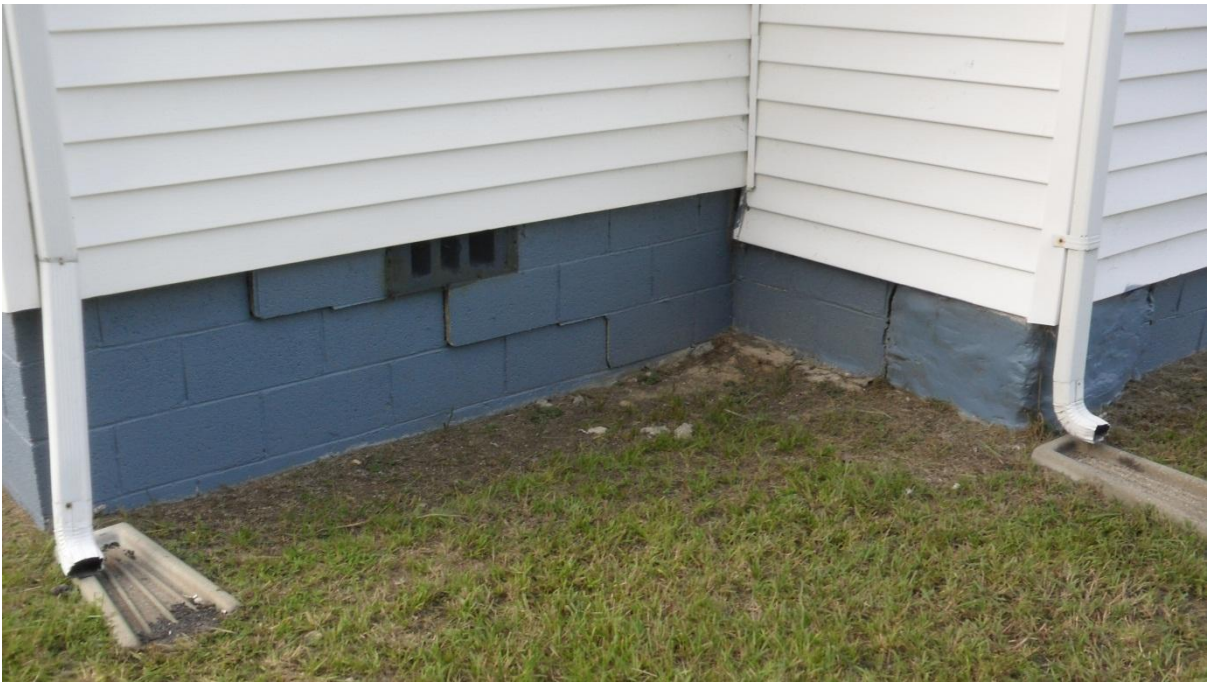
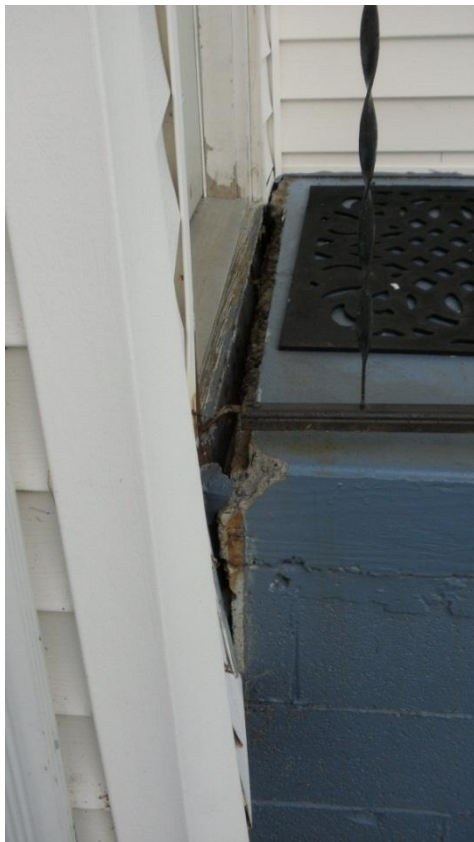
Figure 55. Typical damage to block foundation (37.9455, -78.0253).

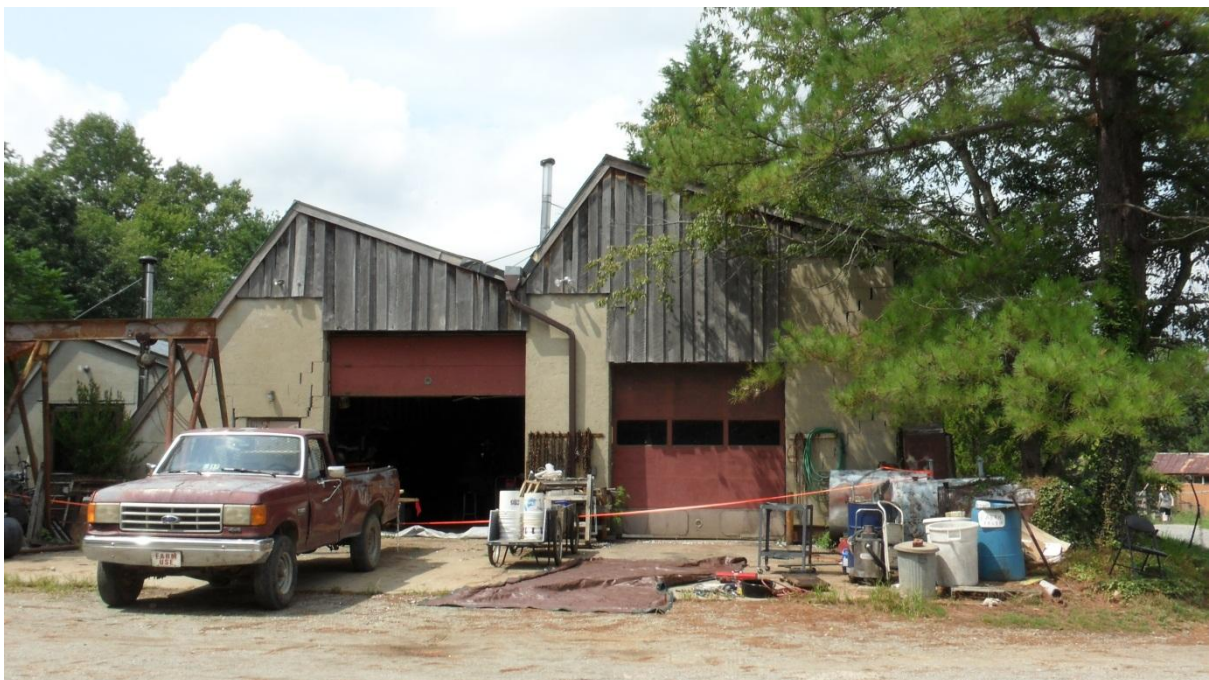
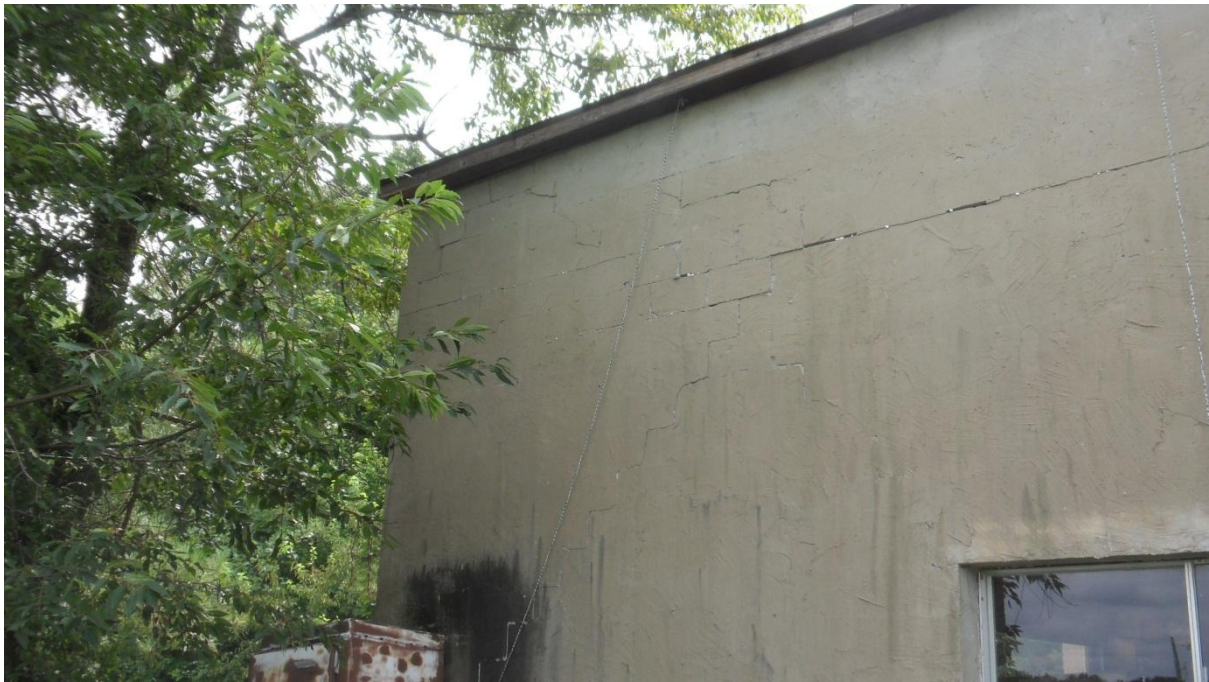
Figure 57. Damage to an unreinforced block garage structure (37.9314, -77.9903).

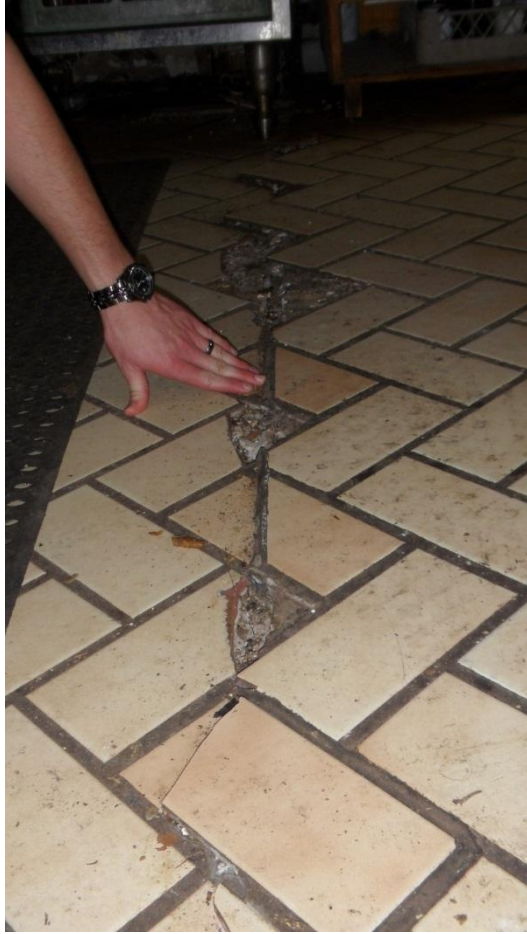
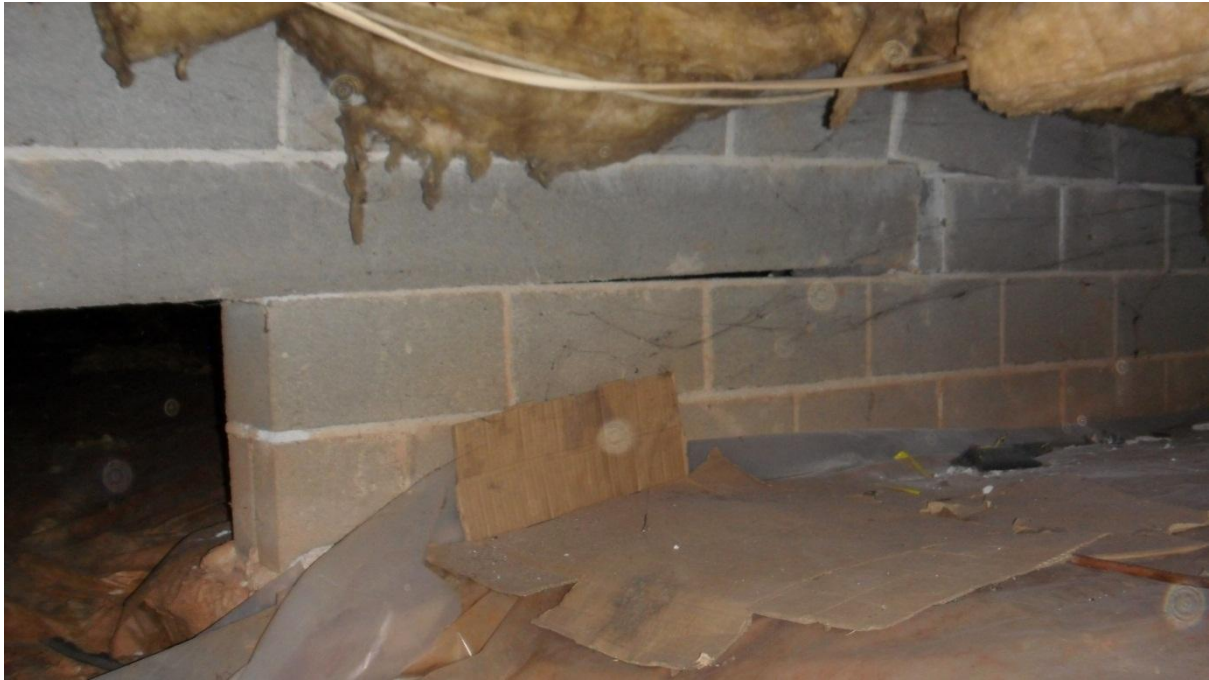
Figure 58. Damage to floor in dining facility (37.9306, -77.9898) caused by damage to unreinforced block foundation wall: (a) Crack in the tiled floor; (b) foundation wall below the crack in the tiled floor (note the broken block supporting the sill beam); (c) gap between sill beam and concrete block formed due to rotation of the sill beam resulting from the broken block supporting the sill beam.
