## Geotechnical Quick Report on the Affected Region of the 23 August 2011 M5.8 Central Virginia Earthquake near Mineral, Virginia

EDITOR: James R. Martin, II, Team Leader (Virginia Tech, Blacksburg, VA)

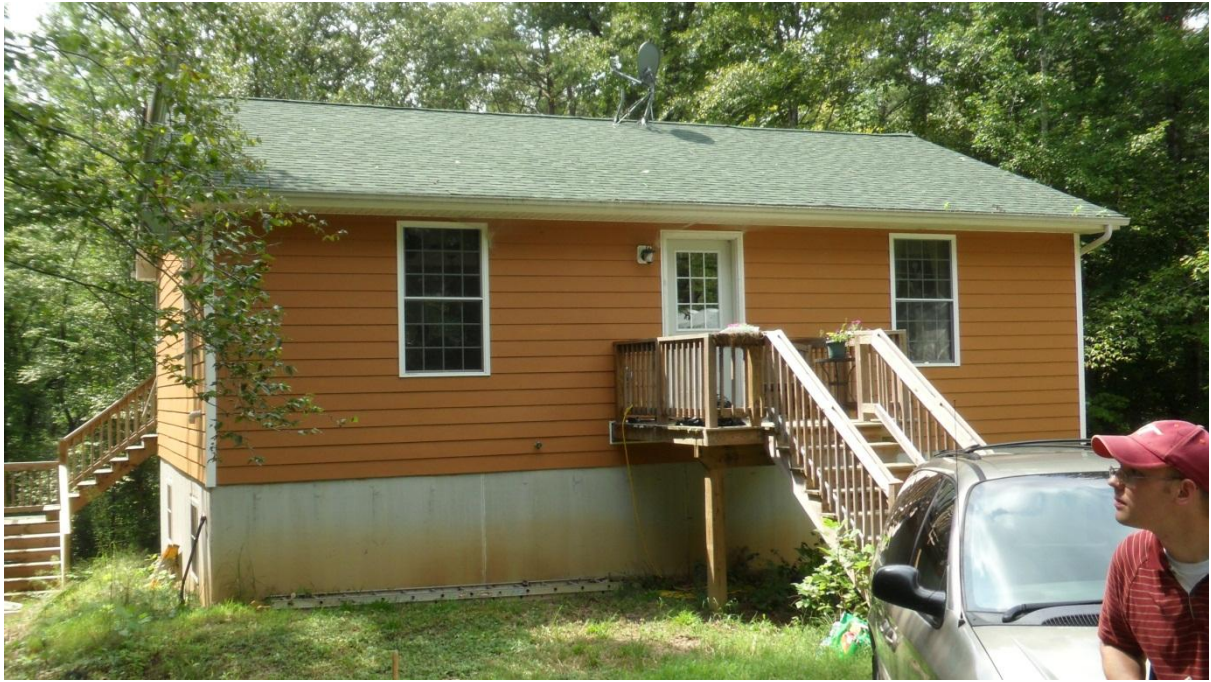
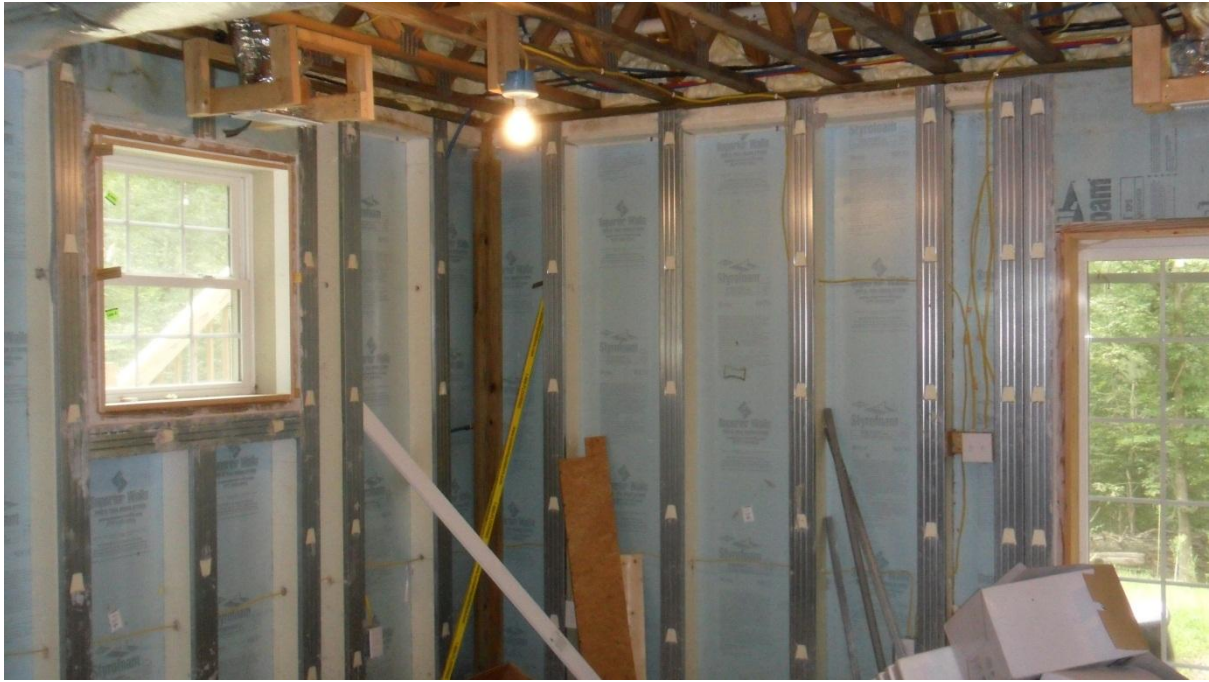
Team members inspected several houses on Bend of River Rd. The house shown in Figure 59 had a Superior Walls foundation system. The system consists of precast panels that are bolted together onsite. The owners of the house were home at the time of the earthquake and described the level of shaking as very intense. However, we could not find any damage to the foundation system.

Figure 59. Small house with a Superior Walls foundation system. We found no damage to the foundation system despite intense shaking. (37.95806, -78.00606)

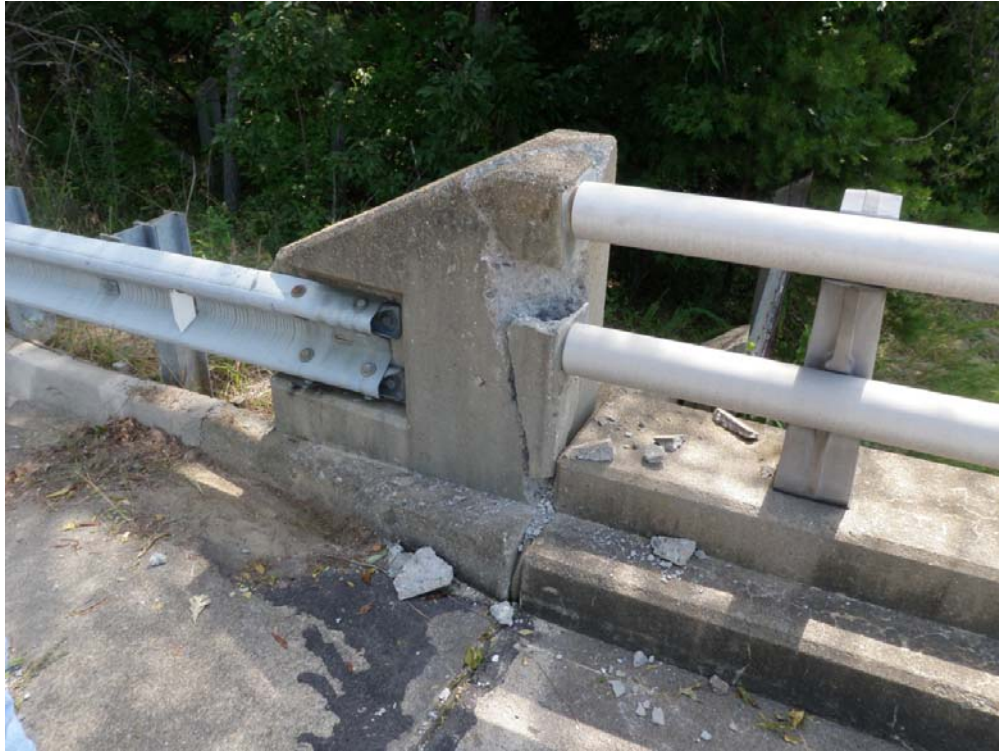
**Figure 5-5 Parish Road over Interstate I-64 –spalling (37.89477, -78.04297).**

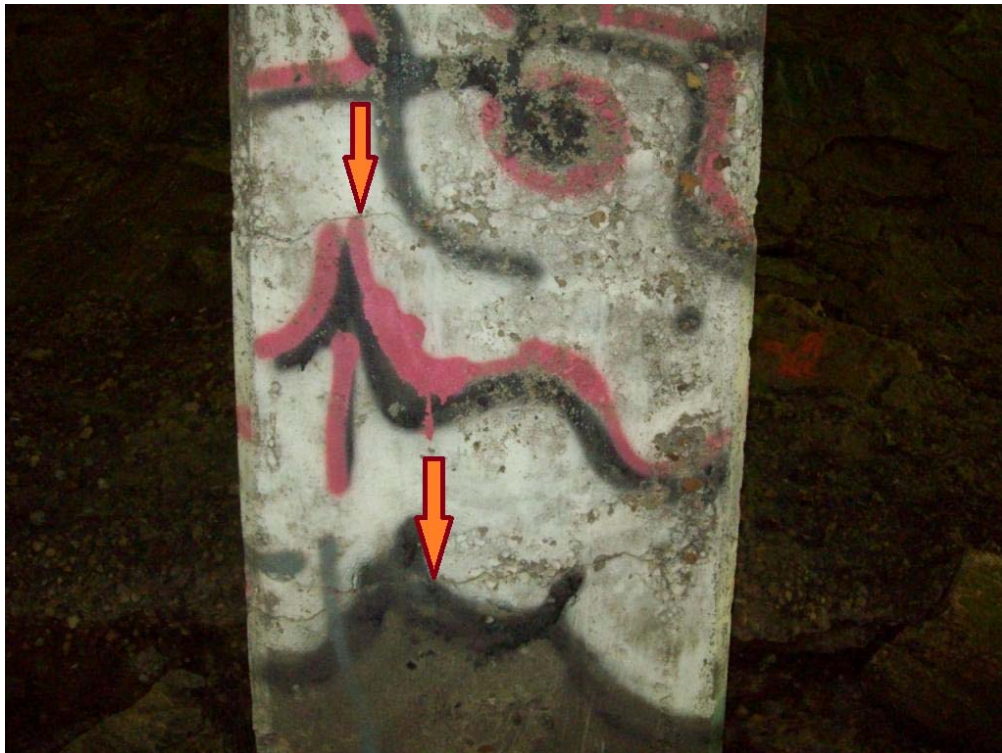
**Figure 5-6 Route 1 over Hazel Run- horizontal cracks at Column 4, Pier 1 (38.28778, -77.48687).**

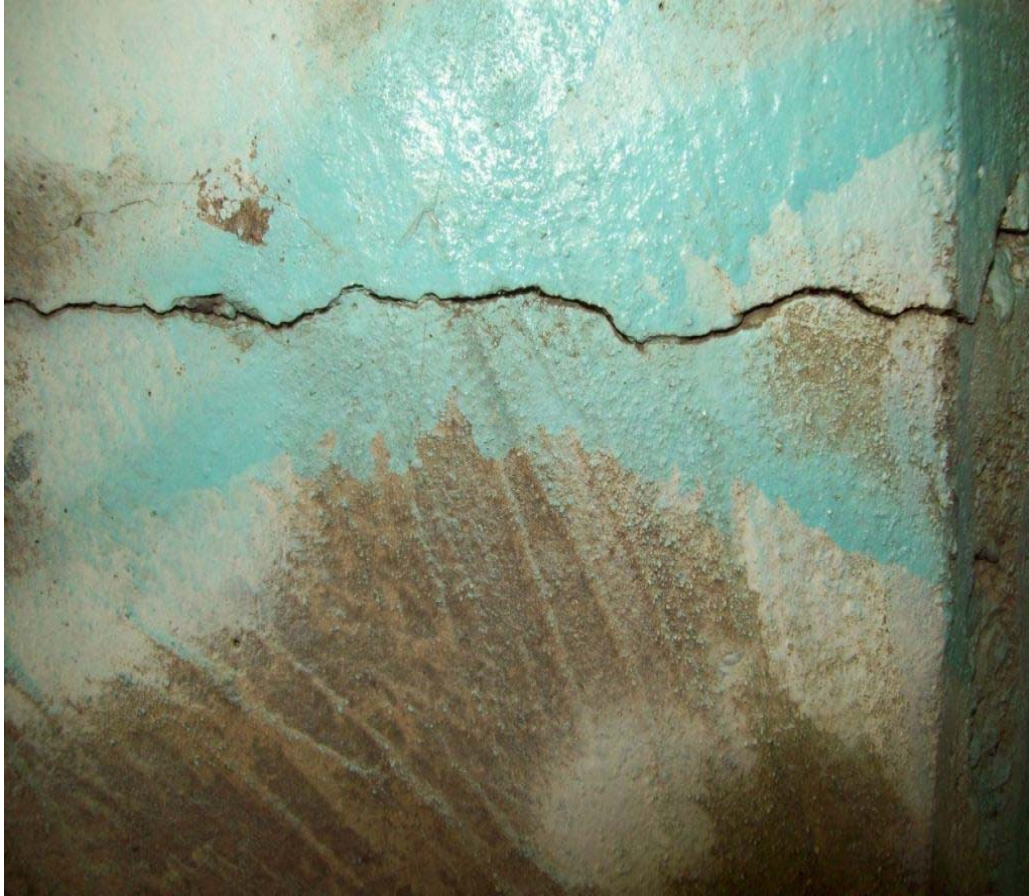
**Figure 5-7 Route 1 over Hazel Run – horizontal crack at Column 3, Pier 1.**
