## Fatal Accident: Equipment Mechanic April 1, 2005

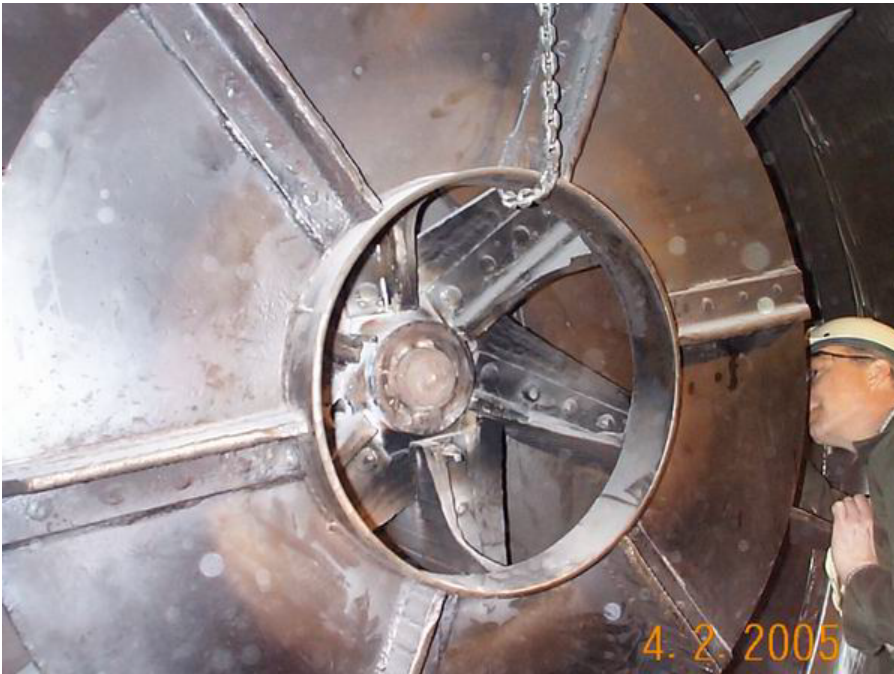
Exhaust fan that was being installed.

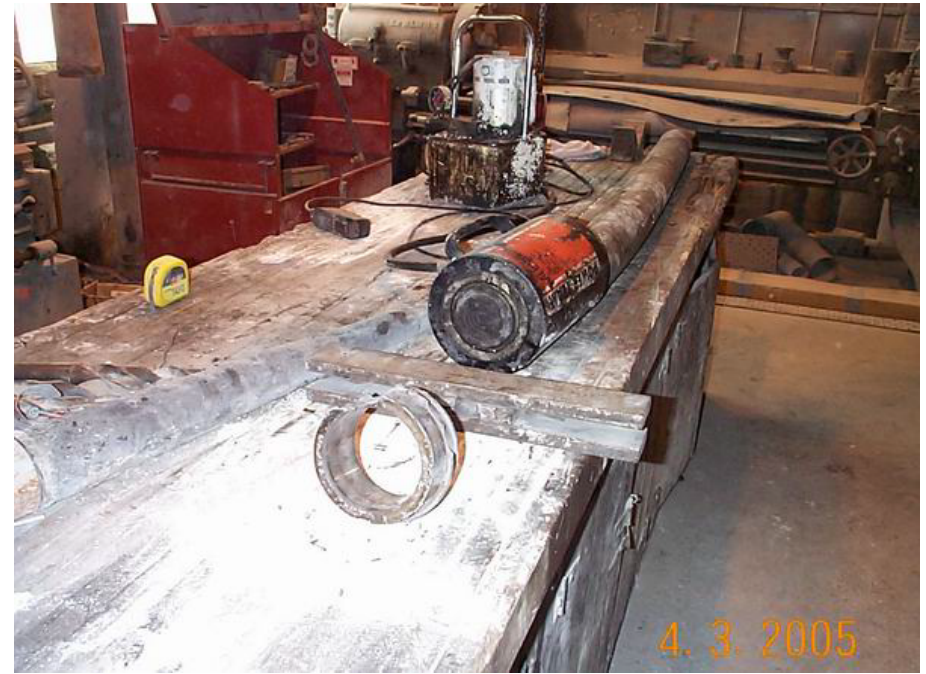
The metal ring and metal bar in the foreground of this photo were positioned between the port-a-power jack and the ram assembly.

**CONCLUSIONS/RECOMMENDATIONS:** This accident occurred due to unsafe working conditions and unsafe work practices. The porta-power jack was used in a way for which it was not designed. In addition, the make-shift ram assembly, which was comprised of at least five separate metal parts, was constructed in a manner that did not prevent its components from becoming airborne. Virginia Safety and Health Regulations for Mineral Mining require that machinery and equipment be used only for the purpose and within the capacity for which they were intended and designed (4 VAC 25-40-330). The Division of Mineral Mining recommends that operators and contractors periodically conduct job safety/risk analyses to identify potential safety hazards associated with all work tasks and to develop safe work procedures.
