Division of Mineral Mining

Accident Investigation: Mobile Equipment Accident May 15, 2002

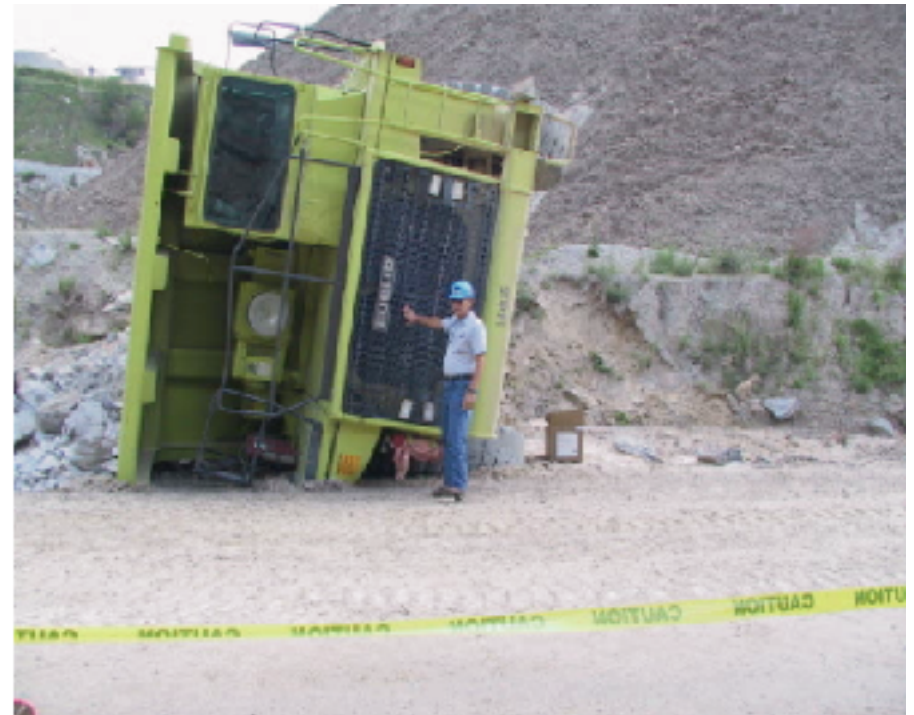
The drive shaft of a Euclid R-65 haul truck broke as the vehicle approached the ramp to the mine's gyratory crusher. After the drive shaft broke, the truck traveled approximately 0.3-mile under momentum force before the driver stopped the truck near the bottom of the elevated quarry ramp. The driver then shut off the engine to investigate the mechanical problem, which resulted in a loss of power to the truck's hydraulic brake system. The truck then rolled down the quarry ramp and overturned. There were no serious injuries as a result of this accident.

RECOMMENDATIONS: To avoid the occurrence of a similar accident, the following safeguards should be implemented:

- Task training should address loss of power to brakes when engine is shut down as specified in a vehicle's users manual.
- Truck drivers should be trained in proper emergency procedures to be used in the event of sudden mechanical failure.
- During the required "pre-operational inspection," drivers should ensure that the vehicle has a sufficient quantity of fuel to avoid fuel starvation and subsequent engine shut-down.
- Mechanics should inspect brake hydraulic lines, drive shaft, and yoke assemblies on a periodic basis and replace worn parts as needed.
- Avoid stopping on quarry ramps.
