# DMM Safety Alert: Jaw Crusher Operator Injured

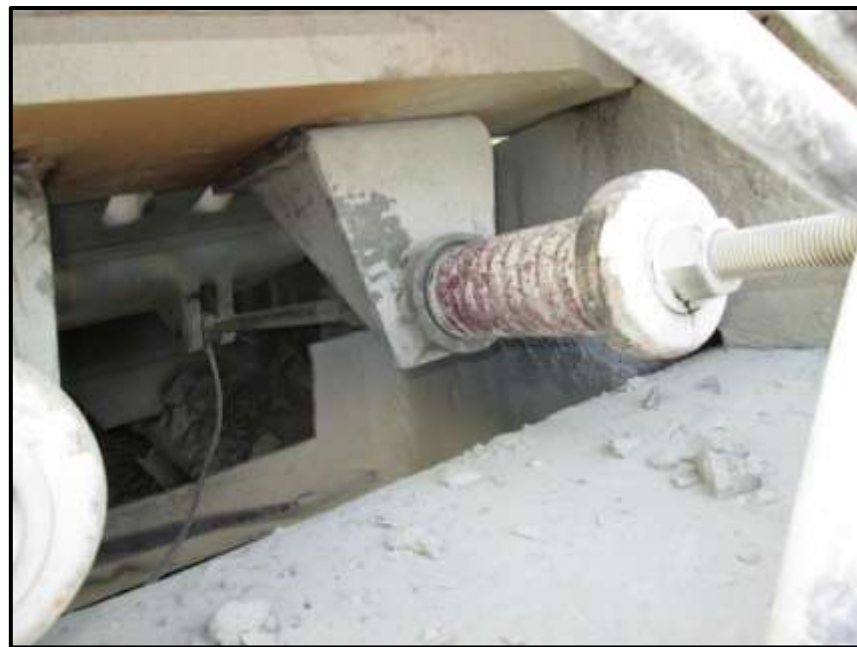
On December 4, 2012, a miner was seriously injured at a Virginia mineral mine while tightening the tension rod assembly on a TelSmith 36X48 jaw crusher. The miner was working with a crew that had just re-installed the tension rod assembly after completing repairs and maintenance to the crusher. After the rods were re-installed, the miner used an impact wrench to tighten the nuts on each rod to compress the springs to a pre-determined setting. After starting the crusher, the crew determined that the toggle plate was bumping and that the tension rods needed additional adjustment. While the crusher was operating, the miner tightened the nut on the left tension rod until the toggle stopped bumping. As the miner tightened the nut on the right tension rod, the rod snapped and the built up pressure in the compressed spring instantly pushed the rod and impact wrench back crushing the employee's right hand between the wrench and the catwalk toe board. The miner's middle finger was deeply lacerated and his ring finger was severely torn and crushed. Emergency surgery was necessary to restore blood flow to the ring finger. Additional surgeries will be required to replace the crushed bone and reconstruct this finger. To prevent a similar type of injury from occurring, the Virginia Division of Mineral Mining recommends the following:

Tension rod assembly involved in this accident.

- Follow the manufacturer's recommendations regarding procedures and tools to be used during equipment maintenance.
- Review maintenance procedures prior to starting a job to ensure all hazards have been identified and addressed.
- Comply with 4VAC25-40-350, which states "Repairs and maintenance shall not be performed on machinery until the power is off, the power supply is locked out and tagged, and the machinery is blocked against motion, except where machinery motion is necessary to make adjustments."
- If adjustments have to be made while machinery is in operation, take proper precautionary measures to ensure the safety of personnel.
