Another Five To Stay Alive

**Based on information from
MSHA's "Rules To Live By III"**

**Presented by DMME
Division of Mineral Mining
2012**

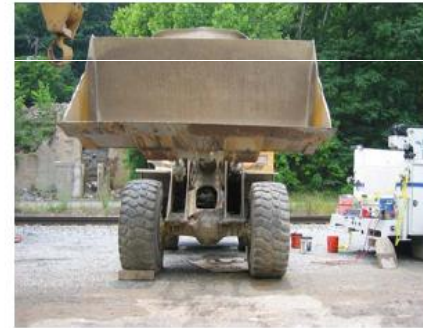
June 12, 2006 - Virginia

METAL/NONMETAL MINE FATALITY - On June 12, 2006, a 39-year-old plant operator, with 14 months experience, was fatally injured at a crushed stone operation. The victim was starting to repair a hydraulic line on a front-end loader that was parked outside of the shop. He was underneath the raised boom, loosening a hydraulic connection, when the boom arms fell, pinning him against the frame.

- Task training was a factor in 21 fatalities including the 1 in Virginia. Some of the specific results:
 - The miner in Virginia was crushed by the unsupported bucket arms of a front-end loader when he loosened a leaking hydraulic line for repair.
 - A miner was run over after being ejected from the cab of a wheeled loader.
 - A miner was fatally burned by a release of steam while cleaning a tank.
 - A laborer was killed when the forklift he was operating overturned.
 - A contractor was killed when a trench wall collapsed and buried him.
 - A plant laborer was killed when his arm was drawn into a conveyor belt as he attempted to adjust a return roller.

- Stop, Look, Analyze, and Manage (SLAM) each task to identify all potential hazards before performing maintenance work. Practice safe work habits during the entire task.
- Consult and follow the manufacturer's recommended safe work procedures for the maintenance task.
- Train miners in safe work procedures before beginning repairs.
- Securely block equipment against all hazardous motion at all times while performing maintenance work.
- Never travel or work under a raised loader bucket.
- Never loosen hydraulic hoses or components without first determining if they may be holding something up or trapping pressure.

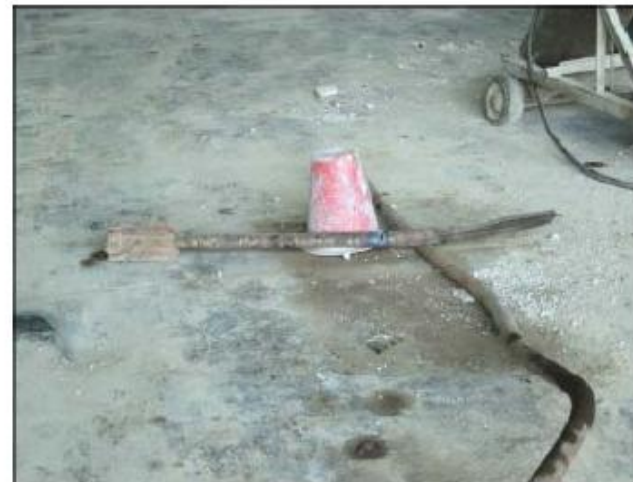
Fatality #6 – May 14, 2010

- 46.7(a) was cited in this case.
- The drill steel contained traces of explosives that detonated when the flame was introduced.
- The welder had not been task trained regarding explosion hazards.

METAL/NONMETAL MINE FATALITY - On May 14, 2010, a 35 year-old mechanic/welder with 4 years of experience was fatally injured at a cement operation. The victim was using an oxy- acetylene torch to cut a damaged drill steel to salvage the drill bit. The drill steel exploded causing metal fragments to strike the victim.

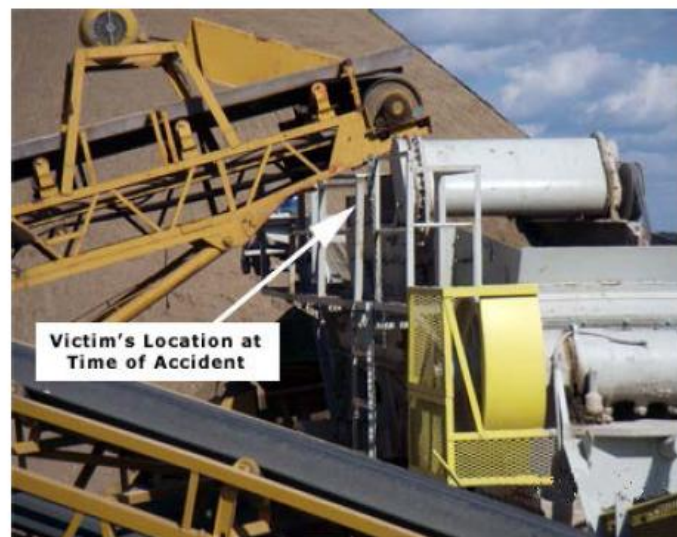
Fatality #7 - August 9, 2011

46.7(a) was cited in this fatality. The victim accessed an unguarded head pulley. He had not been trained to work with plant equipment.

METAL/NONMETAL MINE FATALITY - On August 9, 2011, a 24-year-old skid-steer loader operator with 12 weeks of experience was killed at a sand and gravel operation. He accessed an elevated platform near an unguarded head pulley and became entangled in the operating conveyor system.

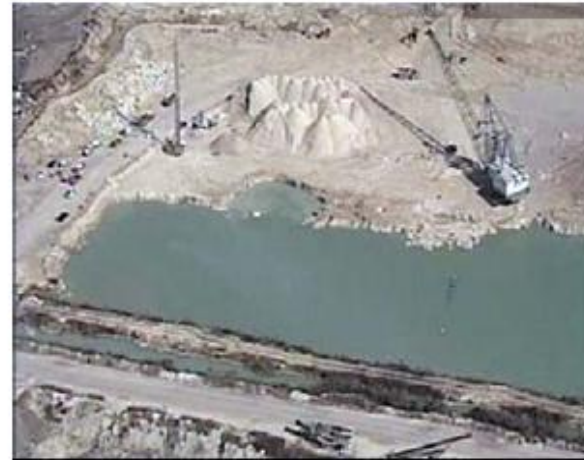
Fatality #23 - December 23, 2010

- 56.3130 was cited in this fatal accident.
- The mine operator was aware that an underground cavity/cavern extended under this area and took no action to address the hazard.

METAL/NONMETAL MINE FATALITY - On December 23, 2010, a 35 year- old contract blaster with 12 years of experience died at a crushed stone operation. After firing the blast, he immediately walked into the blast site to examine the shot material. The victim was approaching the edge of the shot material when the ground collapsed, engulfing him in the water-filled pit.

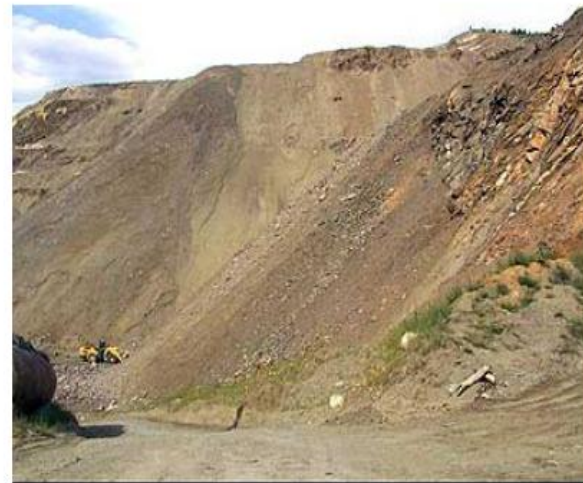
Fatalities #22 - August 27, 2005
Fall/Slide Material - CO - Stone (C&B)
Albert Frei & Sons Inc. - Walstrum Mine

- 56.3200 was cited in this accident.
- Material was being dumped from an upper level and allowed to flow down to the third level where the loader was operating. No effort was made to keep people and equipment out of the area while this was being done.

METAL/NONMETAL MINE FATALITY - On August 27, 2005, a 26-year old front-end loader operator, with four years mining experience, was fatally injured at a crushed stone operation. The victim was digging material with a front-end loader near the toe of a bank when rocks rolled and struck the loader cab.

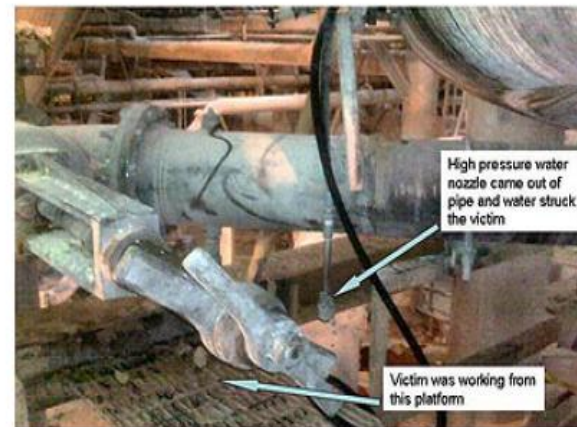
Fatality #3 - January 31, 2009
Machinery - Texas - Alumina
Sherwin Alumina Co. - Sherwin Alumina Co.

- 56.14100(b) was cited in this fatality.
- The hose end attachment (stinger) was improperly sized.
- The mine operator was aware that a necessary guard was not in place and that the equipment operator did not have access to a shut-off valve.

METAL/NONMETAL MINE FATALITY - On January 31, 2009, a 40 year-old contractor technician with 36 weeks of experience was fatally injured at an alumina milling operation. He was cleaning hydrate that had built up inside a 30-inch pipe in the plant. The victim was using a high pressure water hose when the unrestrained hose end and attachment blew out of the pipe. He was struck by the water.

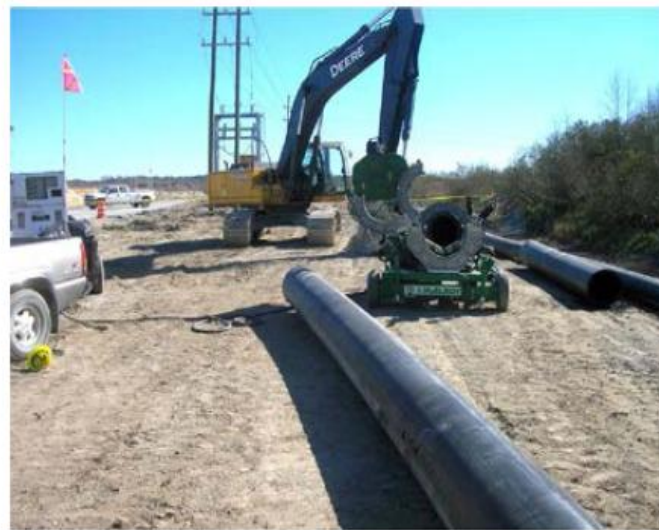
Fatality #2 - March 2, 2011

2011:
56.14100(b) was cited
because a jaw
positioning cylinder
was defective and had
been removed 8 days
prior to the accident,
but the machine had
not been taken out of
service. To use the
fuser, a person was
required to be in an
unsafe position.

METAL/NONMETAL MINE FATALITY - On March 2, 2011, a 51 year- old contract superintendent with 24 years of experience was killed at a phosphate rock operation. The victim was attempting to join two ends of 24-inch diameter pipe. Two excavators were being used to position the pipe in the saddle of a pipe fuser when the pipe slipped out and struck him.

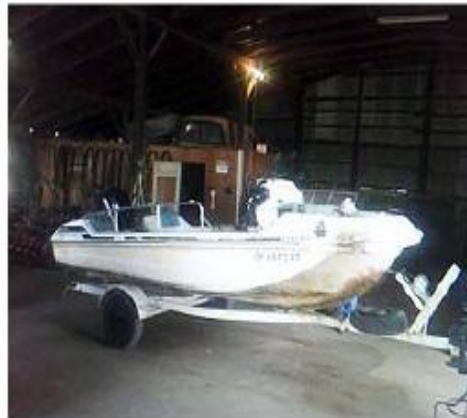
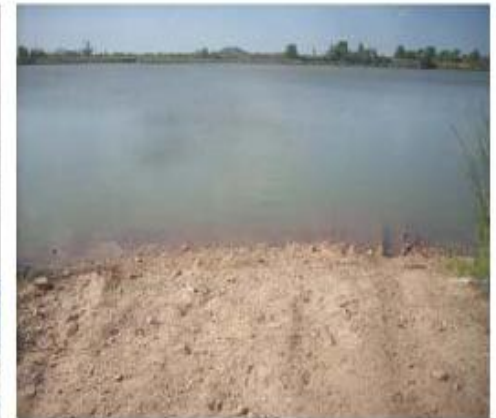
Fatality #15 - August 14, 2010

- 56.15020 was cited in this drowning.
- The dredge operator swam into a dredge pond to retrieve a boat without wearing a life jacket.

METAL/NONMETAL MINE FATALITY - On August 14, 2010, a 23 year-old dredge operator with 4 years of experience died at a sand and gravel dredge operation. The victim and another miner were pulling a small boat from a dredge pond onto a boat trailer attached to a pickup truck. When the boat slipped back into the water, the victim attempted to retrieve it and drowned.
