Accident Investigation: Lube Pump Accident November 10, 2001

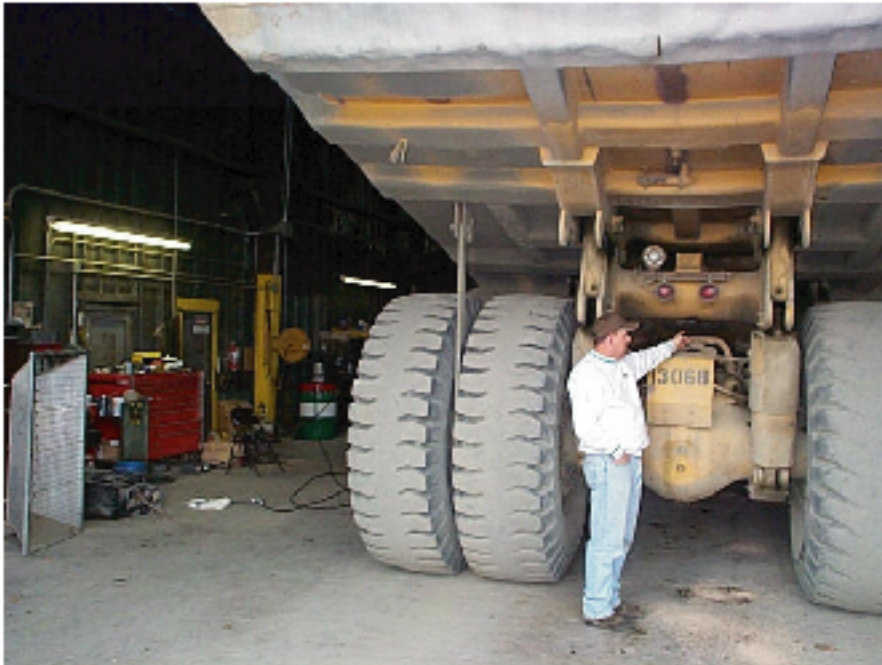
Lube points on the Komatsu haul truck with the Graco chassis pump out of sight in the background.

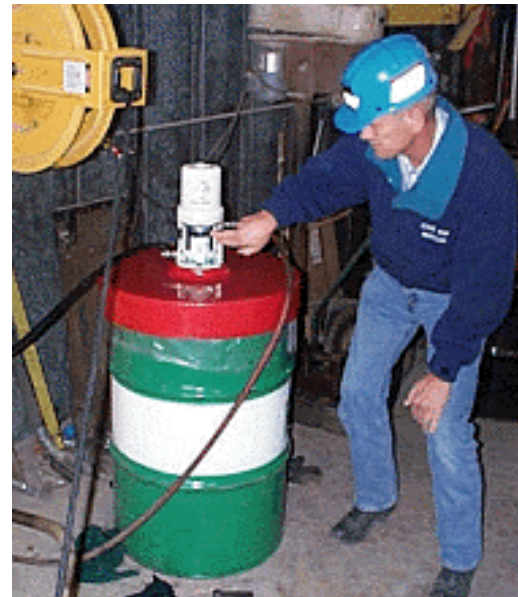
A mechanic was injured while cleaning a Graco chassis lube pump being used by another mechanic to lubricate a haul truck parked in the shop. The victim had removed the two plates that guard the pneumatically driven piston in order to clean built-up grease. As he cleaned the piston, the other mechanic triggered the grease gun to lubricate chassis parts at the rear of the Komatsu haul truck. The victim's left index finger was caught between the moving piston and the pump housing sustaining an avulsion wound which required surgery at the hospital.

The Graco pneumatically powered grease dispenser pump without required guards (cover plates) in place.

RECOMMENDATION: Always de-energize the pump by disconnecting the air hose prior to removing protective cover plates when performing repair or maintenance work as required by DMM safety regulation 4VAC25-40-350.

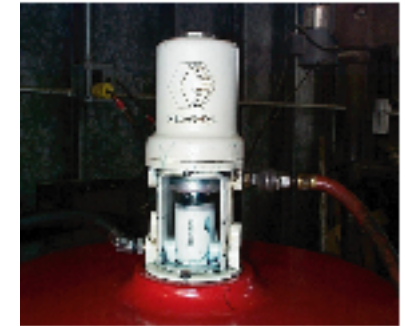
Without protective cover.

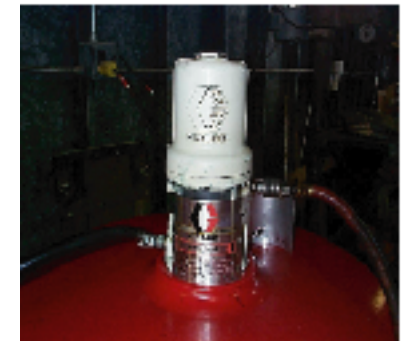
With protective cover.
