FATAL INJURY ACCIDENT: November 2014 Miner Struck By Drill Bit Ejected From Crusher

On November 10, 2014, a miner was seriously injured while using a torch to cut a drill bit that had become wedged in the discharge opening of a jaw crusher. The miner had entered the crusher and started to cut the bit when the bit was ejected due to the pressure exerted on the bit by the crusher components. He was struck in the face and chest sustaining serious injuries and was rendered unconscious for several minutes. Co-workers entered the crusher and, after the injured miner regained consciousness, removed him from the crusher and administered first aid until emergency medical services personnel arrived. When EMS personnel arrived, they performed a tracheotomy on the victim and he was transported by helicopter to a local hospital for treatment. At the hospital, he was treated for two collapsed lungs, a broken jaw, broken teeth, and a fractured C7 vertebra (lower neck). On November 27, 2014, he was transferred to a hospital in Greensboro, North Carolina for further treatment where he remained until he died as a result of his injuries on January 17, 2015.

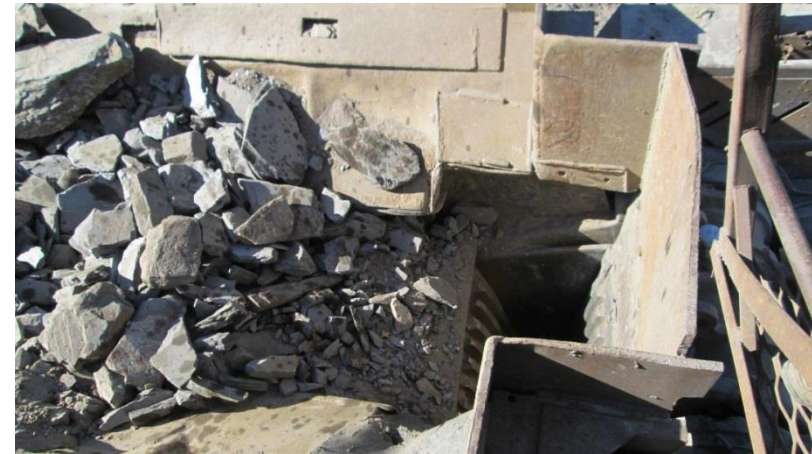
Feeder and crusher opening where accident took place

- Task training must be conducted and documented prior to any miner performing a new task.
- The operator should establish procedures for the safe removal of foreign material from the crusher based on recommendations from the manufacturer and mine safety and health laws and regulations.
- Mine management, specifically the certified foreman, should review their responsibility under Virginia's Safety and Health Regulations for Mineral Mining to ensure work is performed safely and in compliance with the safety laws and regulations.
- The accident, the factors that led up to it, and the steps taken to prevent a recurrence should be reviewed with all personnel.

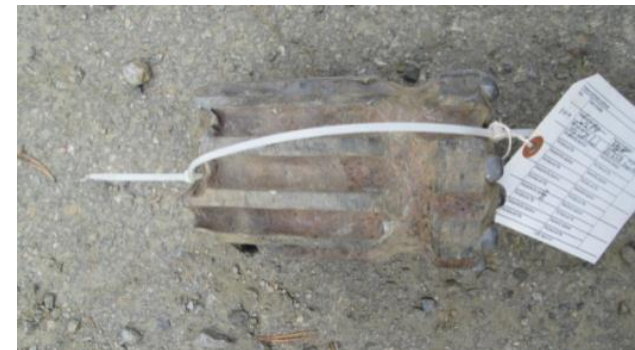
Portion of bit that struck the miner
