Division of Mineral Mining

Fatal Accident: Construction Worker Fall November 20, 2003

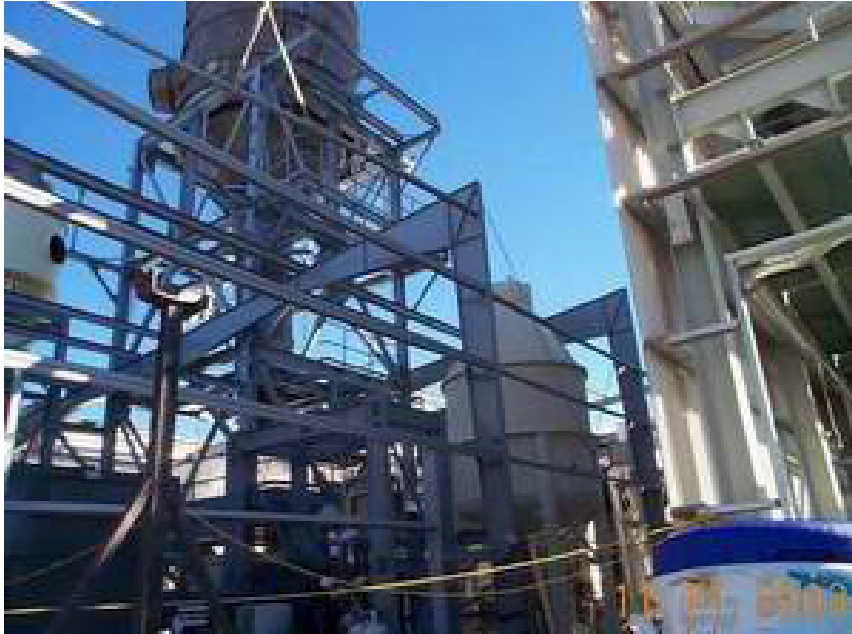
Victim was sitting on the large structural steel beam shown in center of photograph prior to fall.

RECOMMENDATIONS: Always wear a safety harness with a securely anchored lanyard when working where there is a danger of falling (4VAC25-40-1740). Appropriate fall protection equipment and the means or devices to properly secure them must be provided and inspected periodically to ensure they are in proper working condition (45.1-161.292:7)(4VAC25-40-330). All employees required to use fall protection/devices must be trained in the selection, inspection, and use of fall protection equipment and devices (4VAC25-40-100).

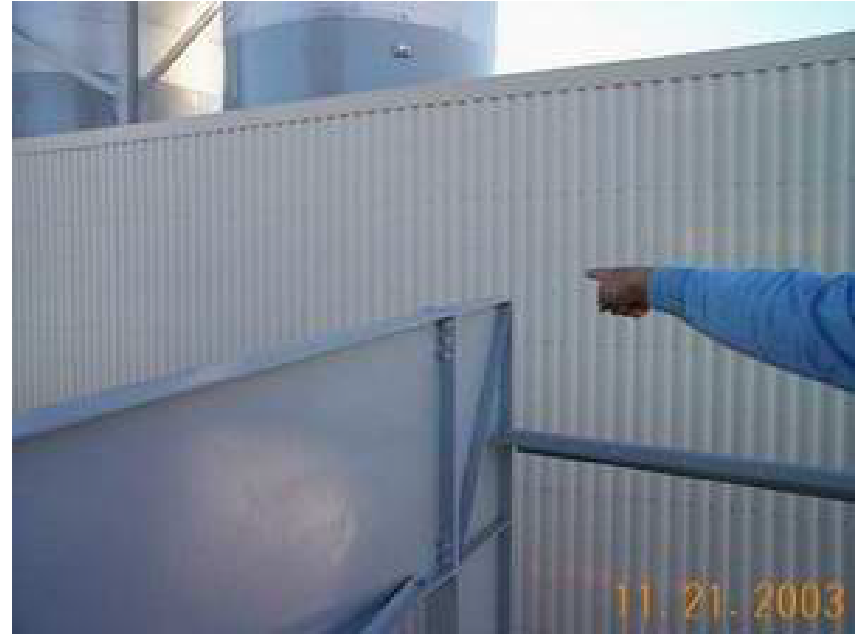
Close-up photo showing location where miner was sitting before he fell.
