SERIOUS INJURY ACCIDENT: April 2010 Miner Falls From Rail Car

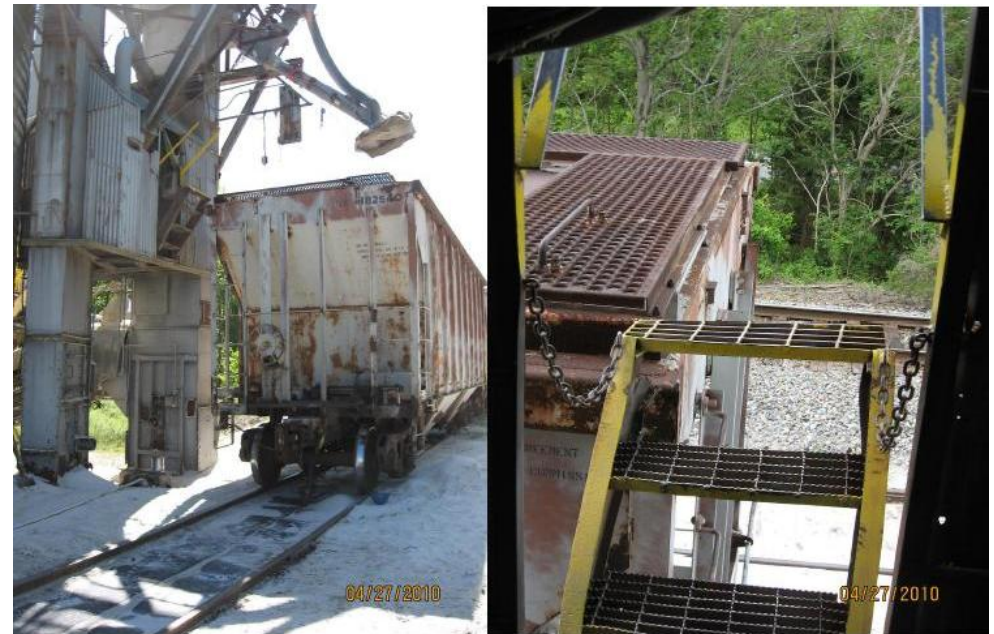
A miner with 32 years of experience was seriously injured as he and a co-worker were preparing a rail car for loading. The rail car had been moved into position and the miner was accessing the top of the railcar to open the hatch to the hopper when he lost his balance and fell approximately 15 feet to the ground below. The co-worker found the injured worker on his feet, stumbling and incoherent on the side of the rail car opposite the load-out. Rescue personnel were summoned and the man was transported by helicopter to a hospital for treatment of his injuries. The miner suffered a broken left wrist, a bruised temple, a broken rib, and fractures to his jaw and cheek bone. The broken wrist required surgery to repair.

- The accident occurred because the injured miner was in a hurry and did not follow state safety regulations and company safety policies regarding the use of fall protection equipment.
- An adequate fall protection system was provided and training in the use of this system was documented.
- Due to variations in the design of the rail cars being used, the pivoting access steps at the load-out did not make full contact with some cars including the one involved in the accident. This made access especially dangerous without fall protection.

- State regulations and company policies concerning the use of fall protection should be reviewed with all employees.
- Load-out personnel should be retrained in the use of the specific fall protection system utilized at the rail load-out.
- The pivoting steps at the load-out should be re-designed to reduce the fall hazard.
