HAZARD ALERT

FALL-RELATED ACCIDENTS

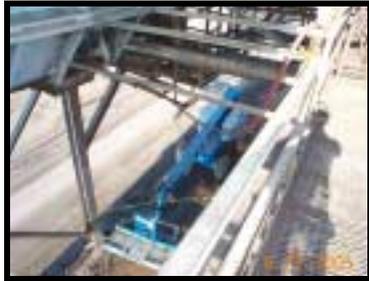
On June 27, 2005, a contract welder with 30 years of experience was seriously injured when he fell approximately 22 feet from an elevated platform/catwalk. The victim, a Virginia certified mine foreman, was dismantling a large bin used to load rail cars as part of a demolition project when he cut two hangers that supported the catwalk he was standing on and caused the catwalk to fail. The victim, who was not wearing a safety harness, broke his pelvis in three places, cracked two vertebrae, and broke a toe.

- Workers must be trained and reminded to examine their work areas for unsafe conditions prior to starting work and frequently thereafter.
- Always wear fall protection (properly secured safety harness) when working in elevated work areas where there is a danger of falling.
- Train all personnel to recognize potential fall hazards and to follow safe work procedures.

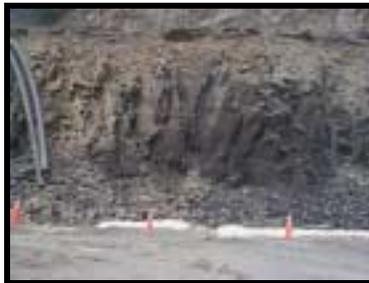
On July 5, 2005, a Virginia certified surface blaster (an independent contractor employee) with more than 11 years of experience was seriously injured when he fell approximately 30 feet off a highwall while measuring burden and inspecting drill holes in preparation of loading a shot. The blaster was working near the edge of the bench without a safety harness when he lost his balance and fell. The blaster fractured a vertebrae and received cuts and abrasions from the fall.

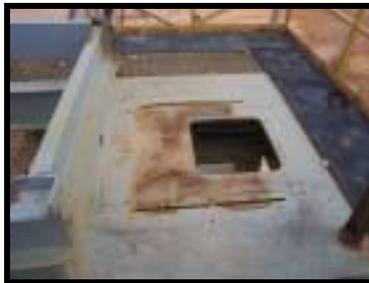
On June 29, 2005, a miner with 2 years of experience was injured when he fell from an elevated work platform while dismantling a secondary crusher. The victim, who was wearing proper fall protection, was washing down the work area when he apparently slipped on some old grease and fell partially through a hole in the platform. The victim fractured a rib when the D-ring on his safety harness got caught between his ribcage and the edge of the hole. The safety harness kept him from falling more than 20 feet and receiving more serious injuries.
