SERIOUS INJURY ACCIDENT: June 2007 Assistant Electrician Falls From Walkway

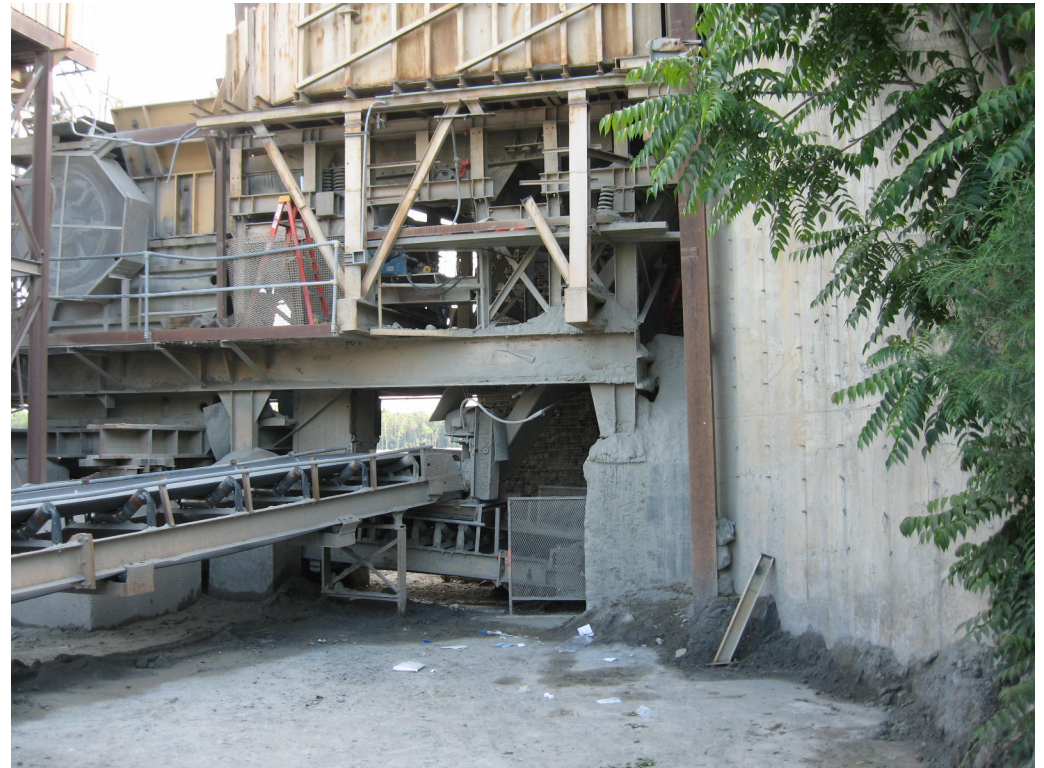
A miner was seriously injured at a crushed stone quarry while assisting an electrician replacing electrical wires beneath a jaw crusher feeder. The miner was standing on a platform on an elevated lower-level walkway beside the crusher feeder and feeding a wire “fish” through a conduit to a worker on the other side of the feeder, one level above him. The walkway’s handrails in the area that the miner was working in had been removed as part of an unrelated maintenance activity. After attaching wires to the “fish”, the co-worker called to the miner to pull it back through the conduit. Upon getting no response, the co-worker went to check on the victim and found him unconscious on the ground approximately fifteen feet below the platform where he had been working and apparently fallen from. The miner, who was not wearing fall protection, was hospitalized with serious head and spinal injuries.

Miner fell from platform at top center of photograph

- This accident occurred due to unsafe working conditions and unsafe work practices. An adequate workplace examination was not done prior to beginning work to identify potentially hazardous conditions such as the missing handrails, creating a fall hazard.
- The injured miner was not wearing fall protection equipment even though several sets of safety harnesses were available for use within 100 feet of the accident scene.
- DMM recommends that all workers be reminded of their responsibility to examine their work areas for unsafe conditions prior to starting work and frequently thereafter (**4VAC25-40-460**).
- Workers are required to wear a safety harness with a line when working in an area where there is a danger of falling (**4VAC25-40-1740**).
