Serious Injury Accident Investigation: Drilling Accident June 25, 2001

Serious Injury Accident Investigation: Drilling Accident June 25, 2001 continued.

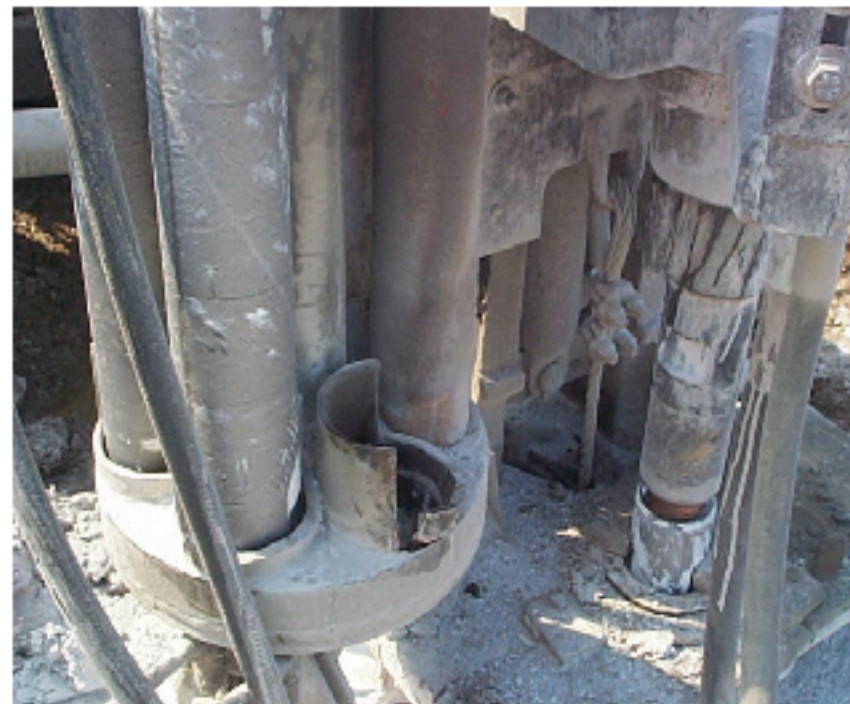
Steel rods in the carousel are held in place by a spider hook on top, and a pod (cup) on the bottom; pod bent outward when rod fell out of the carousel.

RECOMMENDATION: To prevent similar accidents from occurring, the drill operator must inspect the drill rig and associated equipment (e.g., the top plate, spider hooks, pods, and other components) prior to use each shift to ensure safe operating condition. During drilling operations, the driller/helper should ensure that steel rods in the carousel rack are properly secured.

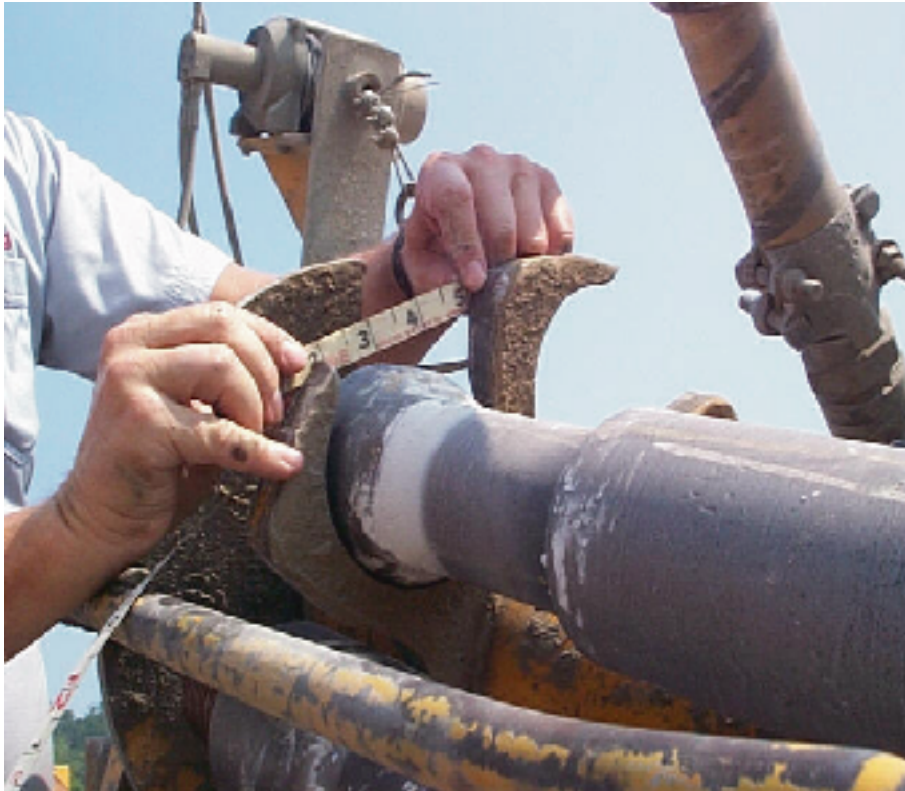
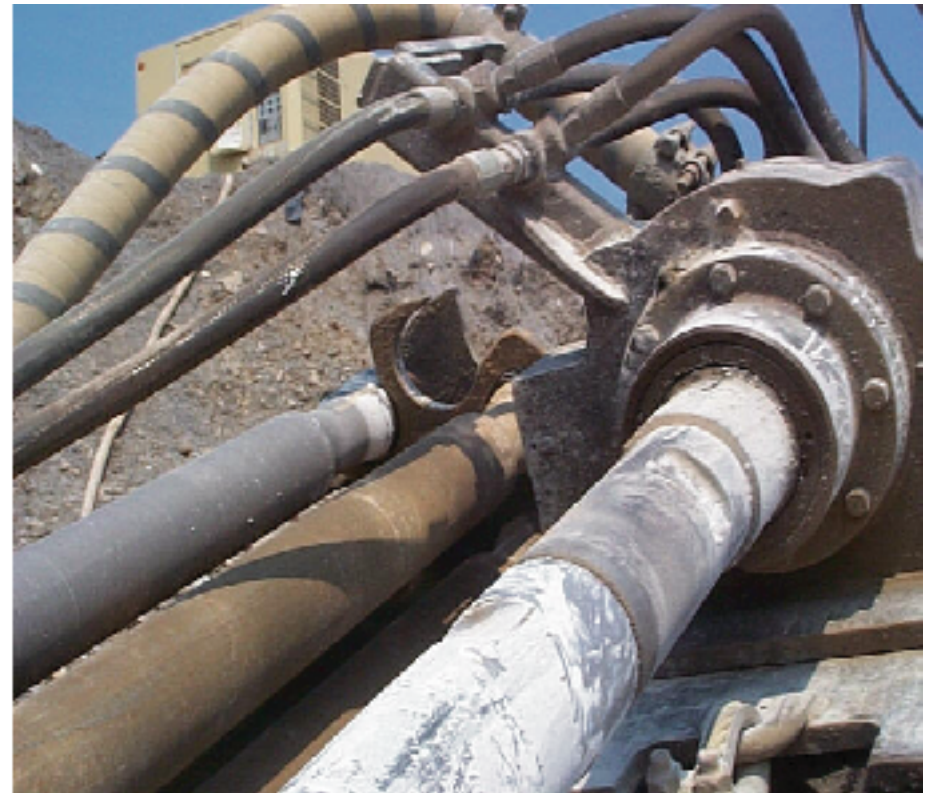
After lowering the drill mast, the spider hooks were closely examined; width between hook openings varied up to one-half inch, and two of the hooks were bent downward out of alignment. In addition, some drill cutting debris was found in the lower pod (cup) where the drill steel rod fell out of the carousel.
