Accident Investigation: Mobile Equipment July 30, 2002

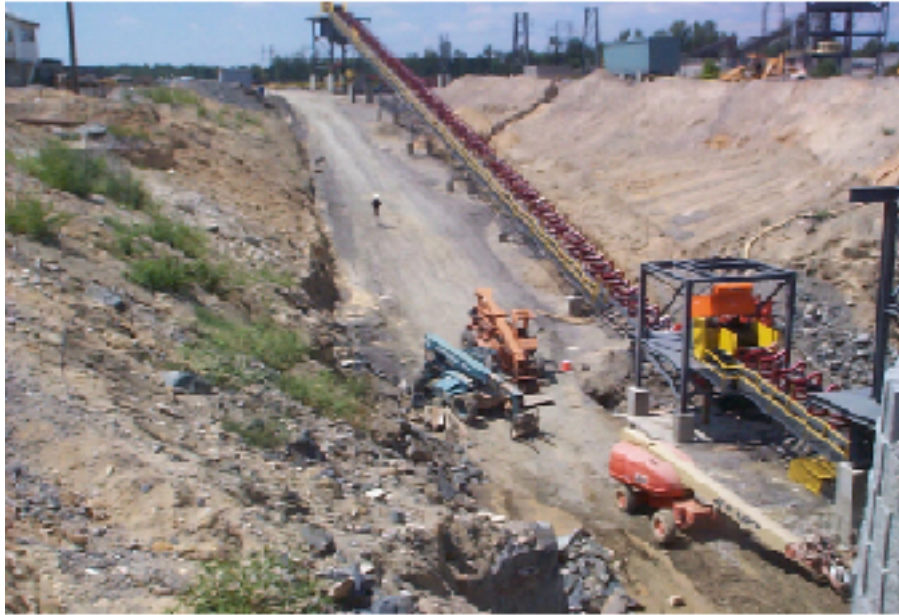
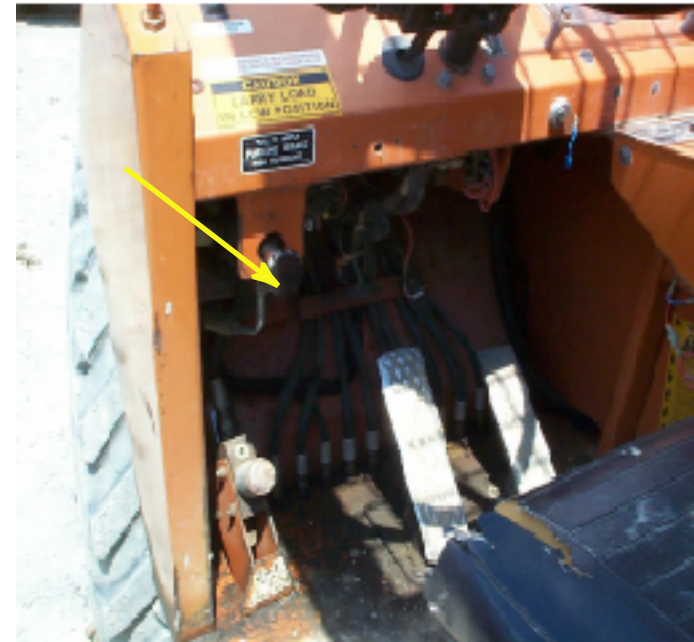
A 49-year-old ironworker employed by a construction contractor was seriously injured when he was pinned between two forklifts at a construction site on a mine property. The victim and two other contractor employees were using one of the forklifts to tow a man-lift that was stuck in mud at the construction site. After freeing the mired man-lift, the victim was standing next to the forklift (the blue one in the photograph below left) that was used to tow the man-lift and approximately 10 feet down slope of the other forklift (the orange one shown in the photograph below left). The victim was struck by the orange forklift and pinned between the blue forklift's cab and the orange forklift's right front tire after it was accidentally set in motion when another contractor employee inadvertently released the parking brake while climbing into it's cab. The victim, who broke both of his legs, was airlifted to a nearby trauma center for medical treatment.

RECOMMENDATIONS: To prevent a similar accident from occurring and as required by the Safety and Health Regulations for Mineral Mining, equipment operators must ensure, either by a signal or other means, that all persons are clear before starting or moving equipment (4 VAC 25-40-1340). In addition, mobile equipment with wheels or tracks, when parked on a grade, must be either blocked or turned into a bank or rib unless the bucket or blade of the equipment is lowered to the ground to prevent movement (4 VAC 25-40-1510). In this particular incident, the parking brake control button of the mobile equipment is located in a position susceptible to inadvertent contact/release by operators entering or exiting the cab. Equipment operators should be made aware of this potential hazard.
