Safety Alert: Excavator Operator Seriously Injured

Mineral Mining Program

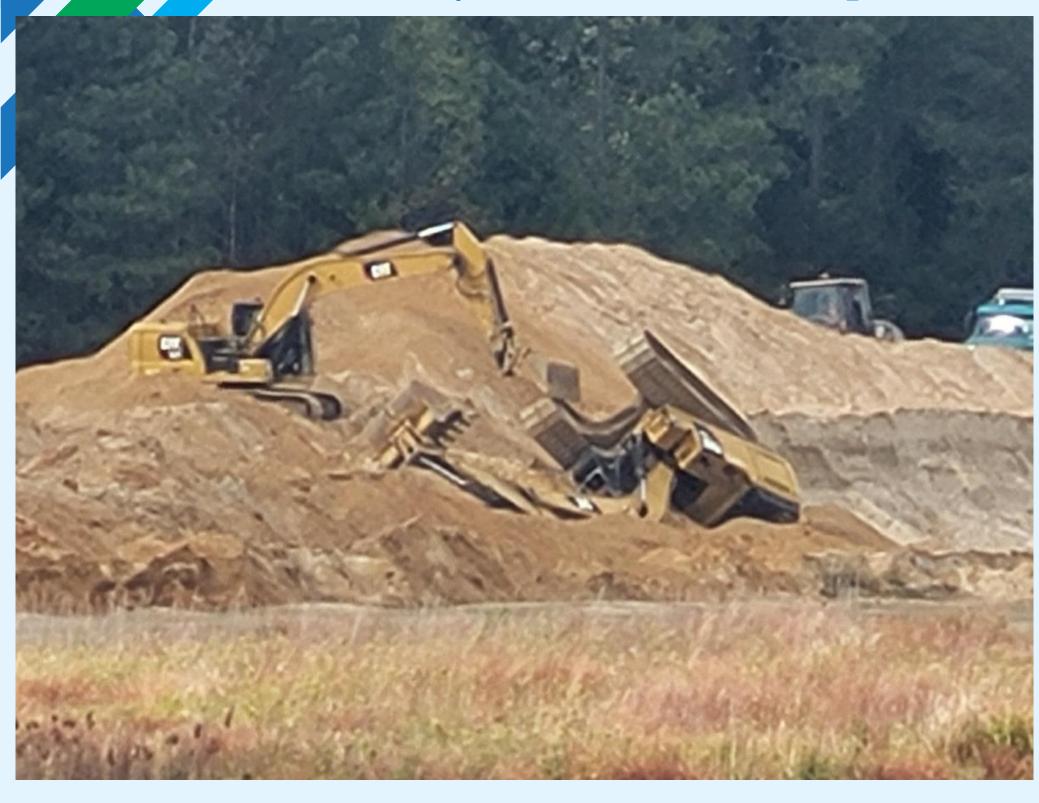
excavator adjacent to a pit bank in a sand mine. The accident occurred just past midnight, but nobody witnessed the accident. A mine employee, who was on site at time, discovered the accident shortly after it happened and immediately called emergency medical services. EMS extricated the injured worker from the excavator, who was then transported by helicopter to a local trauma unit. The injured worker sustained an open fracture of the lower right leg.

On October 15, 2024, a 50-year-old site visitor was

operating an excavator when it overturned and

pinned the operator. He was operating the

- Personnel should be adequately task trained before operating equipment.
- Always wear seatbelts when operating mobile equipment.
- Always conduct adequate inspections of ground conditions prior to operating near a bank or a wall.
- Excavators should be operated with the tracks perpendicular to a bank.
- Care should be taken not to undercut the bank in front of the excavator.
- Adequate lighting must be provided to provide a safe work environment.
