FATAL ACCIDENT ALERT

DECEMBER 22, 2025 – FLASH FIRE CAUSED BY CUTTING TORCH

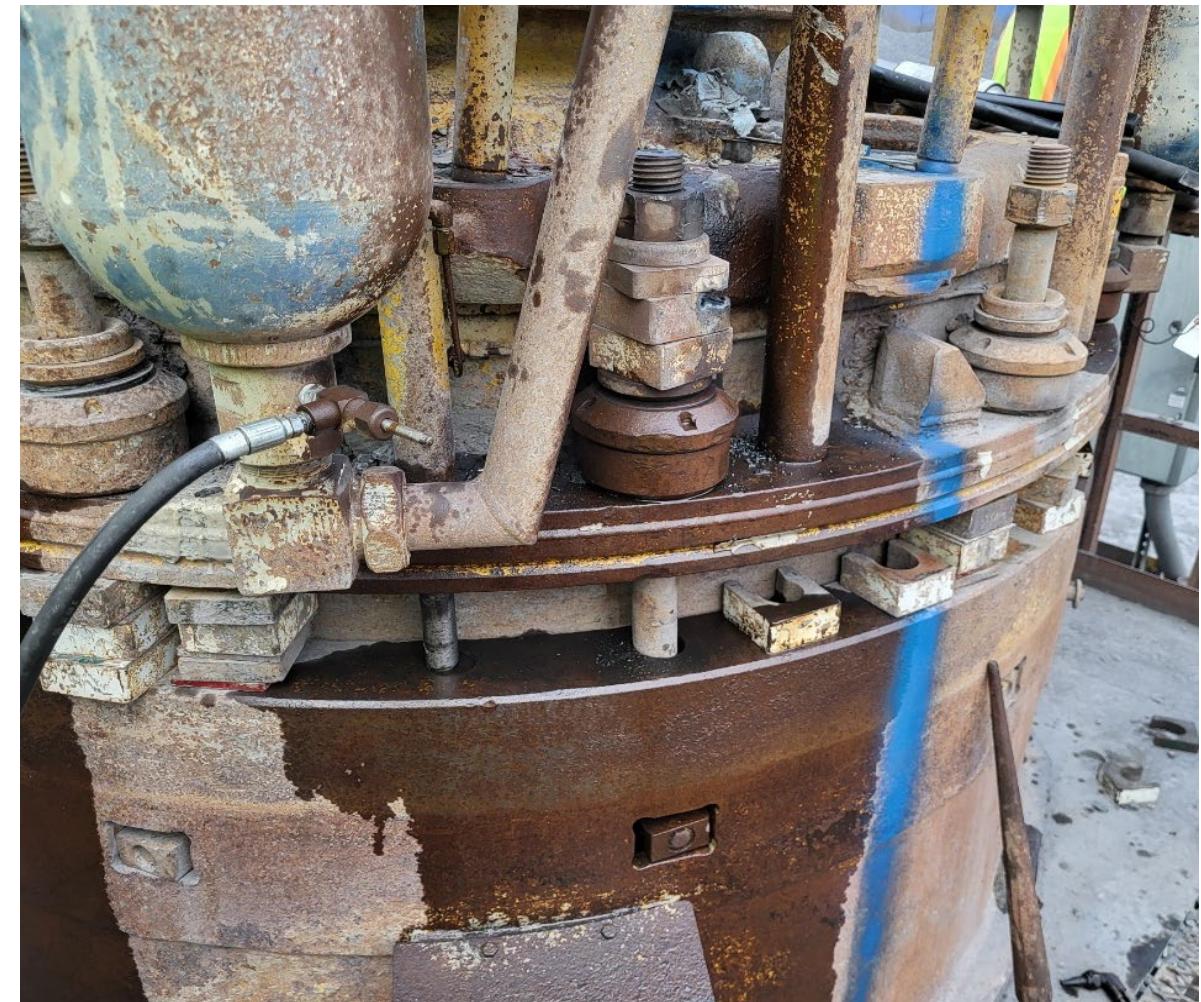
On December 22, 2025, a maintenance contractor employee was fatally injured at a Virginia mineral mine while performing maintenance on a cone crusher. The contractor was using a torch to remove adjustment shims when a nearby hydraulic line ruptured resulting in a flash fire. The contractor received burns to his face and later experienced respiratory difficulties. Immediately following the accident, he was transported to a local hospital where he succumbed to his injuries.

- Always follow manufacturer's recommended procedures when performing maintenance on machinery.
- Carefully inspect areas where hot work is to be performed for fire and explosion hazards and mitigate these hazards prior to commencing work.
- Conduct a job safety analysis to identify safety concerns when conducting infrequently performed maintenance tasks.
- Always wear appropriate personal protection equipment when utilizing a cutting torch.
