DMM Safety Alert

Fall From Conveyor Transfer Chute

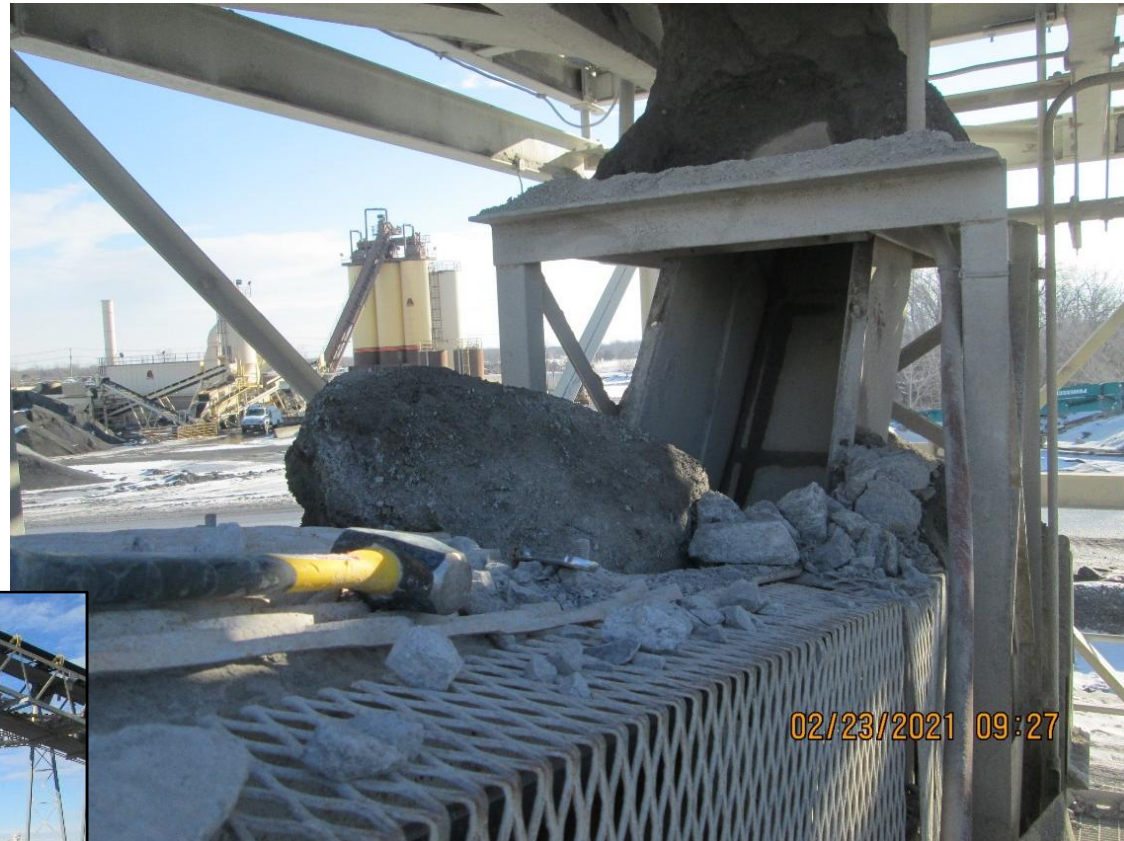
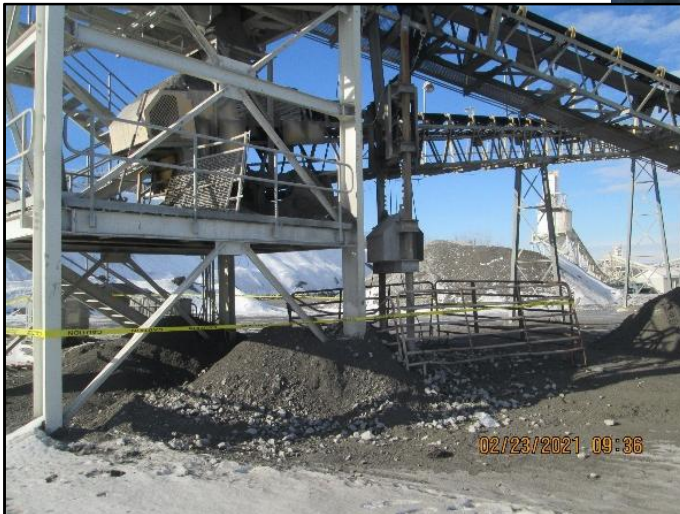
On February 23, 2021, a miner with approximately 22 years of mining experience was seriously injured when he fell approximately 15 feet from an elevated conveyor transfer chute. The miner and a co-worker were trying to clear the chute of bridged material. As the miner opened an access door on the transfer chute, material inside the chute abruptly forced the door open, causing the miner to fall to the ground. EMS was called and the injured miner was transported to a local hospital, where he was treated for several broken ribs, a punctured lung, several broken vertebrae, and a brain bleed.

- Prior to starting work, always stop to identify all potential safety and health hazards associated with a task, and determine the appropriate work procedures and personal equipment needed to do the job safely.
- **4 VAC 25-40-1810**, requires that safe access be provided to all work areas.
- Remember, fall protection is to be used where there is a danger of falling. **4 VAC 25-40-1740** requires a safety harness with a line be worn when persons work where there is a danger of falling.
- Written procedures are recommended for jobs such as this. Training in these procedures must be provided to all persons involved in a specific job.
