DMM Safety Alert: Crane Rigger Injured

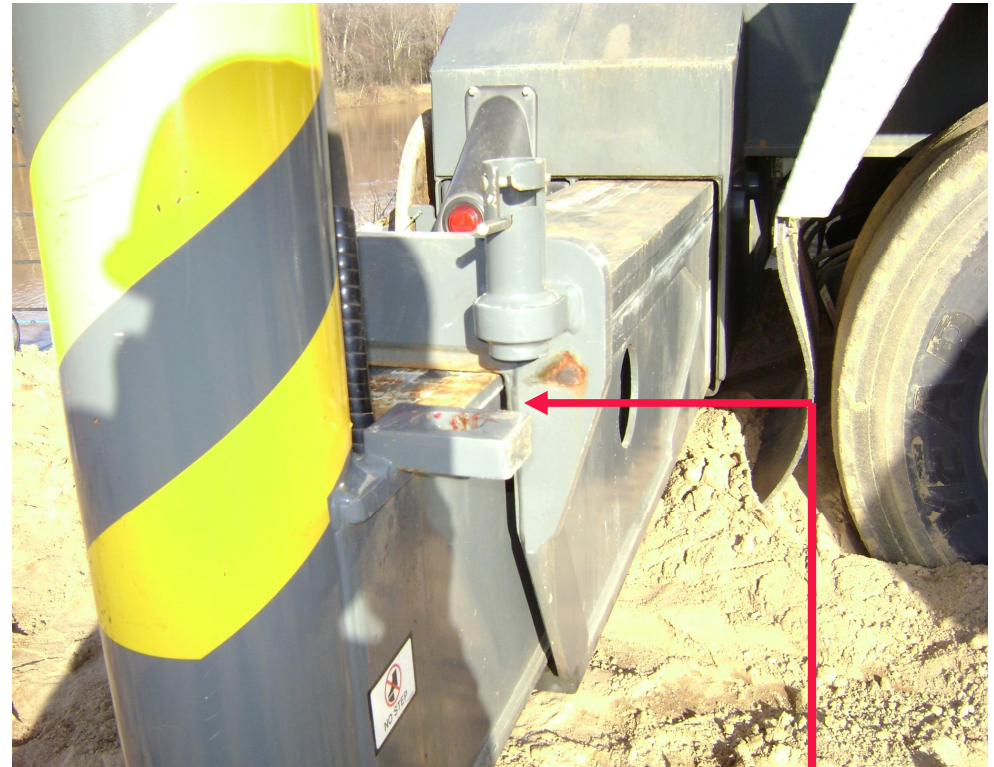
In January 2010, a contractor crane service employee was seriously injured during the breakdown of a crane. The crane had completed a job that involved setting a sand dredge in a river. The injured miner was removing the pad from one of the crane's outriggers when his hand was caught in a pinch point between a moving section and a stationary section of the telescoping outrigger. The injured miner was hospitalized for treatment of a broken thumb and surgery to repair tissue and nerve damage.

Pinch point on telescoping outrigger

- Job procedures should be continually reviewed in order to eliminate hazardous conditions or actions.
- Miners must be alert and remain clear of moving machinery or equipment.
- Machinery and equipment should not be started or moved prior to ensuring that affected persons are in the clear.
- Signs (decals, etc.) should be in place to warn miners of possible pinch points or other hazards that might not be obvious.
