# DMM Safety Alert:

## Conveyor Pulley Guarding

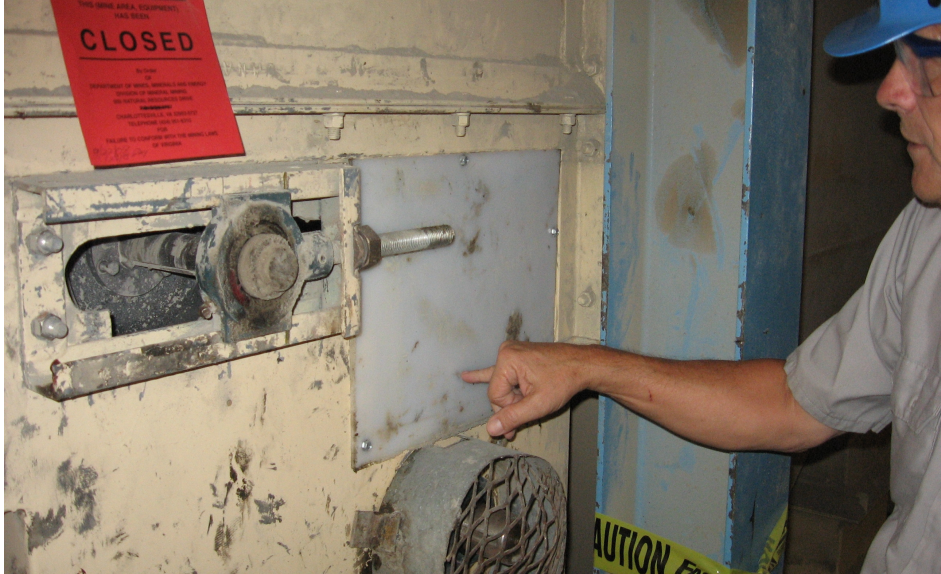
DMM inspector points to access cover that was removed.

- Procedures must be established, and followed, that protect miners from being caught in moving machinery.
- Miners must keep themselves clear of moving parts.
- Utilize lock out/tag out procedures when called for.

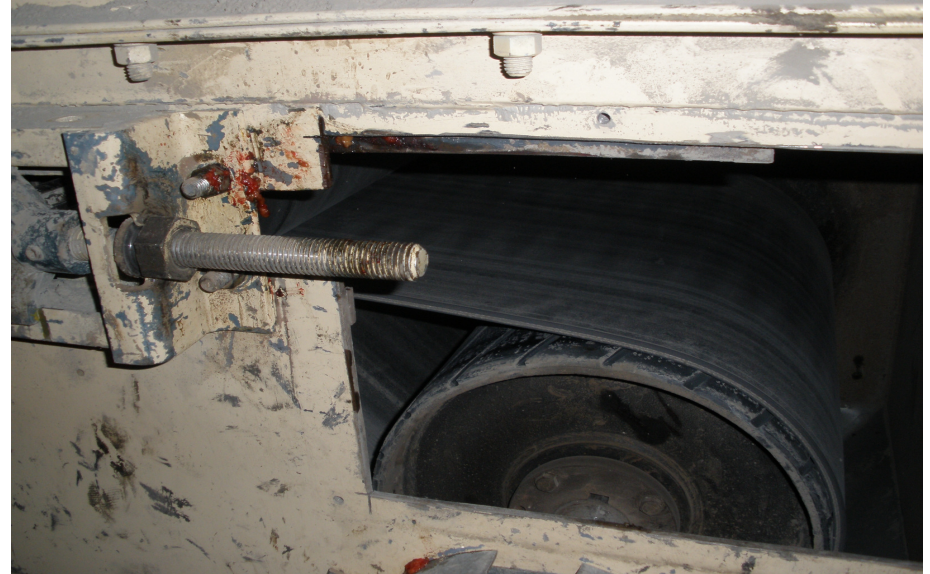
In September 2008, a maintenance contractor employee was seriously injured while working in the processing area of a mine. The miner and a co-worker were checking a recently repaired conveyor to ensure the belt was tracking properly. After removing the access cover of the moving conveyor belt, the maintenance worker's right arm was pulled into the drive pulley assembly. The injured miner was air-lifted to a hospital where he was treated for multiple fractures to his right arm. Virginia Mineral Mining Safety Regulation **4VAC25-40-2740** recognizes the need to remove guards for testing or adjusting machinery, however, to avoid this type of accident, the Division of Mineral Mining recommends the following:

Access cover removed, showing area where miner was injured.
