DMM Safety Alert: Mine Site Railroad Crossings

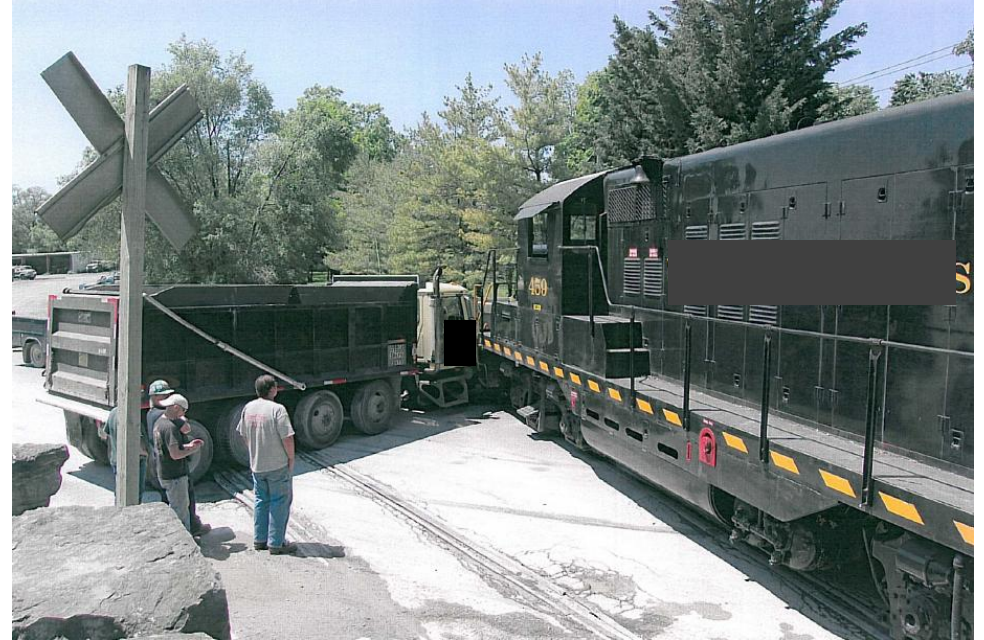
On May 17, 2012, a mine company owned over-the-road truck was struck by a train as it was leaving the mine site with a load. The mine entrance road crosses the railroad tracks near its intersection with a public road. This is an at-grade crossing, but is not equipped with cross-arms or lights. The train, traveling at approximately 10 MPH, sounded its horn as it approached the crossing. The truck driver did not hear or see the train and pulled onto the tracks, and stopped. The train went into an emergency stop and sounded its horn. The truck driver saw the train and tried to back up, but was struck before he could get clear of the tracks. There are adequate sight-lines in both directions at the crossing. The truck driver did not hear the train's horn because he was listening to music with earphones on. Fortunately, no one was injured although the truck was considerably damaged. To keep this type of accident from occurring in the future, the Virginia Division of Mineral Mining recommends the following:

- Ensure that mine and contractor personnel are adequately trained in railroad crossing safety (stop, look, listen, and never stop on tracks).
- Ensure proper sight-lines are maintained by removing tree limbs, brush, etc., that may affect visibility.
- Install and maintain adequate warning signs or signals at all at-grade crossings. Install automatic signals, if practical.
- Institute training and posting of any site specific rules or procedures involving railroad crossings.
- **It is a violation of Virginia motor vehicle law (46.2-1078) to operate a vehicle on the highways while using earphones on or in both ears.**
