DMM Safety Alert:

Drill Bit Ejected From Jaw Crusher

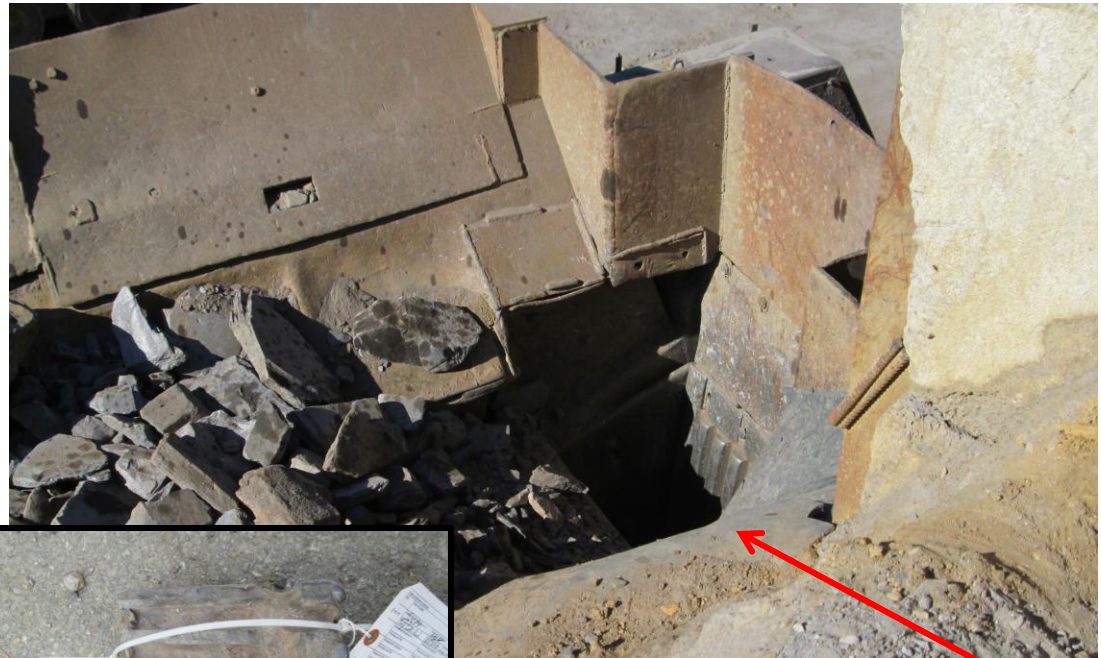
On November 10, 2014, a miner was seriously injured while attempting to remove a broken drill bit that had become lodged in a jaw crusher. The miner entered the crusher with a welding torch to cut the bit free. As he started to cut the bit, residual pressure from the crusher ejected the bit and it struck the miner in the chest and face rendering him unconscious for several minutes. Co-workers removed the injured man from the crusher and administered first aid while waiting for EMS to arrive. Once on site, EMS personnel performed a tracheotomy and summoned a helicopter to transport the miner to a hospital where he was admitted in critical condition and treated for two collapsed lungs, a fractured C7 vertebra, a broken jaw and broken teeth. He remains in the hospital in serious condition at this time. To assist in avoiding this type of injury in the future, The Virginia Division of Mineral Mining recommends the following:

Broken drill bit that struck the miner

- Work on machinery must not be performed until the power is off and the machinery is blocked against motion.
- A safety harness attached to an attended life line must be worn by persons entering confined spaces.
- Manufacturer's recommendations must be followed when performing work on machinery.
- Safe work procedures should be established and followed to prevent miner's exposure to hazards.
