DMM Safety Alert: Metal Chute Falls On Miner

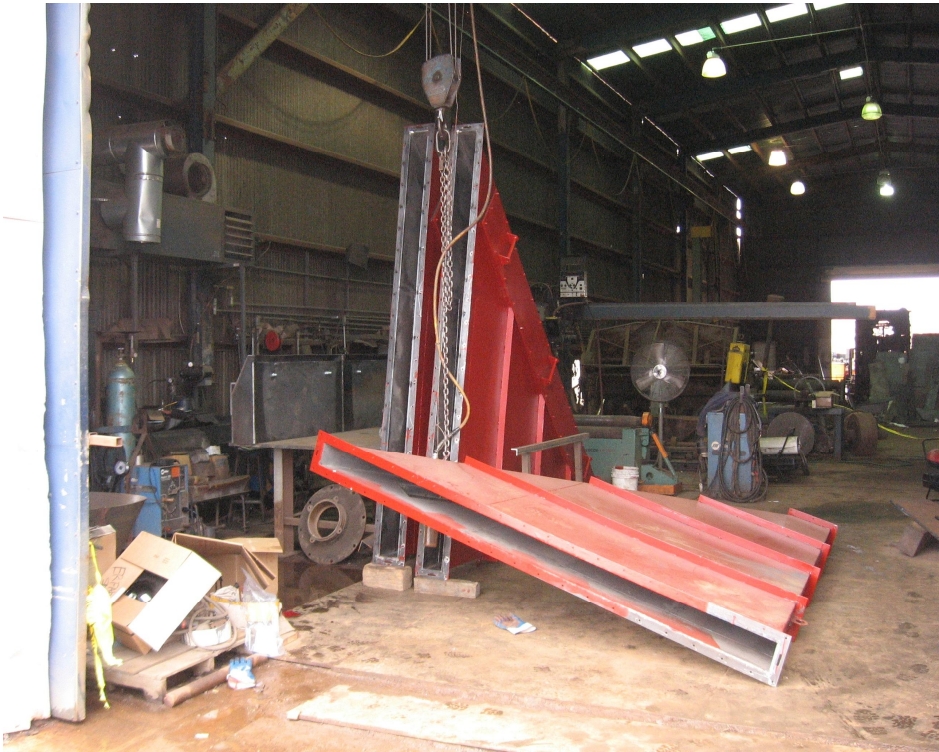
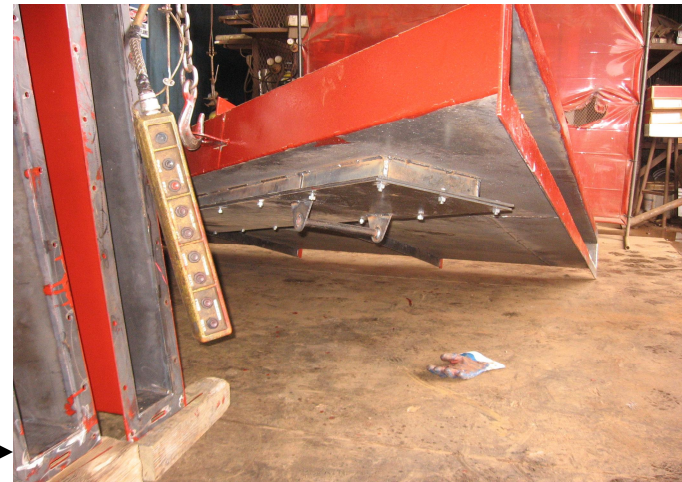
In October 2009, a miner with 13 years of experience was seriously injured when a section of a metal chute fell over and struck him. The miner was helping to position the 1,400-pound chute on its side in a metal fabrication shop using an overhead crane so that it could be painted. The chute (approximately 9.5 feet tall and 6 inches wide with a 2 inch exterior stiffening/mounting flange) was set down on a lifting eye that protruded 1.5 inches beyond the flanges. When the crane's lifting hook was released, the chute became unstable and fell over, striking and landing on top of the worker. He suffered two fractured lumbar vertebrae, facial fractures and contusions to his right shoulder. To prevent a similar accident from occurring, the Virginia Division of Mineral Mining recommends the following:

Views of accident scene

- Materials must be handled in a manner that minimizes fall hazards.
- Tag lines must be attached to suspended loads that require steadying or guidance.
- Persons shall remain clear of suspended loads.
- Equipment/materials must be blocked against unintended motion.
