DMM Safety Alert:

Miner Injured By Falling Electrical Panel

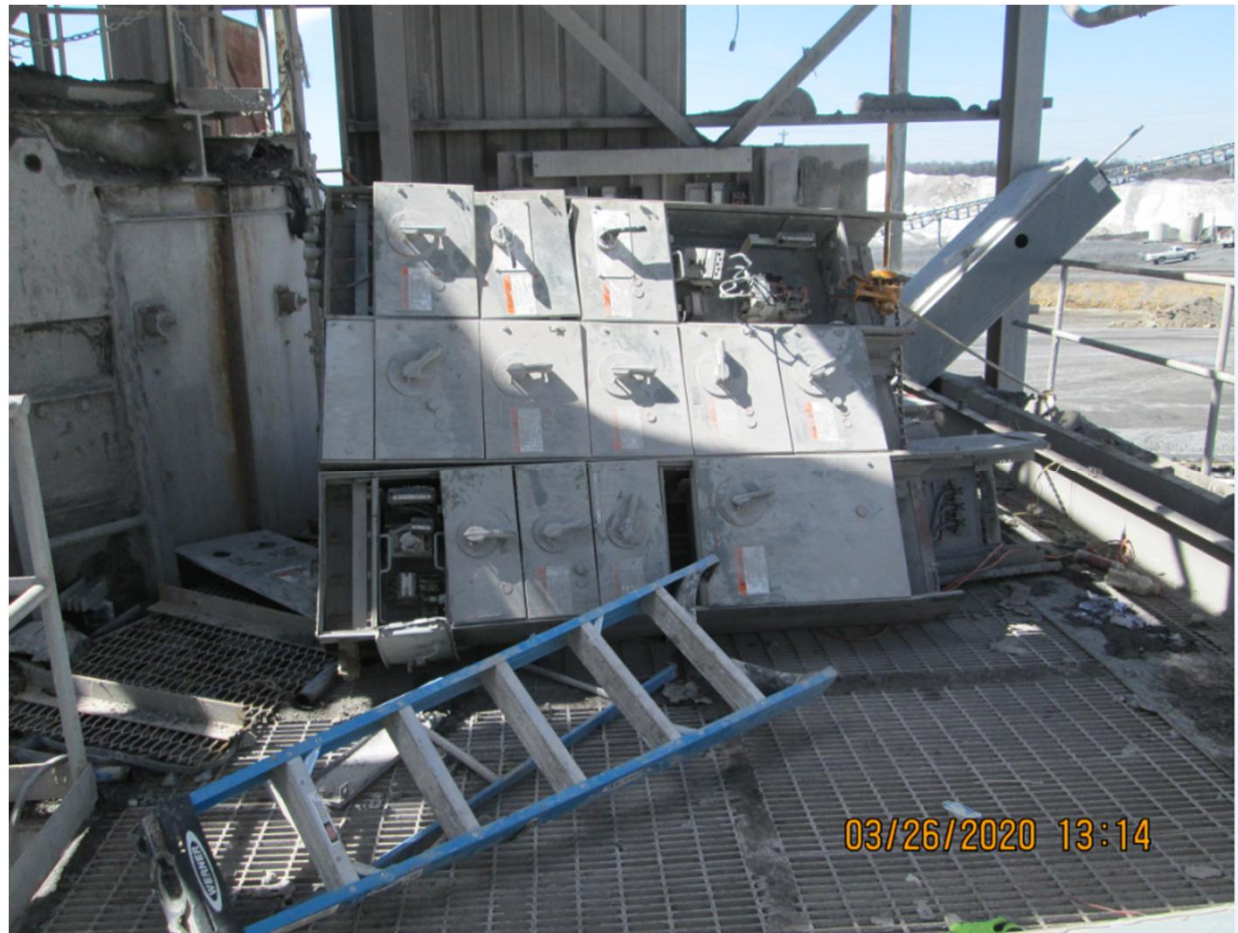
On March 26, 2020, a thirty-year-old contractor employee was seriously injured when an electrical panel fell on top of him. Contractor personnel were demolishing an old aggregate plant when the accident occurred. The electrical panel had been bolted to the flanges of two beams through tabs along the base of the panel. Several of these bolts had been cut and the panel was resting on the two beams, when the panel unexpectedly fell on the contractor employee. The employee sustained back injuries requiring surgery.

The Virginia Division of Mineral Mining (DMM) recommends the following to help prevent a similar type accident from occurring:

- Prior to starting work, assess potential safety and health hazards and determine the appropriate work procedures and personal protective equipment to be used.
- All mine personnel and contractor personnel should be trained in proper procedures for the work assigned and made aware of all hazards associated with the tasks they are assigned to perform.
- While working on any machinery, equipment, or structures, be sure to block or secure against unintended motion.
- Use signs/barricades to keep personnel out of areas containing hazards that may not be obvious.
- Perform work area inspections frequently to ensure potential hazards are identified and that tasks are carried out safely.
