DMM Safety Alert:

Miner Struck By Rock

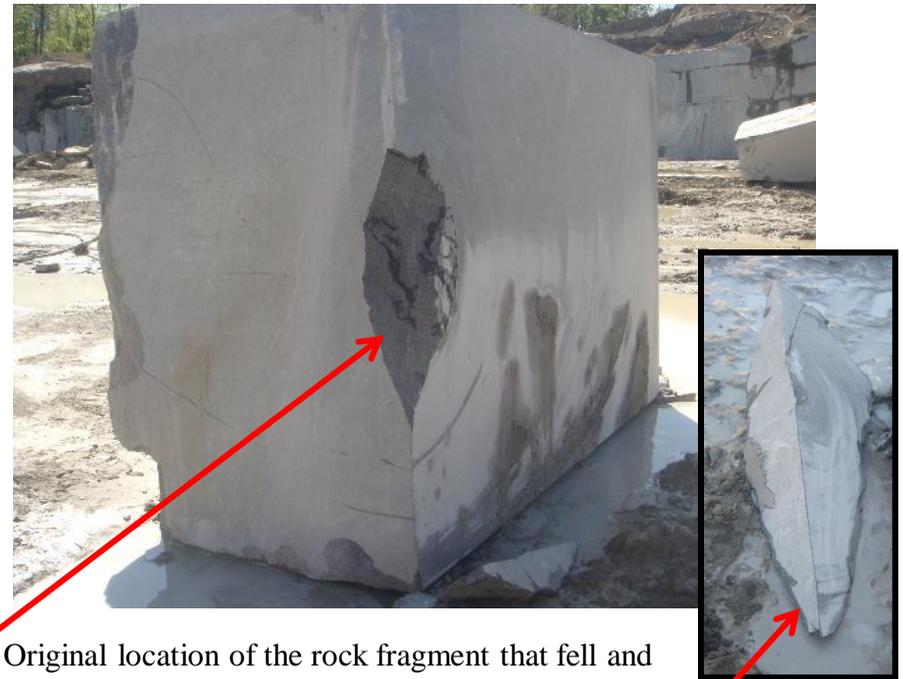
On April 25, 2013, a dimension stone saw operator with 21 weeks of experience was seriously injured when a 2-foot long rock fragment broke off of a large dimension stone block and struck his right foot. The saw operator and his lead-man were examining the stone block for imperfections and discussing sawing techniques to improve block quality. The rock fragment popped loose from the corner of the block without warning and the jagged end landed on top of the saw operator's right boot approximately two inches behind the boot's steel-toe. The injured miner was transported to a local hospital for evaluation, and underwent surgery to repair a severely fractured metatarsal bone in his right foot. He was released from the hospital the next day and is expected to return to light duty work in about two weeks. To prevent this type of accident from occurring, the Virginia Division of Mineral Mining recommends the following:

Original location of the rock fragment that fell and struck the miner.

Jagged end of the rock fragment that landed on the miner's foot.

- Miner training should identify all possible hazards associated with working around large dimension stone blocks and appropriate ways to mitigate these hazards.
- It is important to be mindful of the stresses that can build up in dimension blocks as a result of cutting/sawing and handling. These stresses can cause pieces of rock to break off of the block without warning and where no sign of weakness is obvious.
- Ensure that persons who work around dimension stone blocks or other large blocks of material are equipped with the proper personal protection equipment. Steel toe boots with metatarsal guards may be appropriate.
