Virginia Department of Mines, Minerals & Energy
Division of Mines

Fatal Machinery Accident Investigation Report
February 21, 2014

Dominion Coal Corporation
Mine No. 30
Mine Index No. 14293AH
Linn Camp, Buchanan County, Virginia

**FATAL MACHINERY ACCIDENT
FATALITY INVESTIGATION REPORT
DOMINION COAL CORPORATION
MINE NO. 30**

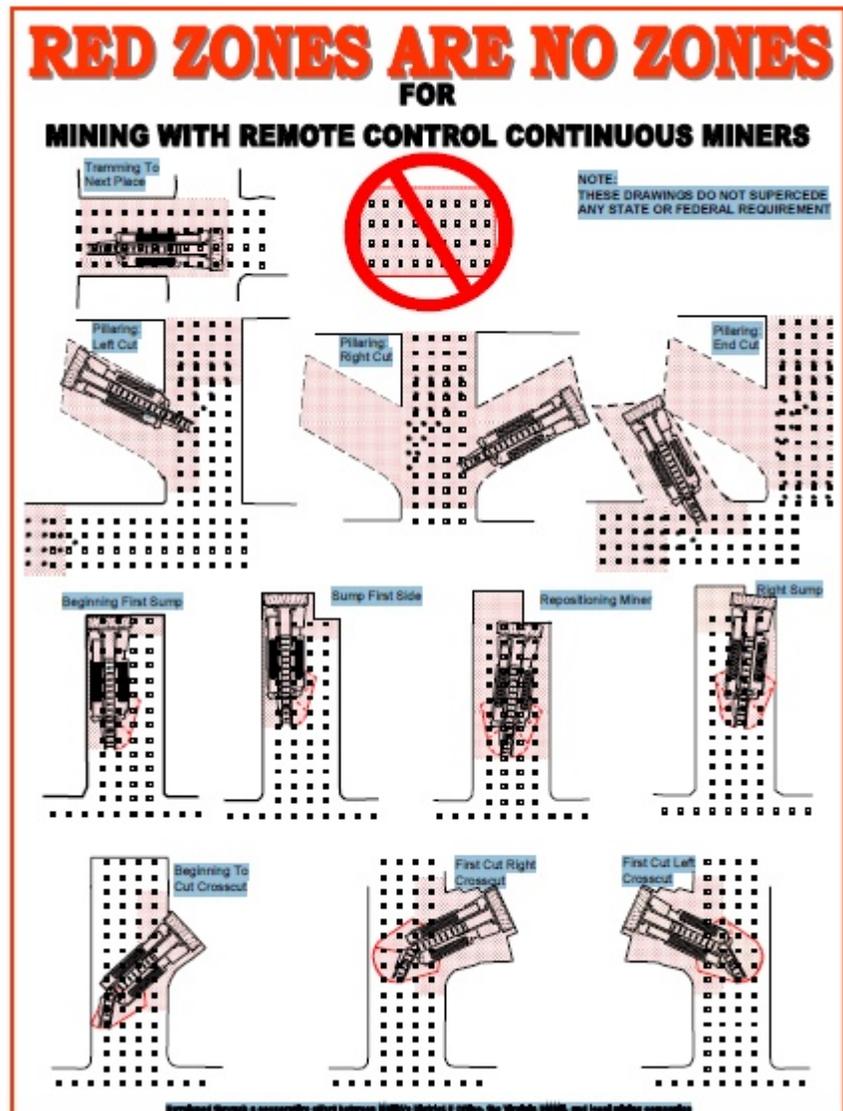
All of the interviewed employees were questioned specifically about the "Red Zone" restrictions. "Red Zone" is a common term used in coal mining to identify areas around remote control continuous miners where crushing hazards exist. Figure 1 is an illustration of red zone areas commonly posted at coal mines. The miners stated that they had been trained by the mine operator and knew about "Red Zones" and no one indicated that they had ever witnessed Mr. Gelentser operate the miner while he was located in a red zone.

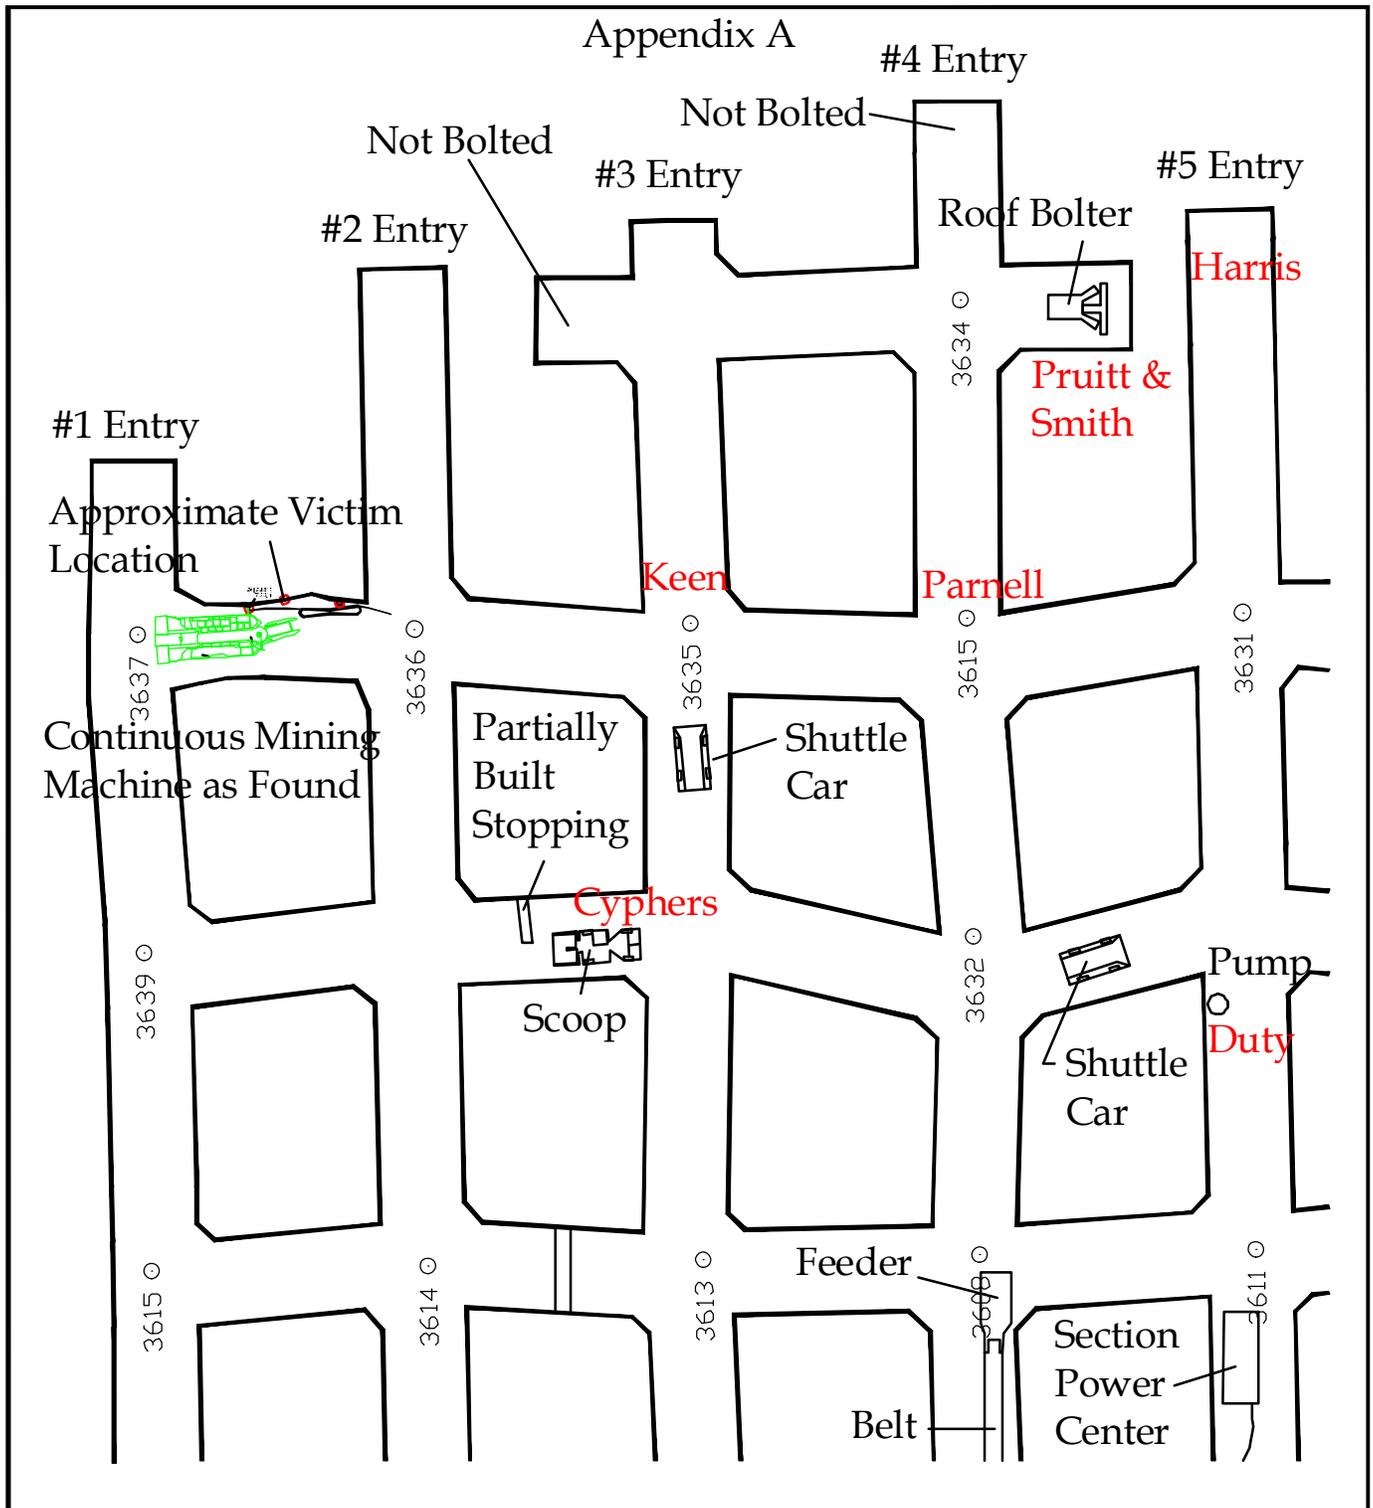
On February 21, 2014, at approximately 3:37 p.m., an underground machinery accident occurred at the Dominion Coal Corporation, Mine No. 30. Mr. Arthur David Gelentser, III, continuous mining machine operator, received fatal injuries as a result of being caught between the conveyor boom tail of the continuous mining machine and the right inby coal rib while tramming the 14CM10-11AX remote controlled continuous mining machine through the No. 2 Entry left crosscut to resume mining operations in the No. 1 Entry working place located on the H-Section.
