**Accident Investigation Report**  
**Underground Coal Mine**

**Fatal Machinery Accident**  
**June 20, 2002**

**Consolidation Coal Company**  
**Buchanan No. 1 Mine**  
**Mine Index No. 11912AA**  
**Buchanan County, Virginia**

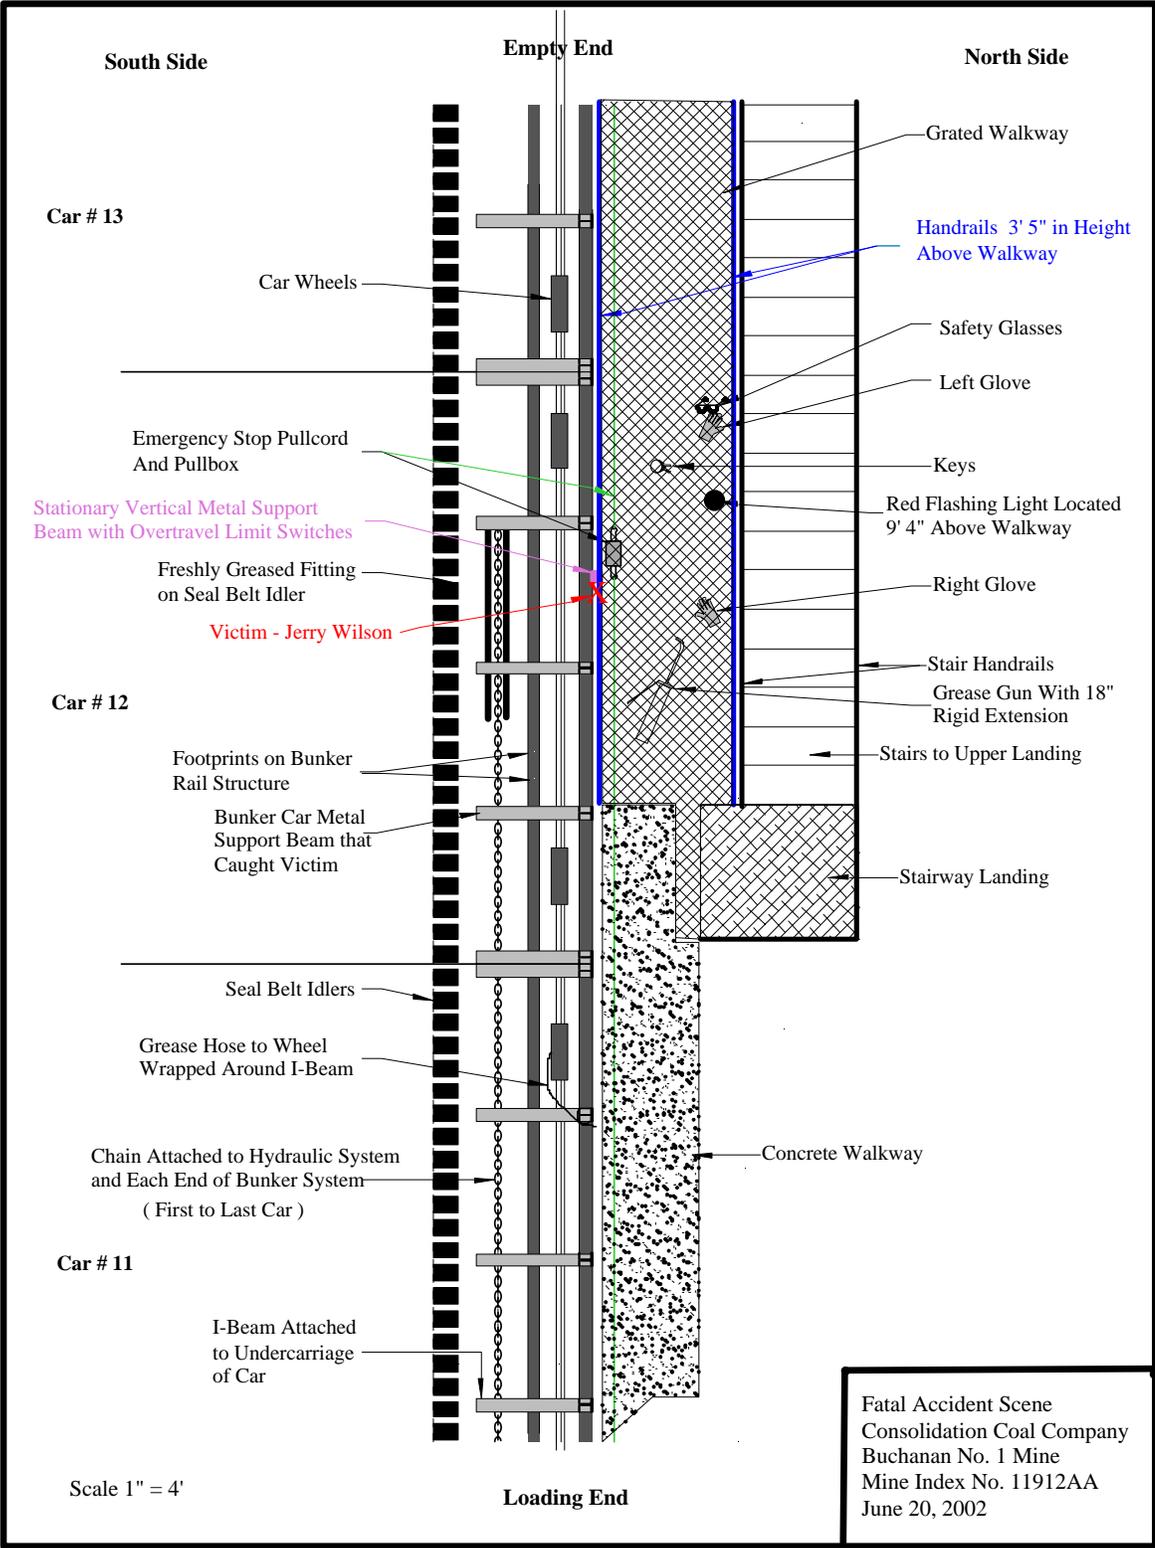
Fatal Accident Scene  
Consolidation Coal  
Company  
Buchanan No. 1 Mine  
Mine Index No. 11912AA  
June 20, 2002

- Bunker for storing coal.  
Bunker cars moves forward and backwards along walkway.
- Vertical metal support beam.  
Attached to walkway structure with overtravel limit switches mounted at top.
- Metal grating walkway.
- Bunker car support legs. These legs move by the vertical support beam (B) as the bunker cars move back and forth.
