Virginia Department of Mines, Minerals & Energy
Division of Mines

Accident Investigation Report
Underground Coal Mine
Preparation Plant

Surface Haulage Fatality
June 28, 2002

Lone Mountain Processing, Inc.
6-C Mine No. 1
Mine Index No. 14344AA
Lee County, Virginia

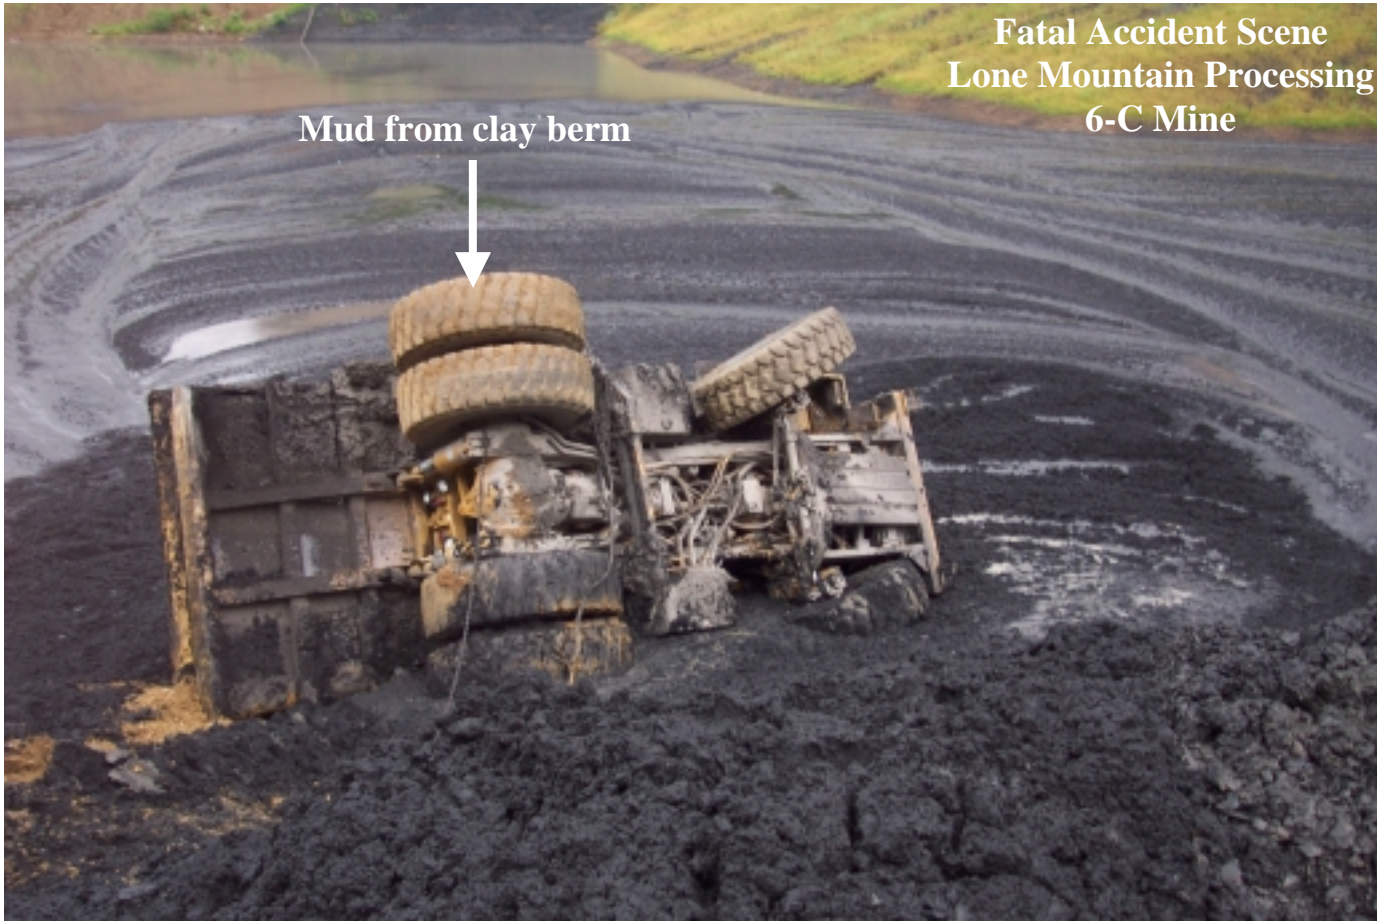
Mud from clay berm

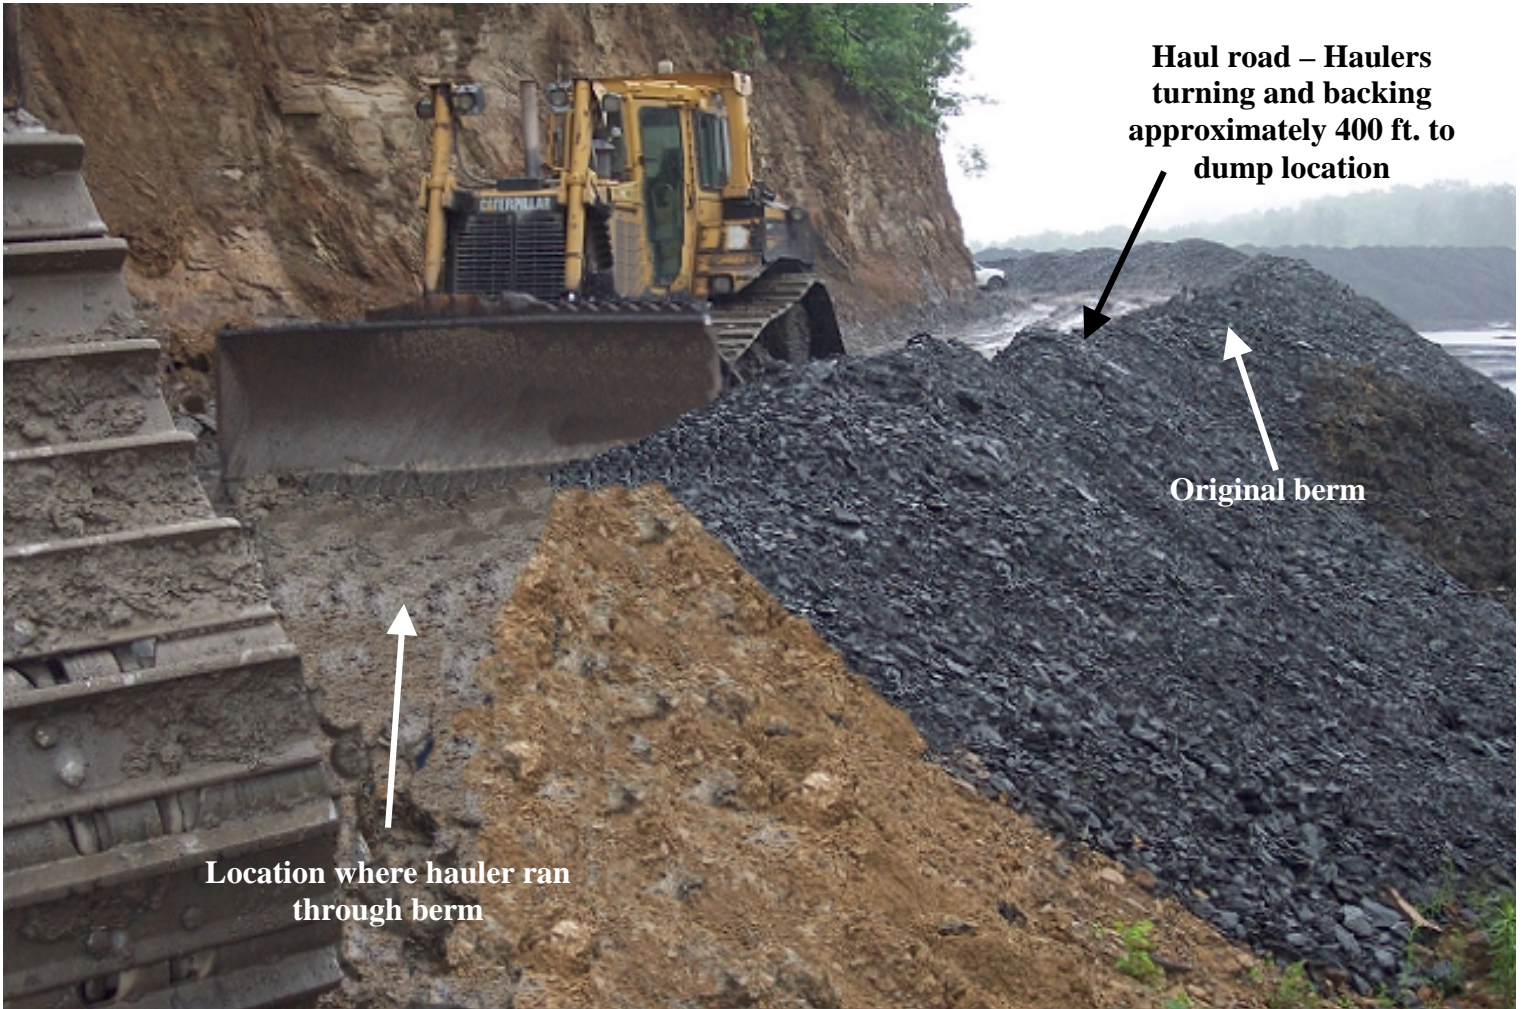
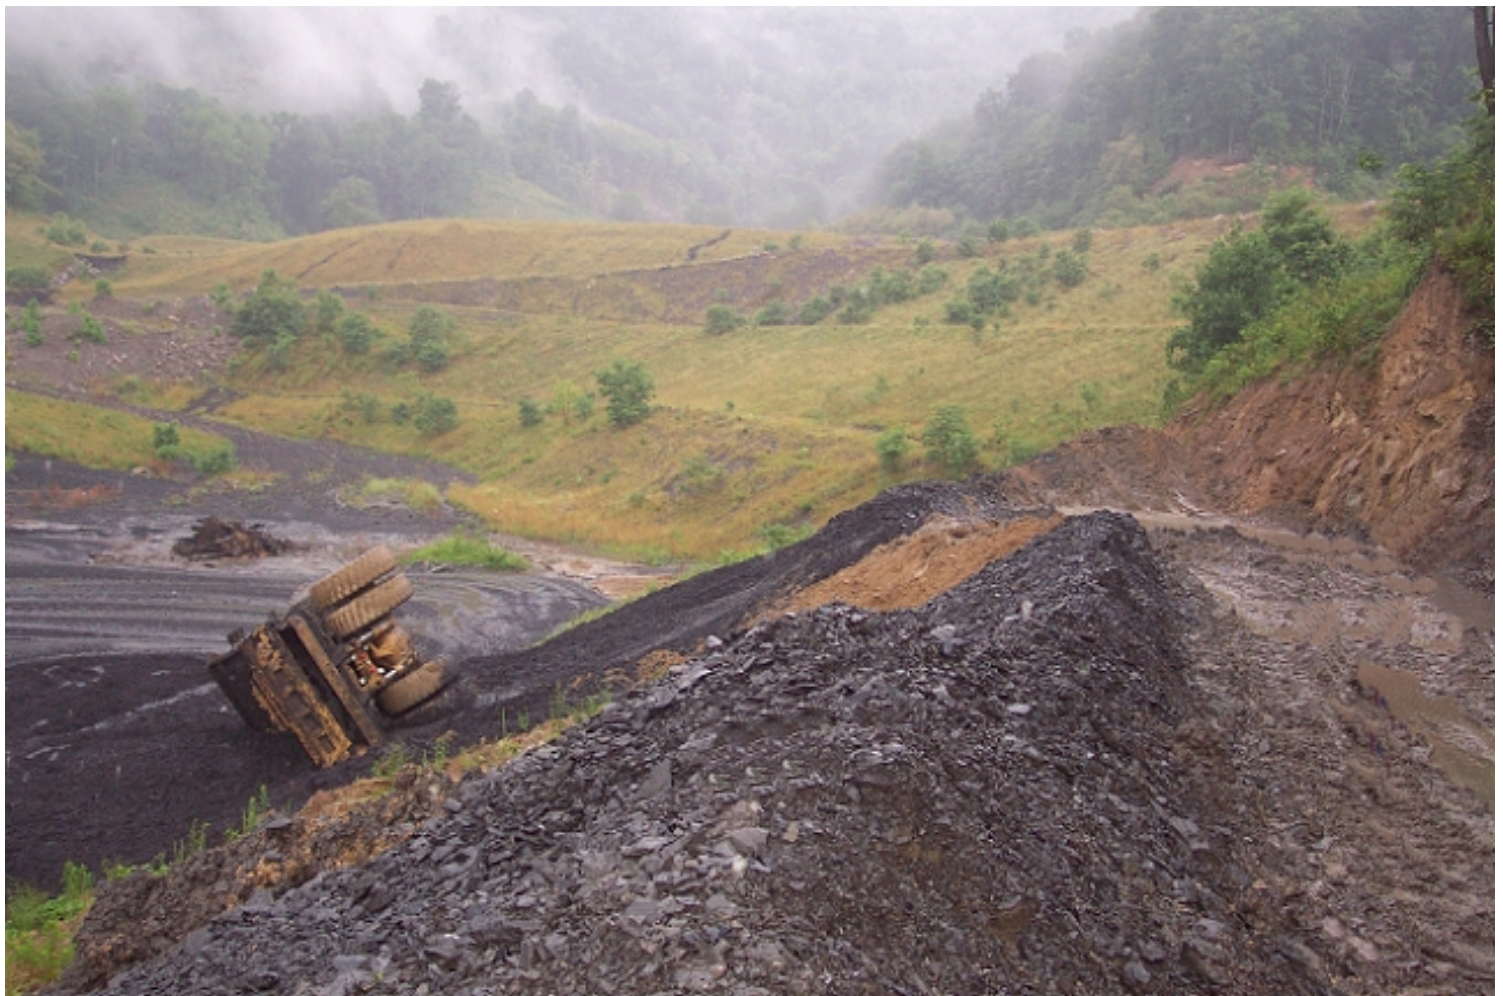
Structural
Damage to
Hauler

10. The seat belt was found unlatched and was functional when examined and tested.
11. The operator's cab and compartment of the 773B end dump truck sustained the following damage:

- A. The steering wheel was bent.
 - B. The steering column housing was broken loose from its mount to the dash panel.
 - C. The turn signal switch was broken loose from the mount on the steering column.

- D. The driver's side mirror was broken.
 - E. The catwalk and handrail at the driver's door was crushed.
 - F. The driver's side door, was crushed in against the driver's seat and steering wheel.

- I. An air fitting on the rear reserve air tank, located behind the operator in a separate compartment within the cab, was cracked and leaking and the protective cover was missing from this compartment.
