### **Accident Investigation Report Underground Coal Mine**

#### **Powered Haulage Fatal Accident September 26, 2004**

#### **Consolidation Coal Company Buchanan Mine No. 1 Mine Index No. 11912AA Buchanan County, Virginia**

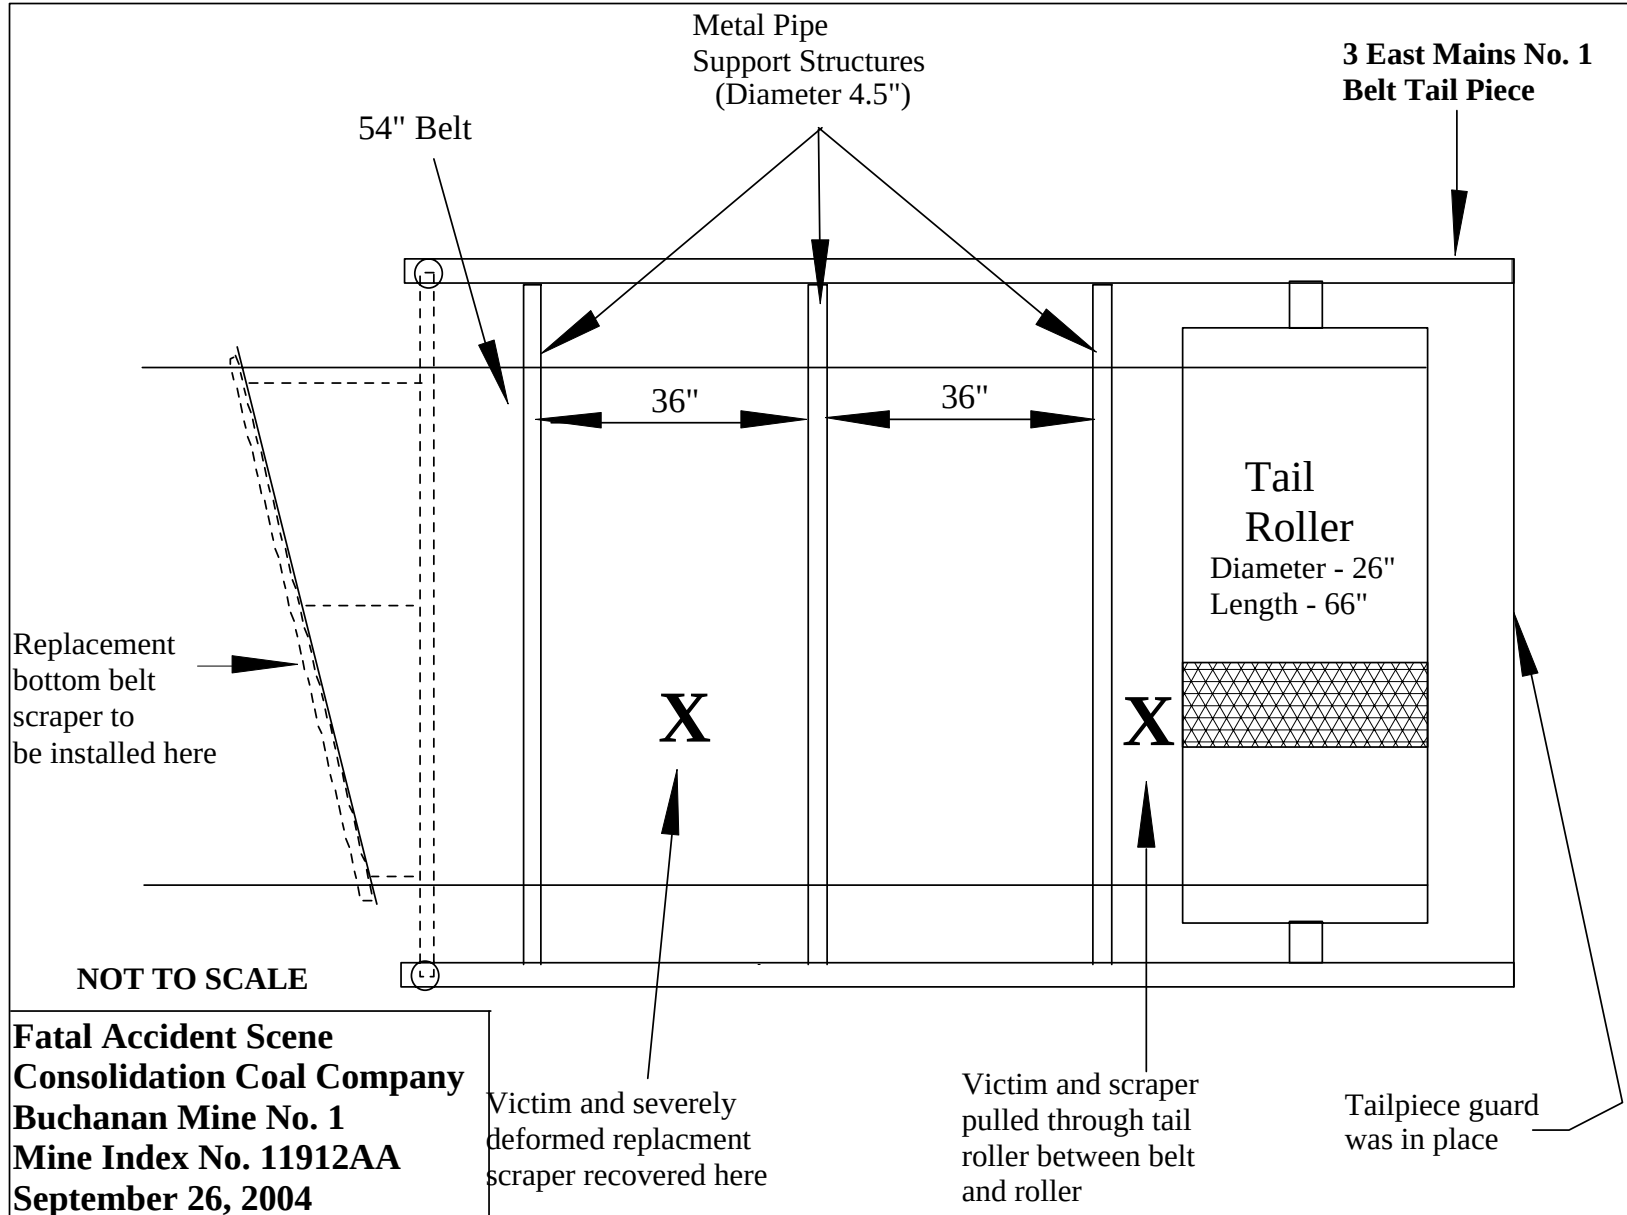
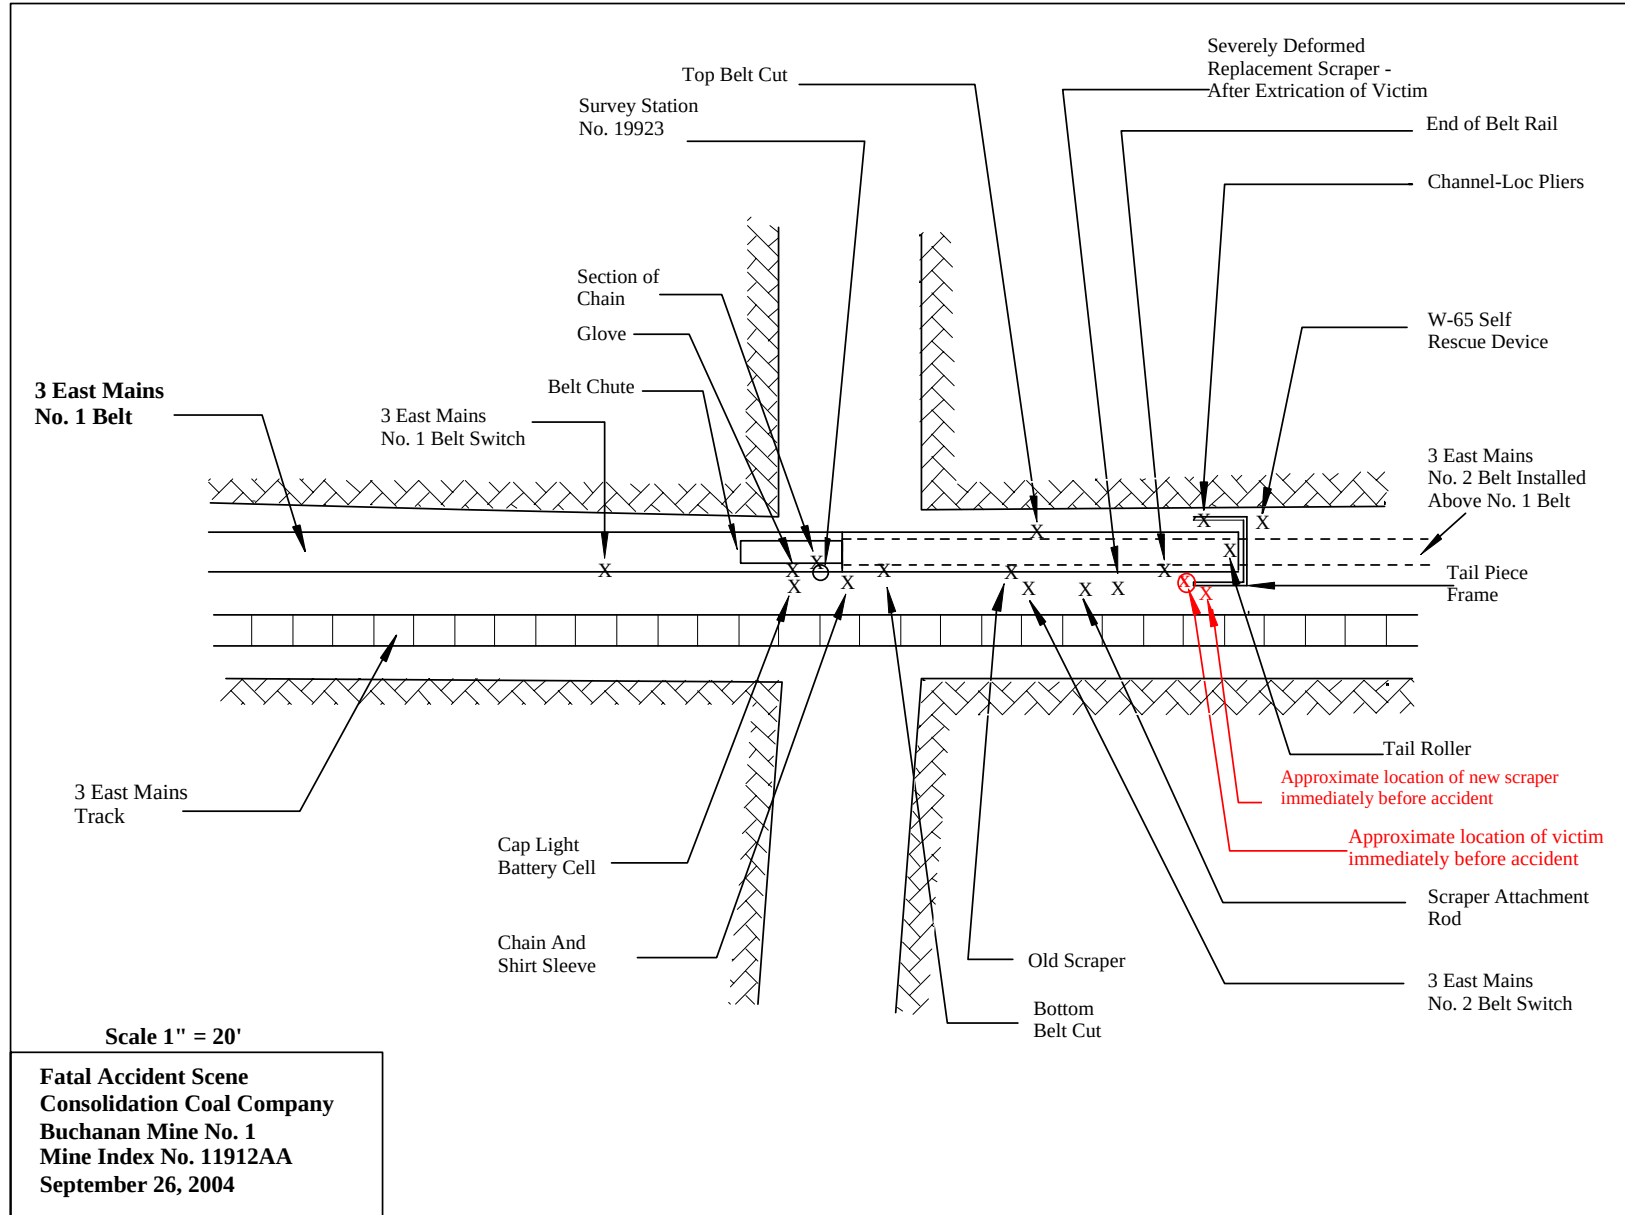
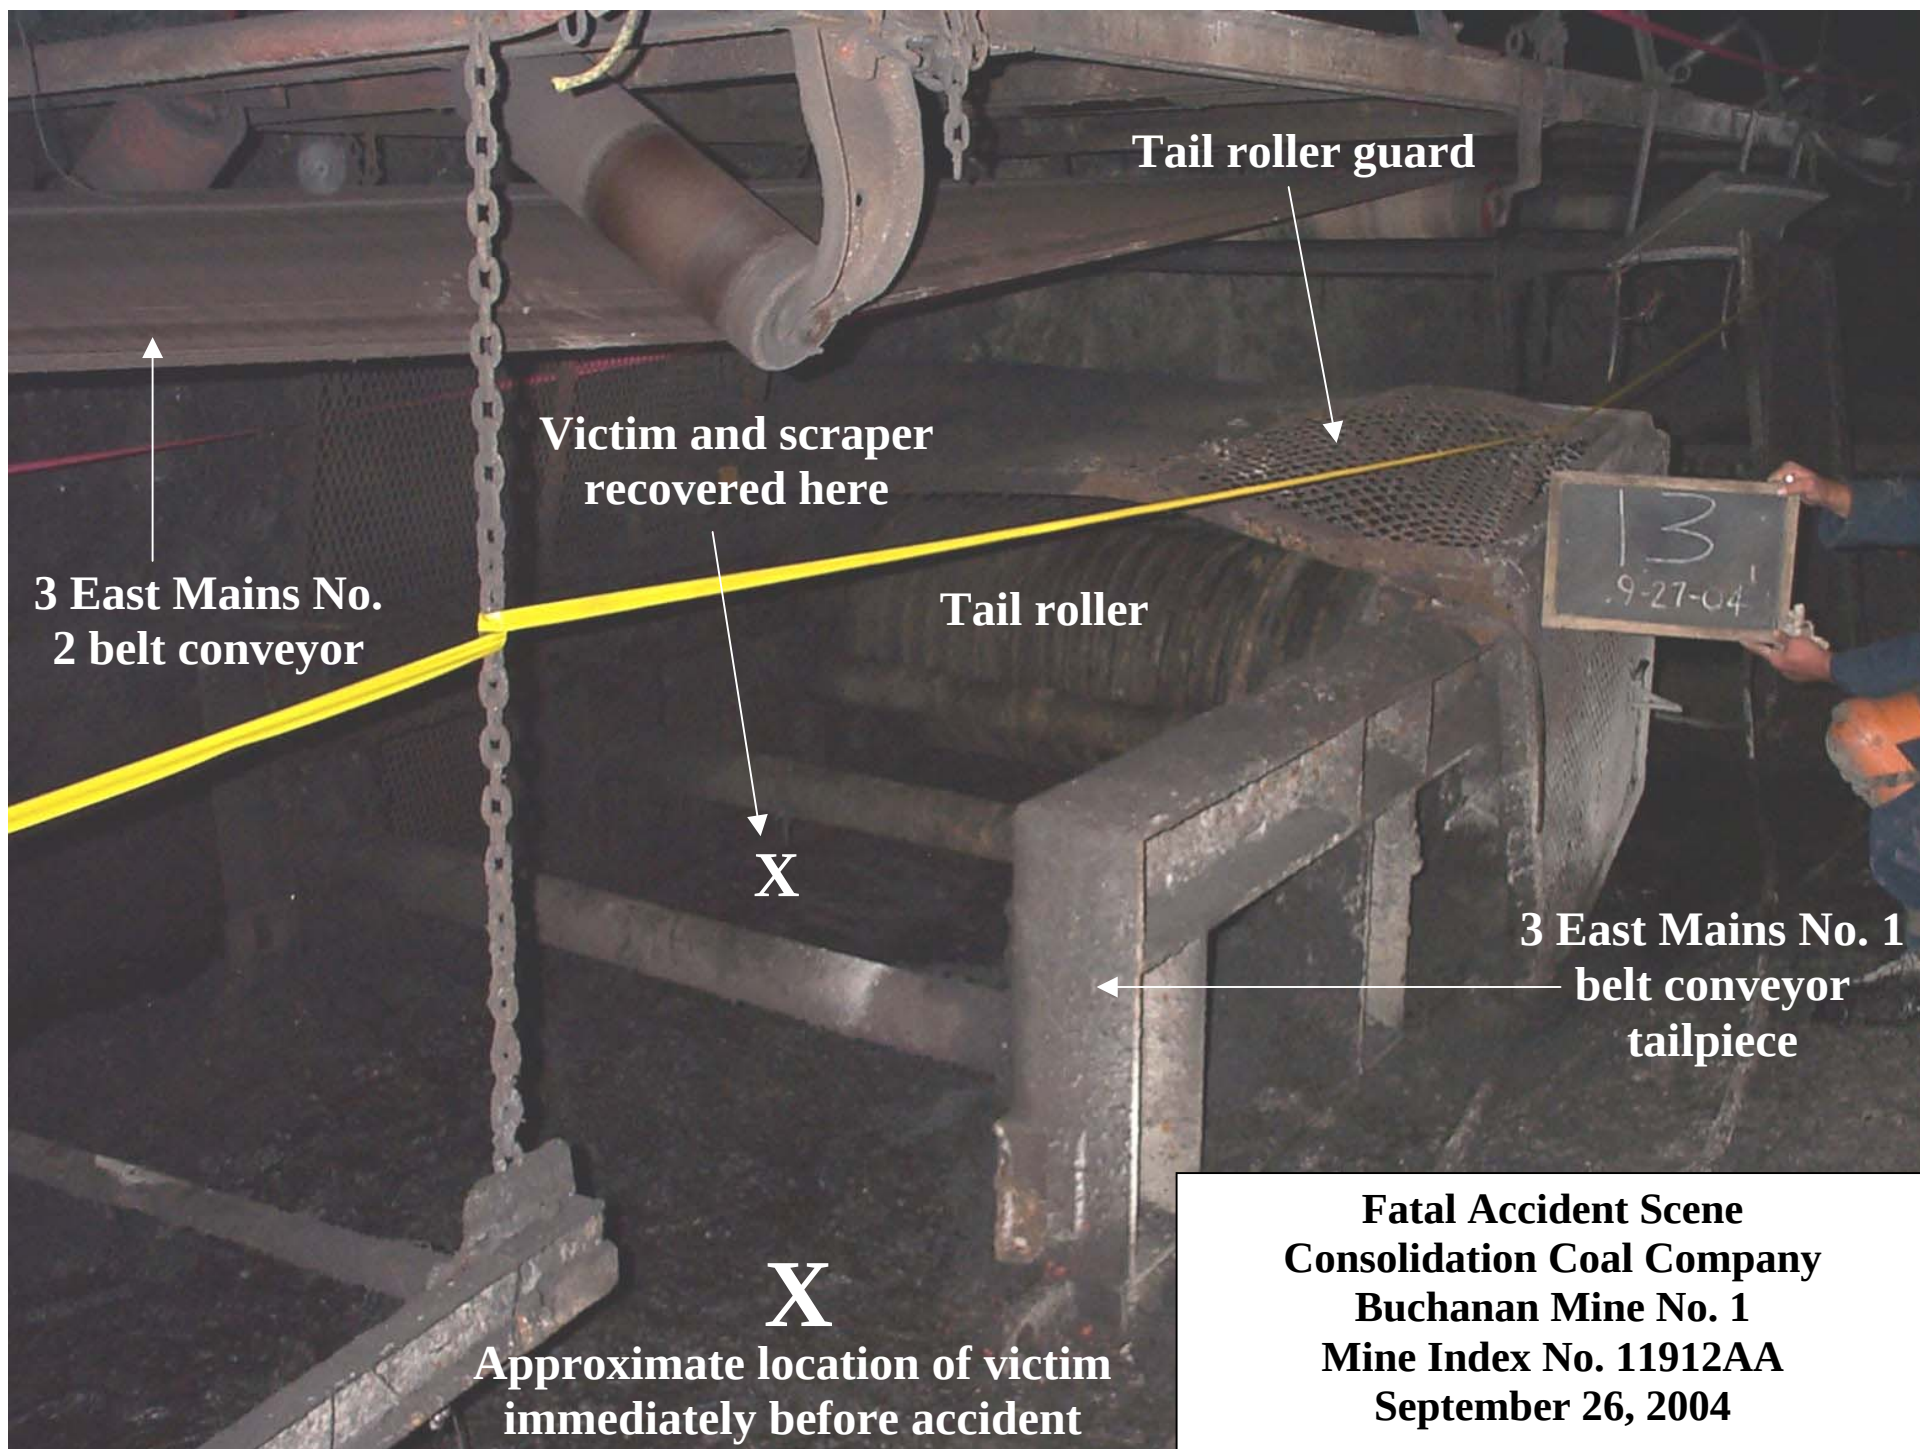
**Fatal Accident Scene  
Consolidation Coal Company  
Buchanan Mine No. 1  
Mine Index No. 11912AA  
September 26, 2004**

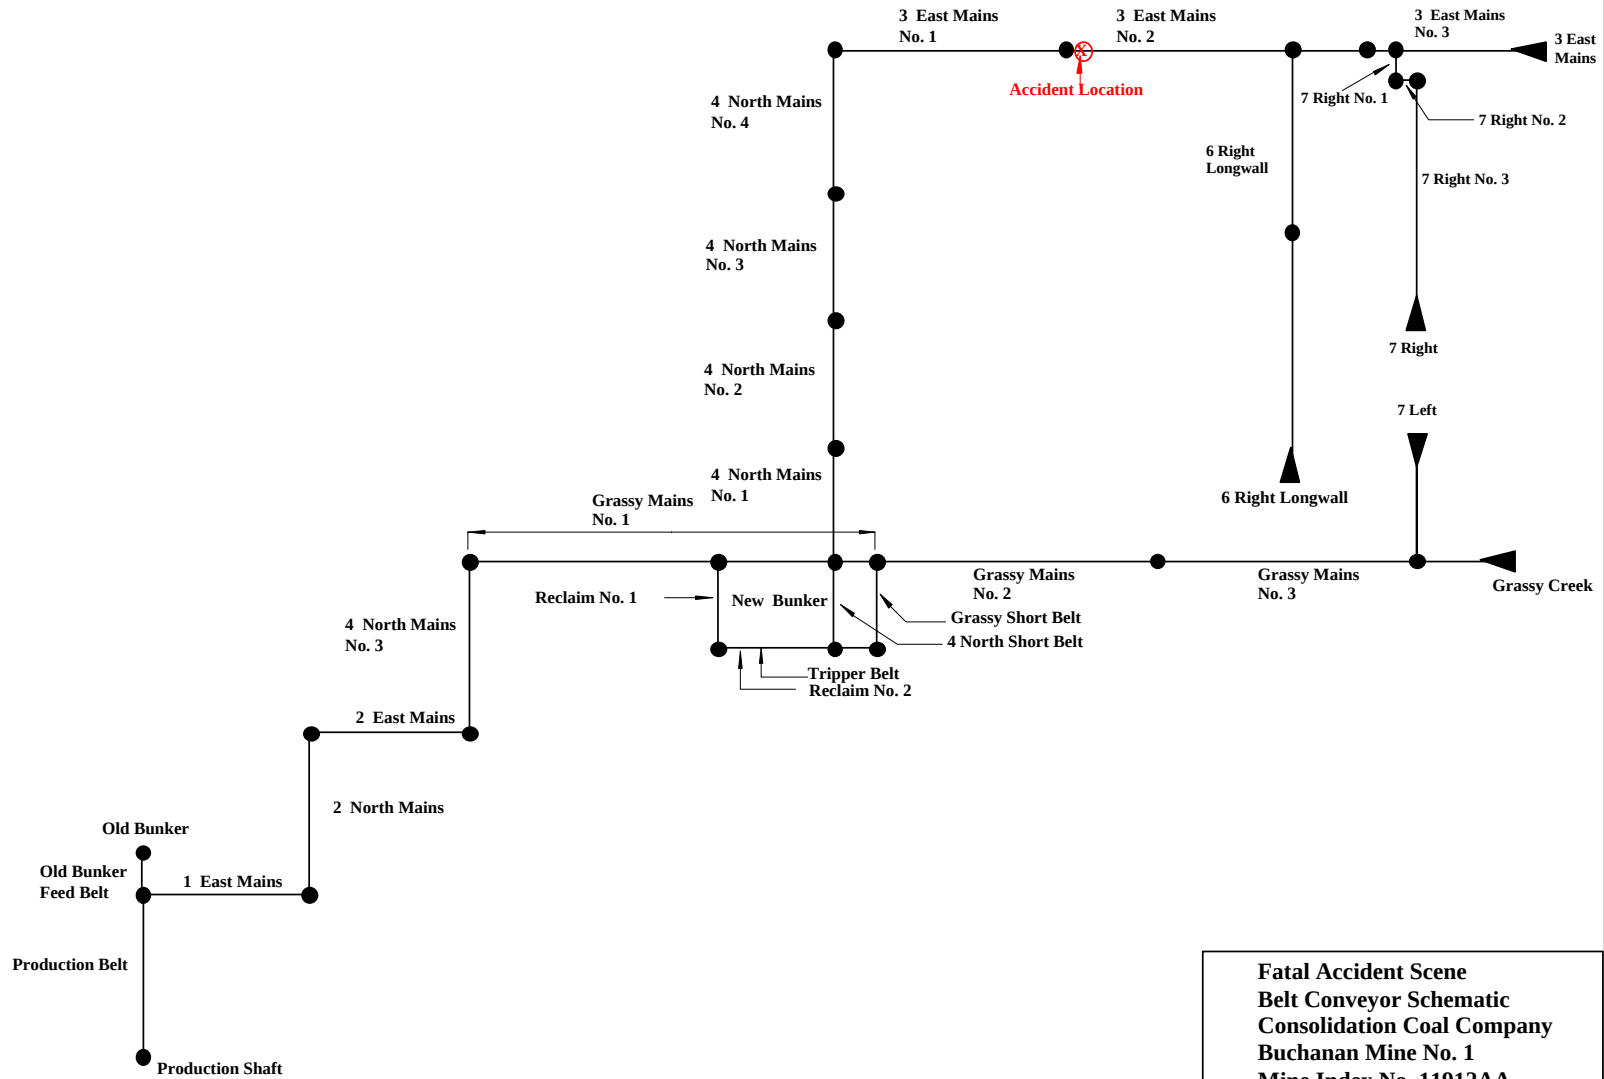
## Buchanan Mine No. 1 - Belt Conveyor Schematic

**Fatal Accident Scene  
Belt Conveyor Schematic  
Consolidation Coal Company  
Buchanan Mine No. 1  
Mine Index No. 11912AA  
September 26, 2004**
