Virginia Department of Mines, Minerals & Energy
Division of Mines

Accident Investigation Report
Surface of Underground Coal Mine

Fatal Electrical Accident
October 23, 2004

Omega Mining, Inc.
Southern Crescent Mine
Mine Index No. 14333AC
Russell County, Virginia

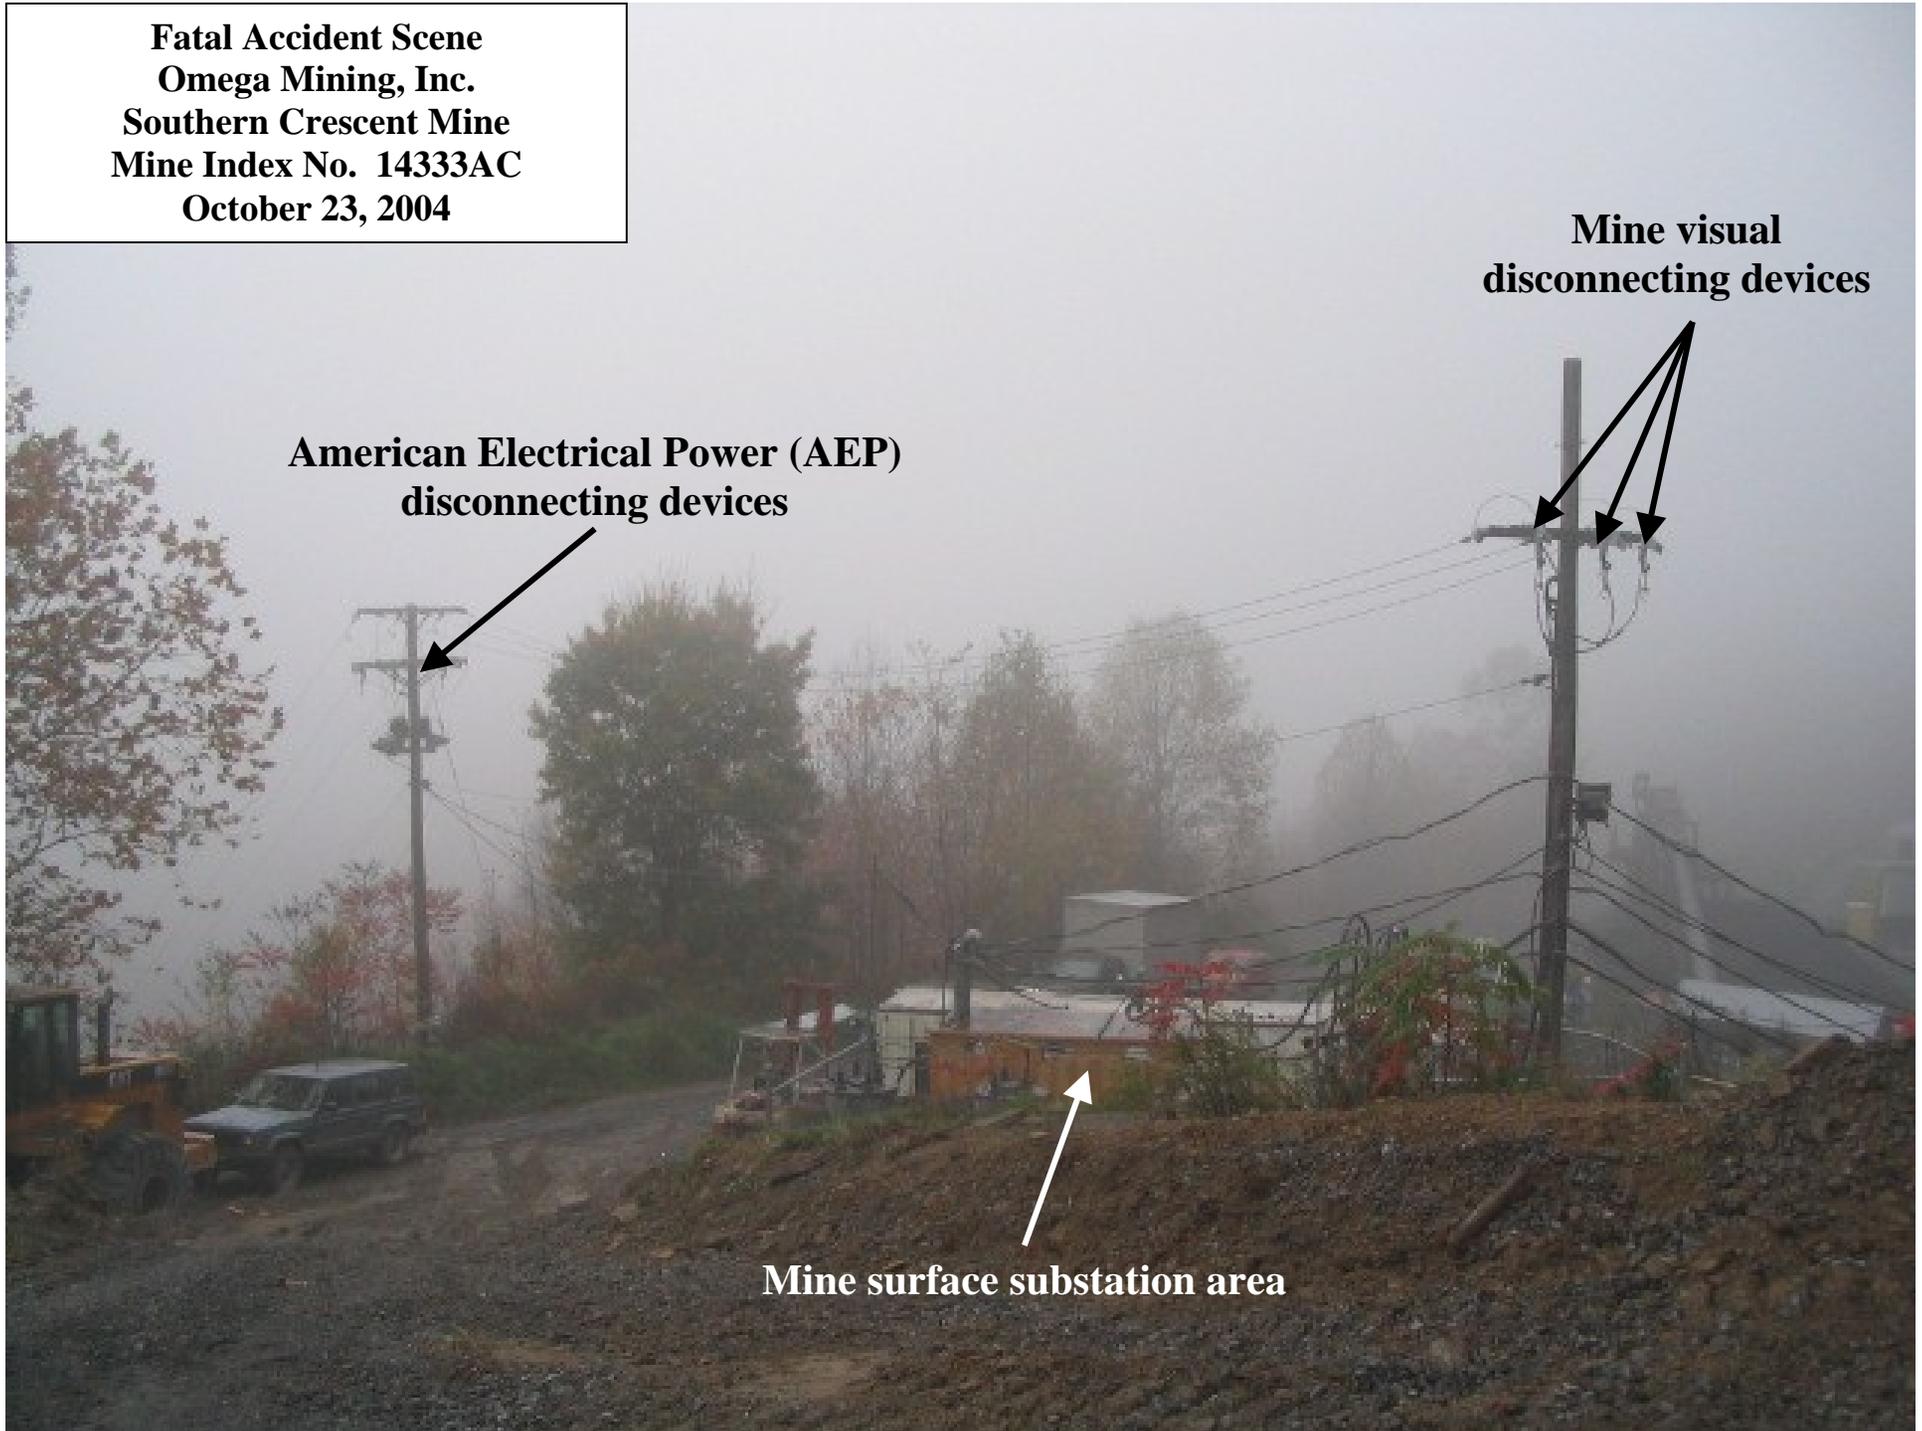
Mine surface substation area

**Mine visual
disconnecting devices**

AMERICAN ELECTRIC POWER (AEP)
34,500 VOLTS PHASE TO PHASE PRIMARY
