Fatality Investigation Report

Fatal Roof Fall Accident

May 31, 2024

Buchanan #1 Mine

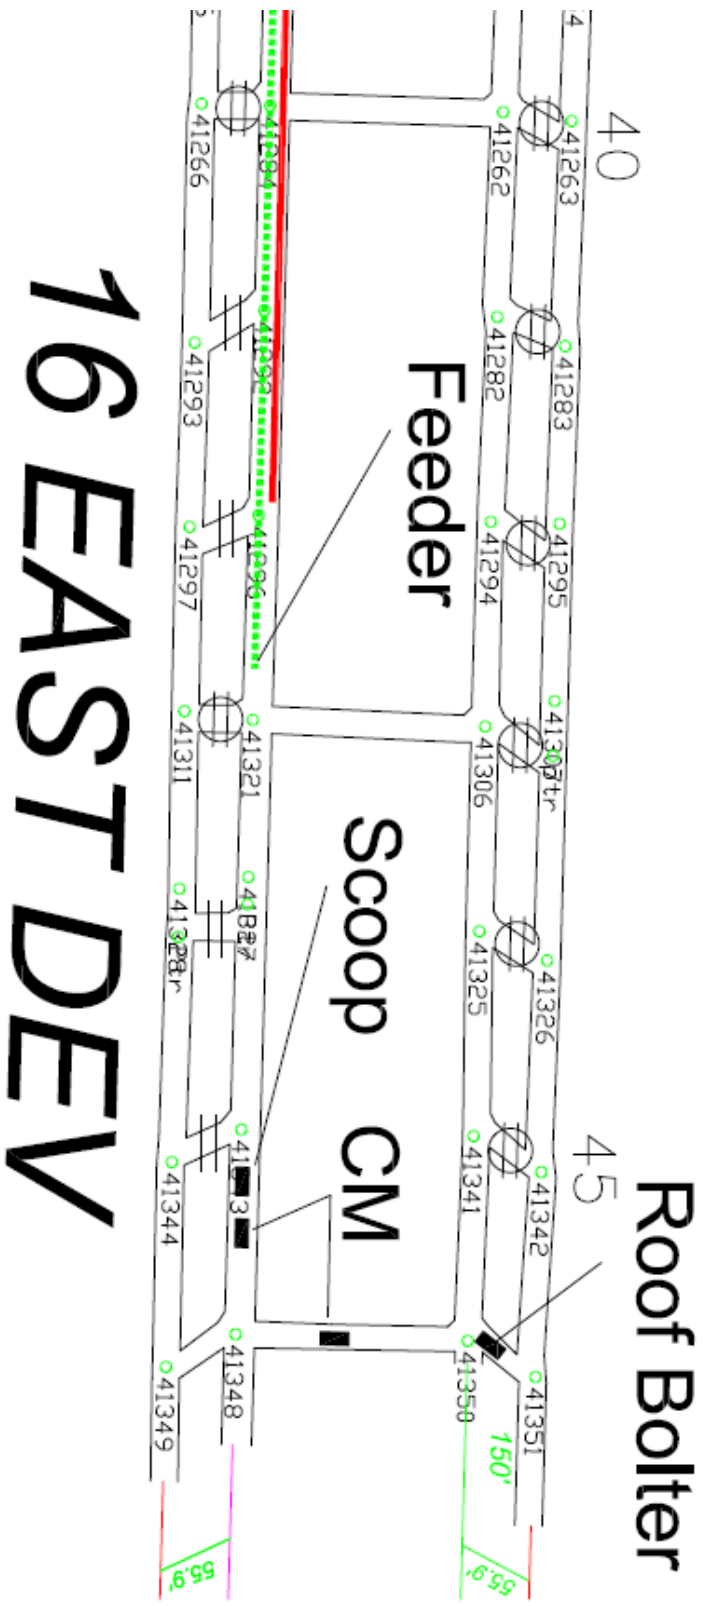
**Figure-4 View of No.2 crosscut entry
Accident Scene**

1. The time of the accident was estimated to be approximately 4:15 p.m. The accident occurred in the No. 2 entry right crosscut on the 16 east development section. Jackson was observed traveling through a 17 feet area of unsupported roof twice. A section of roof material fell striking the victim and entrapping him to the mine floor during the second pass.

3. There were two eyewitnesses to the accident. According to their statements, Jackson was observed traveling through and then returning through the same area of unsupported roof in the No. 2 crosscut. The roof material broke after it separated and fell from the mine roof in the cut through of the crosscut. The section of fallen roof material that struck Jackson measured approximately 72 inches long, 48 inches wide, and 14 inches thick. The fallen roof material broke into two sections. The estimated weight of the section of fallen roof that entrapped Jackson was approximately 3,500 lbs. to 4,000 lbs. Smaller sections of broken roof material surrounded the larger section of the roof fall on the mine floor. The distance of the unsupported top of the crosscut measured approximately 17.1 feet in length.

8. The mine floor condition at the accident scene in the No. 2 right crosscut was dry and unlevel with few apparent floor irregularities. The roof conditions through the crosscut contained several irregularities.
