## Geotechnical Quick Report on the Affected Region of the 23 August 2011 M5.8 Central Virginia Earthquake near Mineral, Virginia

EDITOR: James R. Martin, II, Team Leader (Virginia Tech, Blacksburg, VA)

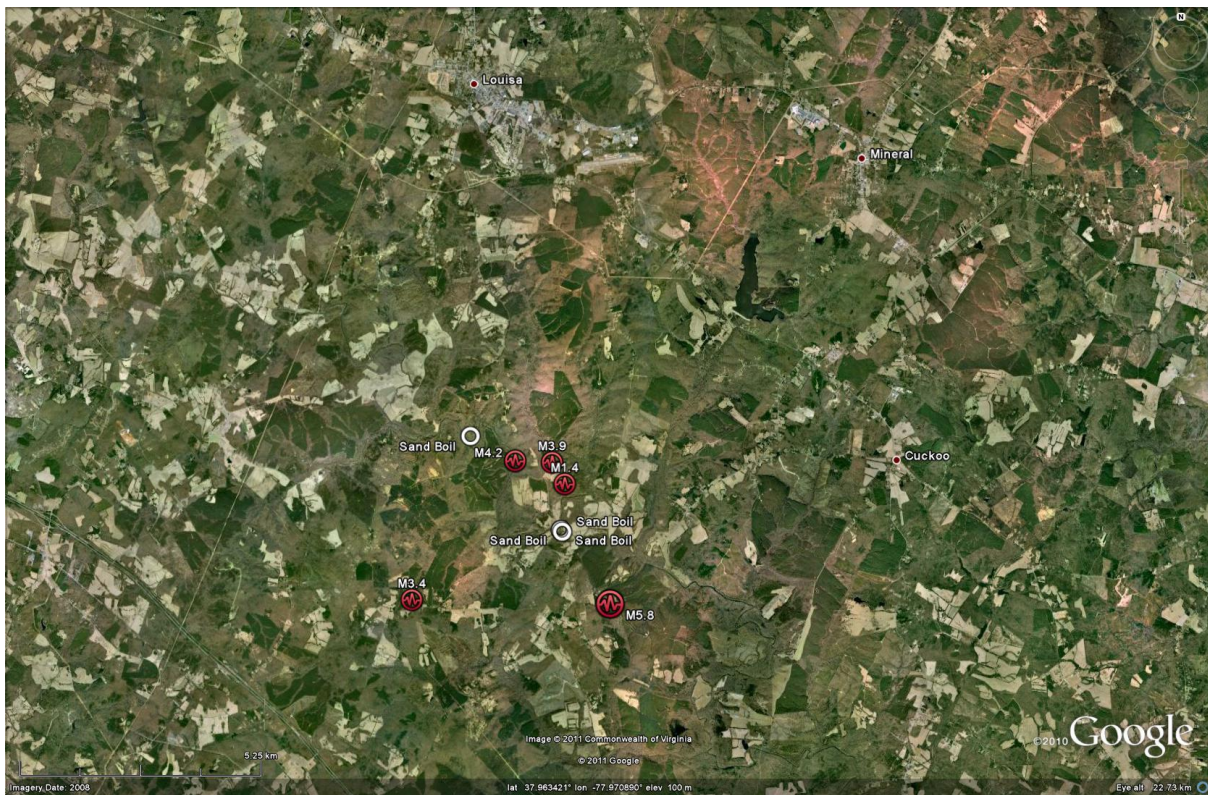
Figure 1. Aerial image of the epicentral region showing locations of observed liquefaction sand boils. Also shown in this image are the epicenters of the main shock and aftershocks that occurred within two days of the main shock that had magnitudes greater than 3.0.

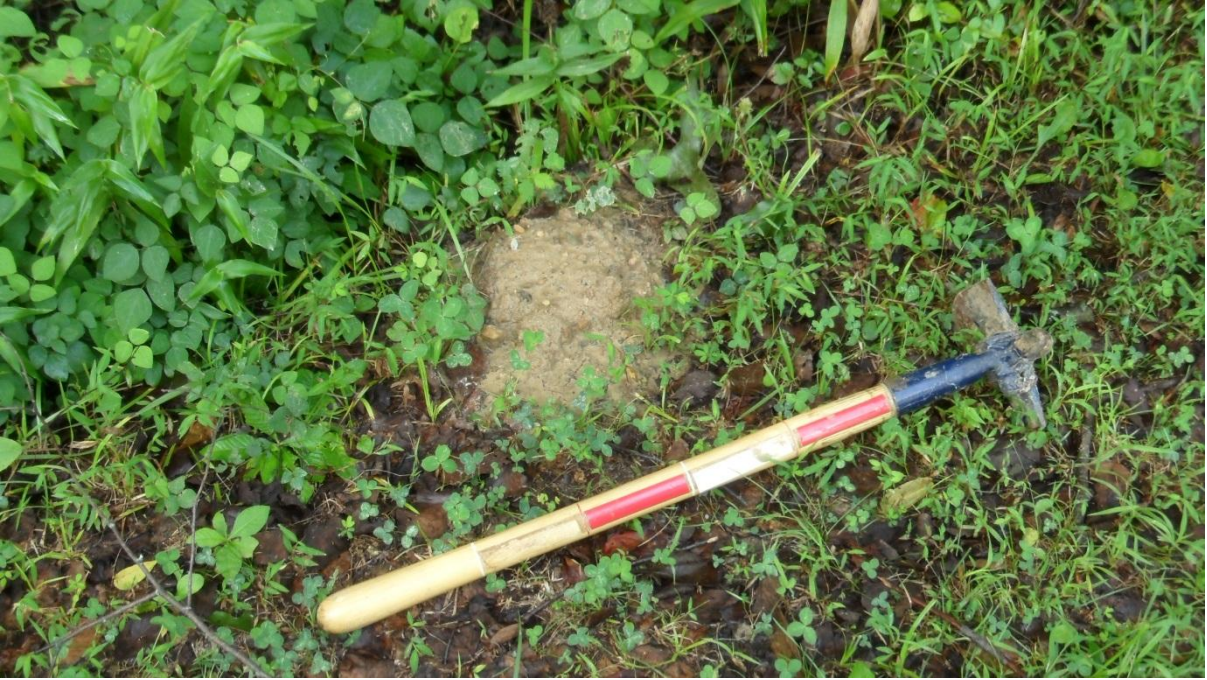
The liquefied soil was coarse sand, with the feature in the drainage channel containing some plasticity. No feeder dikes could be found for the features in the S. Anna River riverbed (Figure 2b), but the riverbed was very gravelly and the water table was only an inch or two below the ground surface. As a result, a clean cut could not be made vertically through the feature and the cut quickly filled with water. The features on the roadside (Figures 2c,d) and the feature in the drainage channel in the woods (Figures 2e,f) both appeared to have vented through existing animal holes or burrows.

Figure 2. Liquefaction sand boils found in the epicentral region: (a) two sand boils in the S. Anna River riverbed near Yancy Mill (features found by Jeff Munsey, TVA) (37.93839, 77.98269); (b) cross-sectional cut through one of the sand boils in the S. Anna River riverbed. The trowel points to a layer of leaves, indicating that the blow material was recently placed; (c) sand boil found across the road from the features in the riverbed (feature found by Ed Harp, USGS) (37.93807, -77.98238); (d) horizontal cut through the roadside feature showing a plan view of the feeder dike; (e) sand boil found in a drainage channel in the woods of Bend

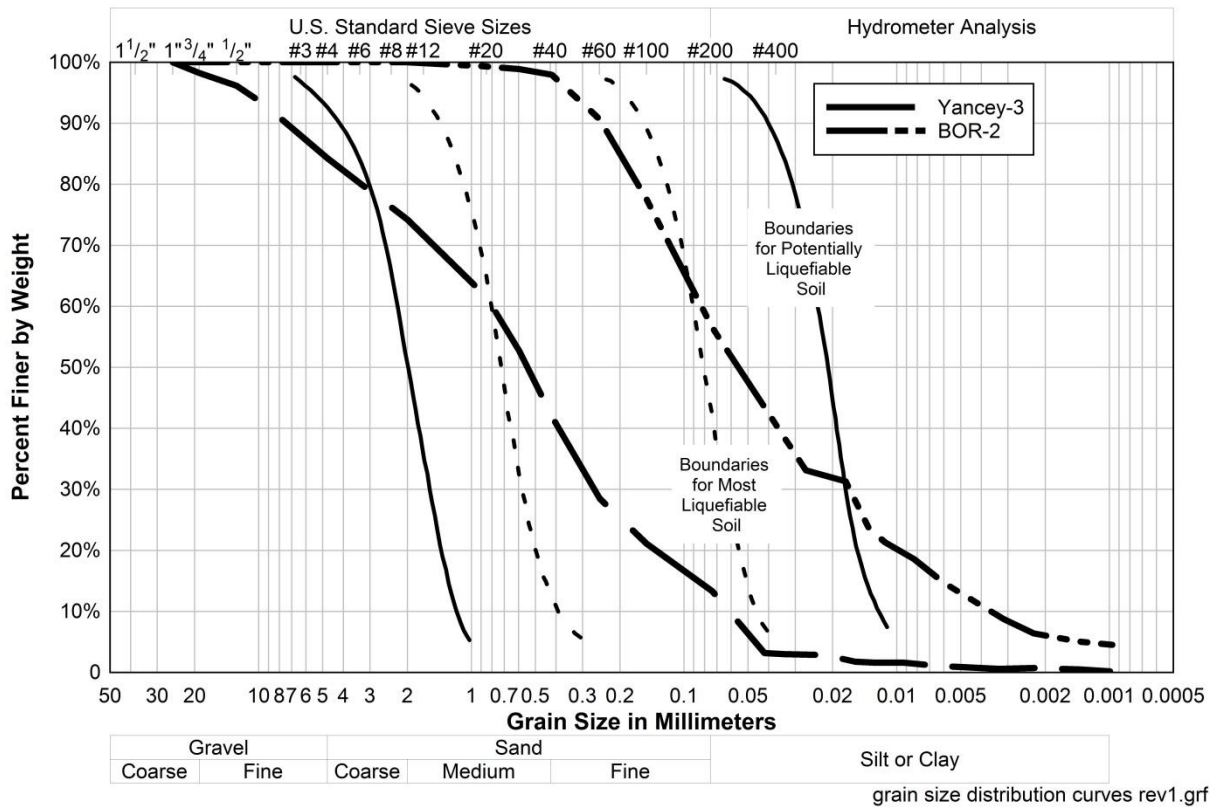
Samples of liquefaction ejecta were collected from both liquefaction sites for grain size analyses. Figure 5 shows the grain size distribution curves for the samples. The ejecta from the features at the Yanceyville mill site (Yancey-3) classified as SW-SM: Well-graded Sand with Silt and Gravel per the ASTM-2487 soil classification system (ASTM 2011). Because the ground surface layer at this site was very gravelly and the water-table was only several centimeters below ground surface, a clean cut could not be made vertically through the feature and the cut that was made quickly filled with water. As a result, feeder dikes for the features could not be found (Figure 2a,b). The ejecta sample from the Bend of the River site (BOR-2) was much finer than that from the Yancey-3 site and classified as ML: Silt per the ASTM-2487 soil classification system (ASTM 2011). The feature at the Bend of River site (Figures 2e,f) appeared to have vented through an existing animal or root hole, and it is likely that the feature would not have manifested on the ground surface in the absence of the pre-existing hole. Finally, superimposed on the grain distribution plot are the bounds proposed by Tsuchida (1970) for the grain size ranges for soils that are “most susceptible to liquefaction” and “potentially susceptible to liquefaction”. While grain size distribution is only one aspect influencing the liquefaction susceptibility of a soil stratum, it can be seen that the samples from the Yancey-3 and BOR-2 sites generally fall outside the “most susceptible to liquefaction” boundaries, but do generally fall within the boundaries for “potentially susceptible to liquefaction”.

**Figure 5.** Grain size distribution curves for the liquefaction ejecta samples. Superimposed on the grain distribution plot are the bounds proposed by Tsuchida (1970) for the grain size ranges for soils that are “most susceptible to liquefaction” and “potentially susceptible to liquefaction”.

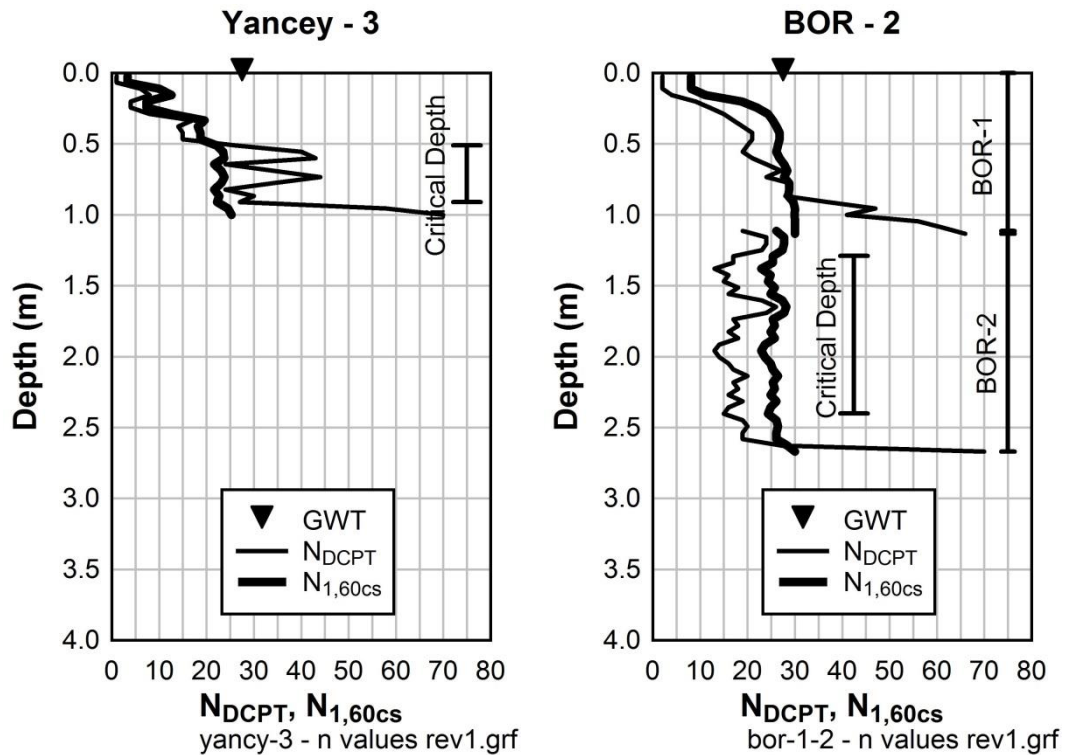
In addition to the effective stress and hammer energy corrections, the  $N_{SPT\text{equiv}}$  values were also corrected for fines content following the procedure proposed in Youd et al. (2001), where the fines contents were determined from the grain size distribution curves shown in Figure 5. Figure 7 shows a plot of  $N_{DCPT}$  and  $N_{1,60\text{cs-SPT}\text{equiv}}$  for the two liquefaction sites identified by the ground reconnaissance team.

**Figure 7.**  $N_{DCPT}$  and  $N_{1,60cs-SPT_{equiv}}$  for the two liquefaction sites identified by the ground reconnaissance team (Yancey-3 and BOR-2).

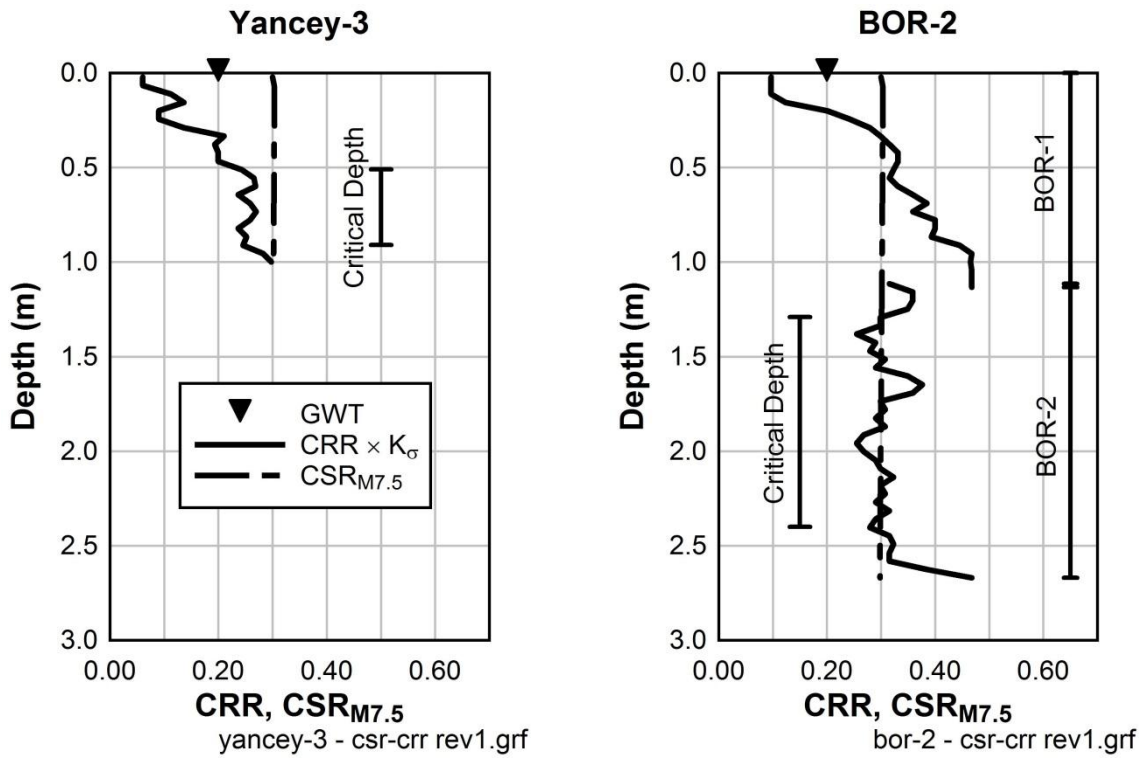
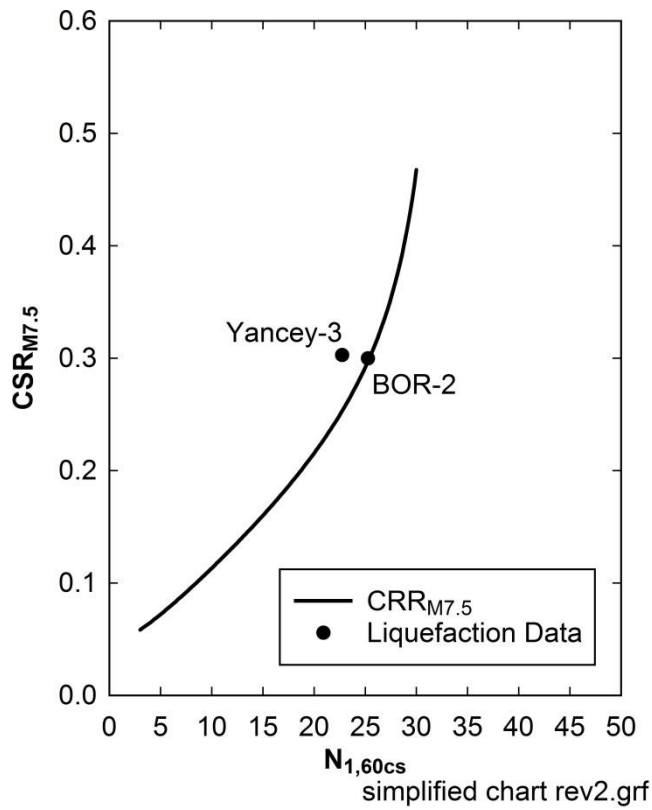
The cyclic stress ratios (CSRs) at the DCP test sites were calculated following the methodology outlined in Youd et al. (2001), assuming the peak ground accelerations (PGA) at both sites were 0.5 g (Chapman, 2012b). The average of the recommended range of magnitude scaling factors (MSFs) proposed in Youd et al. (2001) was used to compute  $CSR_{M7.5}$  at the sites. Using the  $N_{1,60cs-SPT_{equiv}}$  described above, the correlation proposed by Youd et al. (2001) was used to estimate the cyclic resistance ratio for a  $M_w7.5$  event (i.e.,  $CRR_{M7.5}$ ). Comparisons of the computed  $CSR_{M7.5}$  and  $CRR_{M7.5}$  for both sites are shown in Figure 8. As shown in this figure, liquefaction is predicted to have occurred at both sites (i.e.,  $CSR_{M7.5} > CRR_{M7.5}$ ). However, the factors of safety against liquefaction ( $FS = CRR_{M7.5}/CSR_{M7.5}$ ) are very close to 1.0 and the thicknesses of the liquefied layers are predicted to be relatively thin. These predictions are consistent with the small sand boils found at the sites. Furthermore, these analyses show that the stark contrast in the paucity of features produced by the Mineral earthquake compared to the widespread liquefaction that was caused by similar magnitude events in Christchurch, New Zealand in June 2011 is most likely due to the differences in the liquefaction susceptibility of soils in the two regions, rather than the difference in the characteristics of the ground shaking (Green and Lasley, 2012).

**Figure 8.** Results from simplified liquefaction evaluations of Yancey-3 and BOR-2 liquefaction sites.

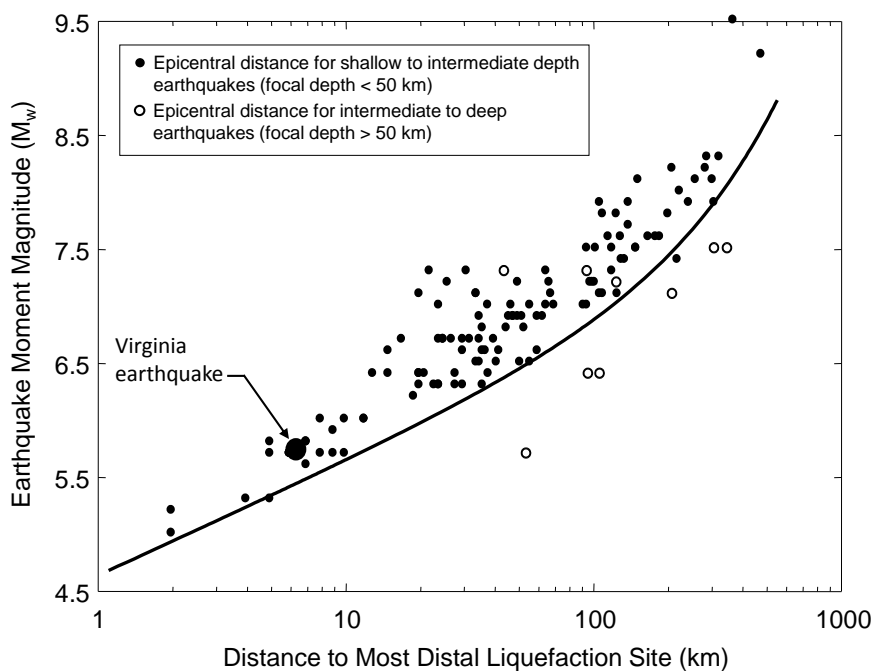
Finally, from an engineering perspective, the observed liquefaction during the Mineral, Virginia earthquake is not significant in itself. However, it adds to the relatively limited database of earthquake-induced liquefaction in stable continental regions and is valuable in validating relationships used to estimate the magnitude of pre-instrumental and/or paleoearthquakes in the region. Towards this end, the most distal liquefaction feature from the epicenter for this event is BOR-2 site, which is ~6.25 km from the main shock epicenter. This distance is plotted in Figure 9, along with data from worldwide earthquakes compiled by Ambraseys (1988). As may be observed from this figure, the epicentral distance falls close to, but within, the boundary for maximum distance.

**Figure 9.** Comparison of the most distal liquefaction feature from the Mineral, Virginia earthquake of 23 August 2011 with worldwide earthquake data collected by Ambraseys (1988).

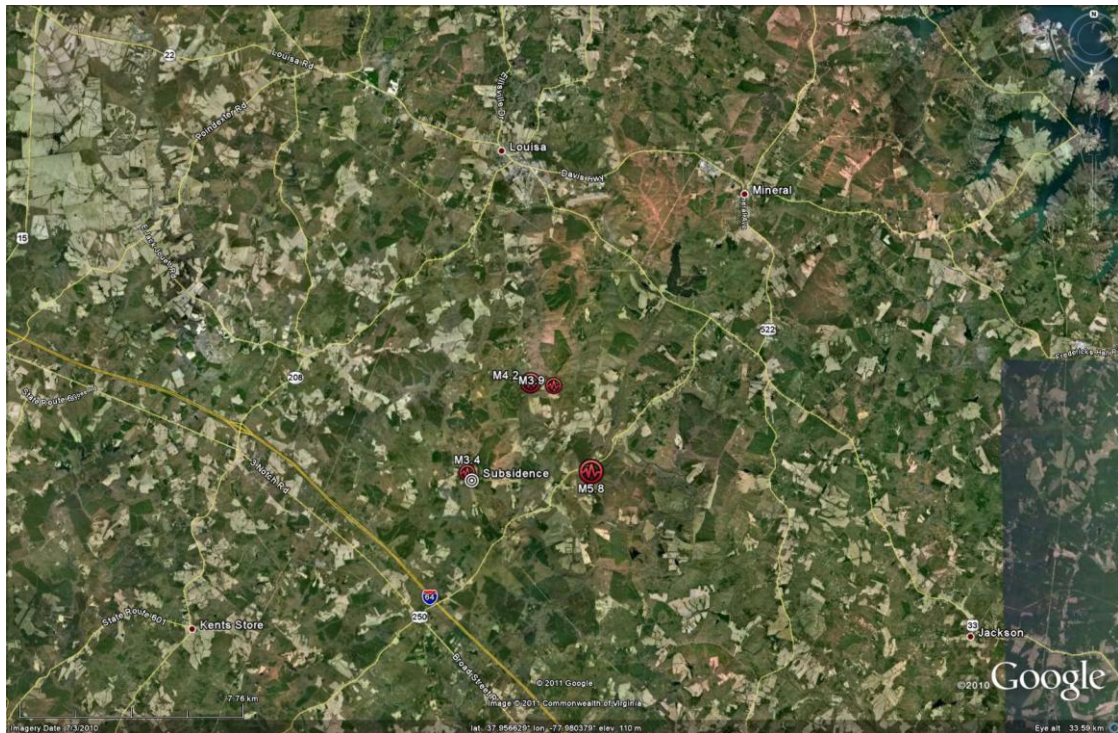
Mark Carter, USGS, found what is believed to be earthquake-induced subsidence of an abandoned gold mine. The location of the subsidence is shown in Figure 11. A photograph of the subsidence is shown in Figure 12.

Figure 11. Aerial image showing the location of where it is believed the earthquake-caused subsidence of the ground surface above an abandoned gold mine.

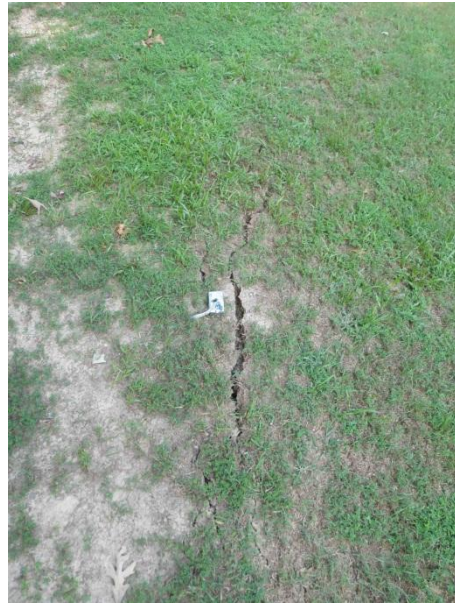
(b)

Figure 12. Photograph of the area that subsided (Photo by Mark Carter) (37.9229, -78.0176).

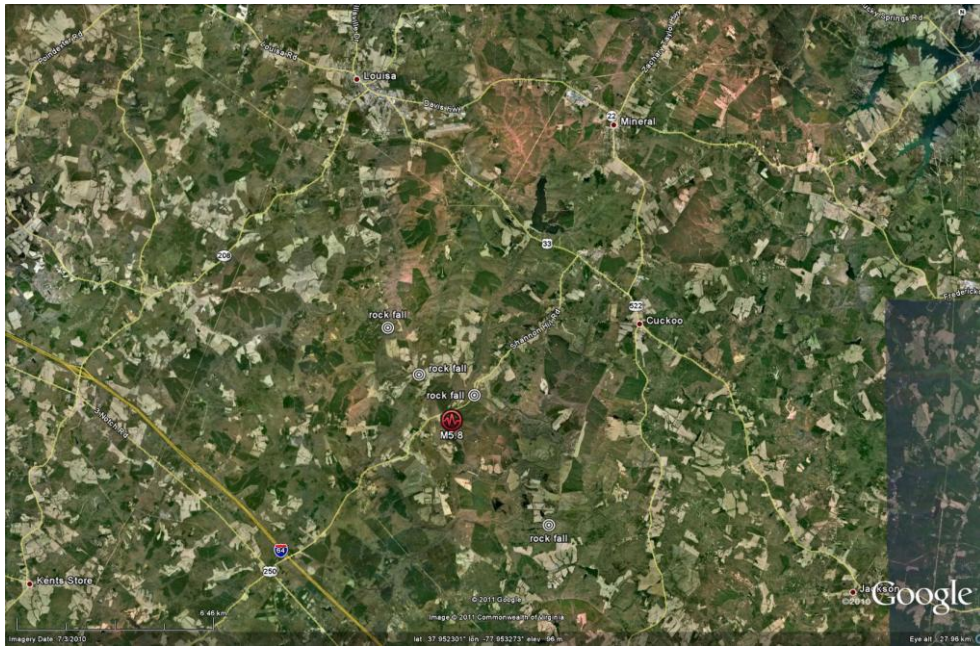
Mark Carter and Ed Harp, both of the USGS, identified four minor rock falls in the epicentral region, two along the banks of the South Anna River and two in road cuts. The locations of these rock falls are shown in Figure 13, with photographs of two of these rock falls shown in Figure 14.

Figure 13. Locations of rock falls found in the epicentral region along the S. Anna River and road cuts.

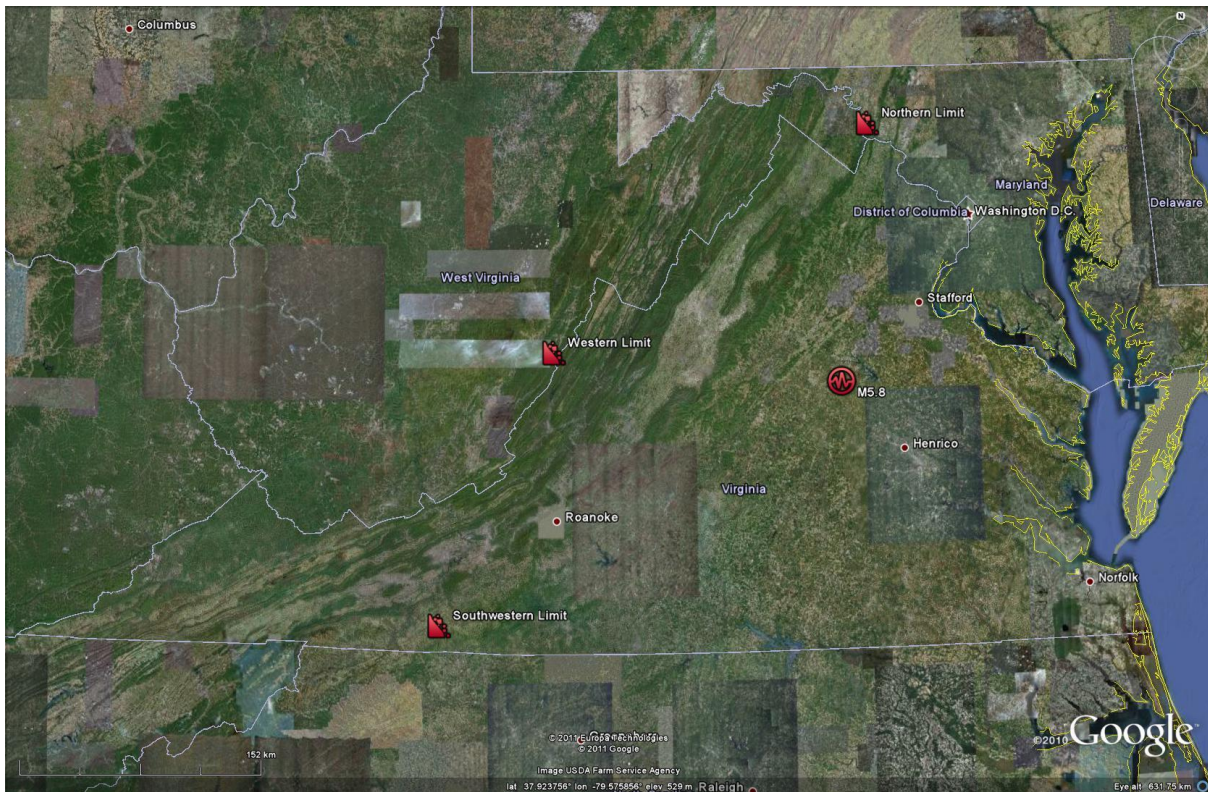
Ed Harp and Randy Jibson, both from the USGS, determined the areal extents of rockfalls to be just north of Harper's Ferry to the north, the Virginia - West Virginia border to the west, and about 10 miles north of the North Carolina border along the Blue Ridge Parkway to the

southwest. They were not able to determine the eastern limit. The determined limits are shown in Figure 15.

Figure 15. Aerial image showing the areal extent of rock falls to the North, West, and South of the epicenter; the eastern extent could not be determined.

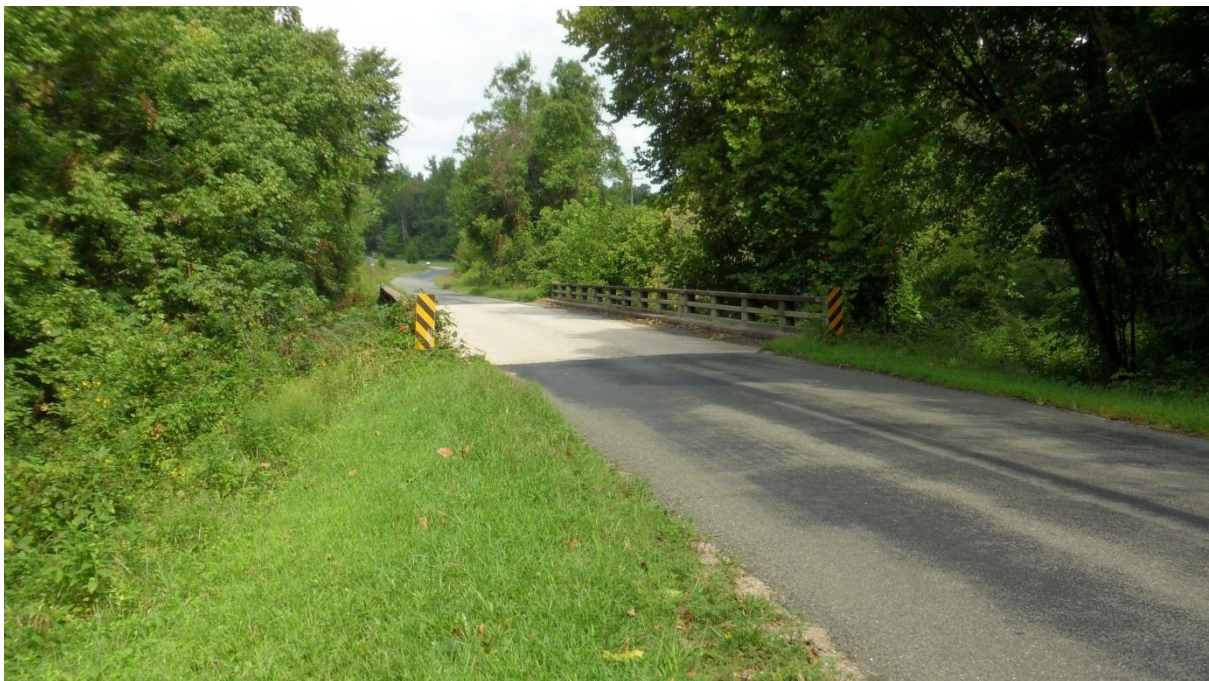
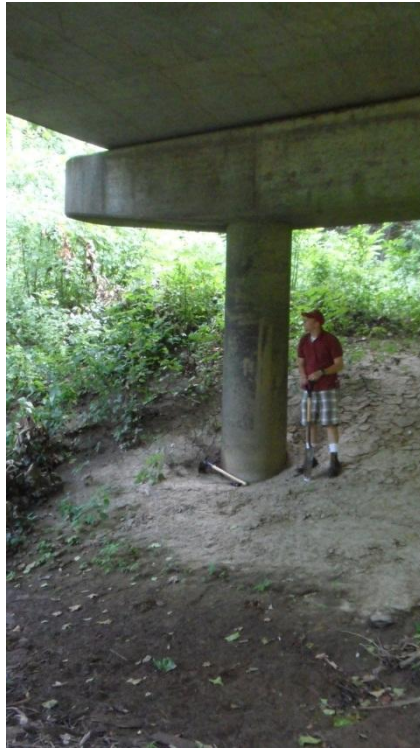
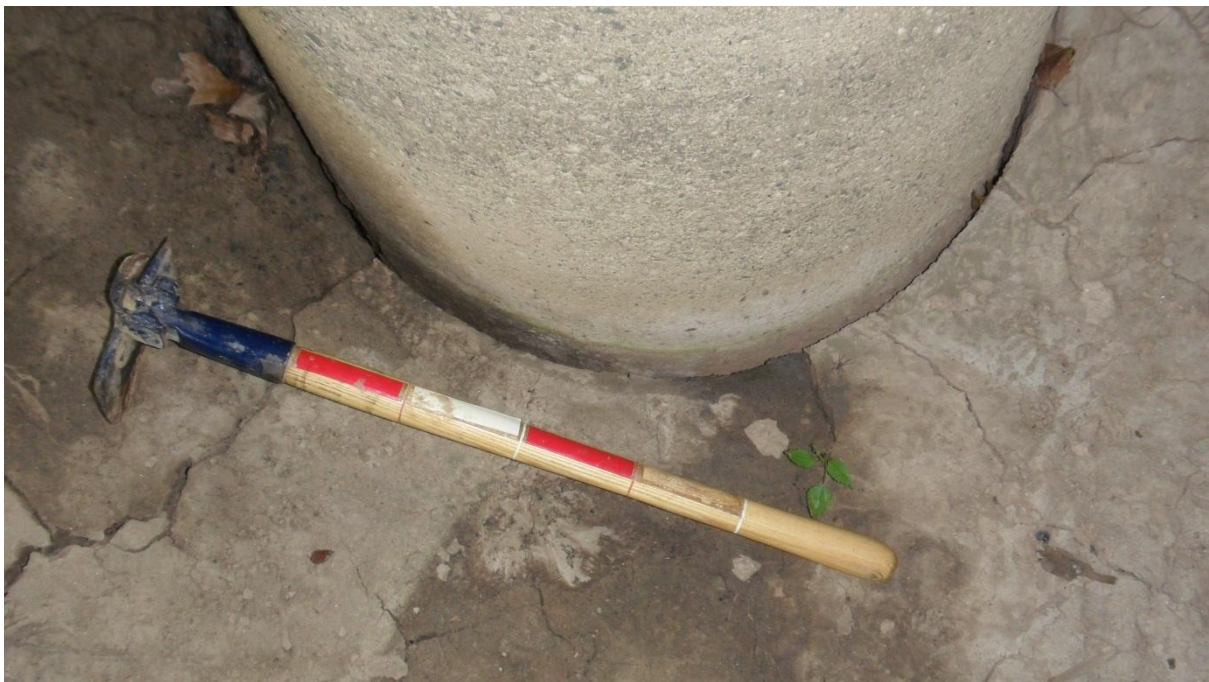
Numerous bridges in the epicentral region were given rapid inspections, with two bridges inspected in detail. The locations of the two bridges are shown in Figure 16. The first is the Yancyville Rd bridge, which is ~40 m long and crosses the S. Anna River in the NW-SE direction. We inspected this bridge in detail because it is very near where the liquefaction features were found in the riverbed and along the roadside. Photos of the bridge are shown in Figure 17. The bridge has a two lane concrete deck that sits on two bents, in addition to the NW and SE abutments. The only effects of the earthquake that could be found was ~2.5 cm gap between the soil and the SE pier (Figure 17b). The gap is shown in Figure 17c and was on the river side of the piers. It is uncertain whether the gap was due to movement of the pier due to earthquake shaking (i.e., movement of the bridge in the NW direction relative to the ground) or due to slumping of the river bank. No other evidence of slumping of the river bank near the bridge was observed

Figure 17. Yanceyville Rd Bridge (37.93898, -77.98269): (a) photo of the bridge looking to the NW; (b) photo of the SE bridge bent; and (c) photo of ~2.5 cm gap between one of the SE piers and soil (riverside only).

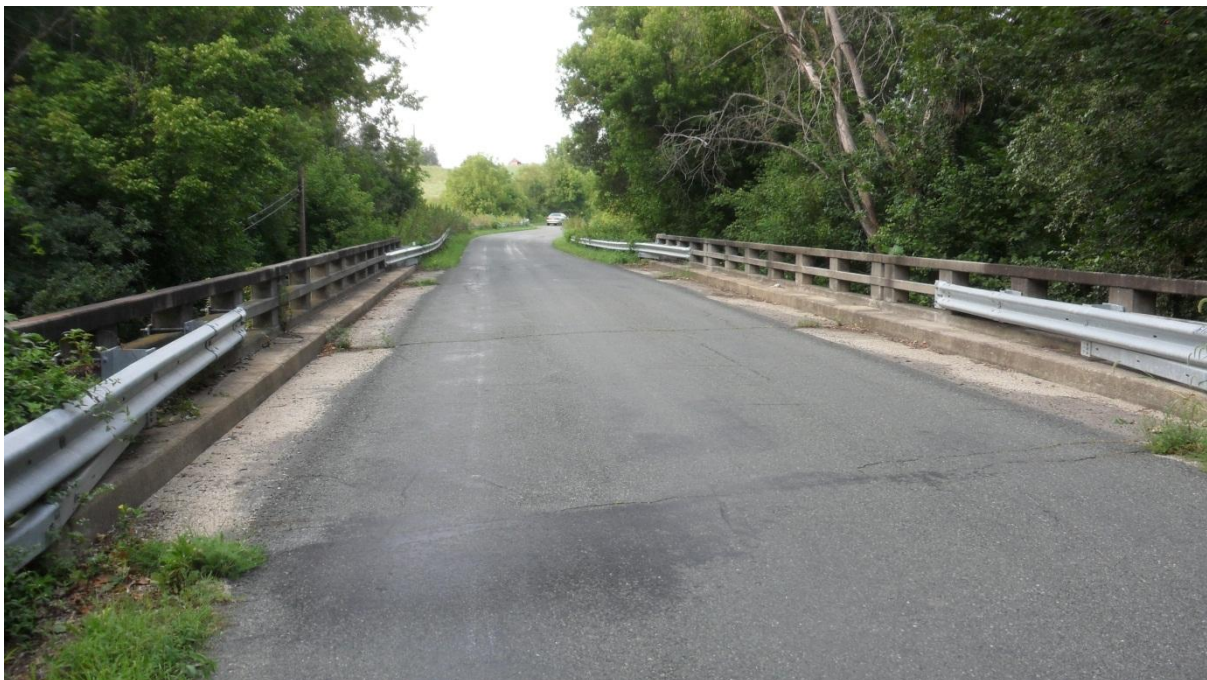
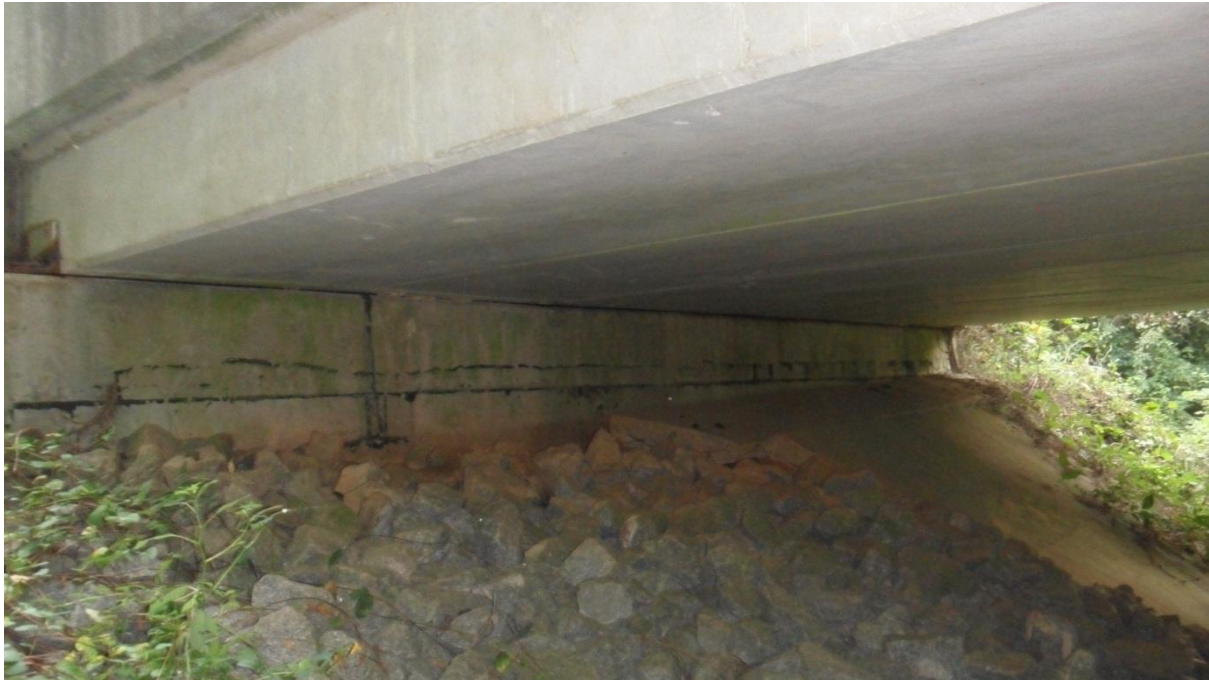
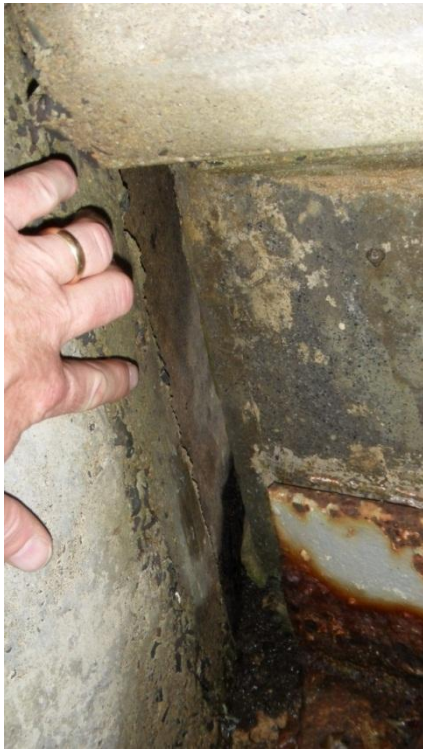
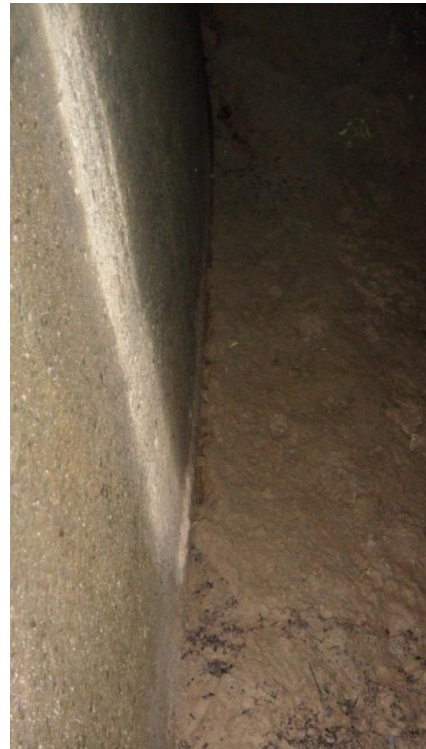
The second bridge that was inspected in detail was the SR 604 bridge, the location of which is shown in Figure 16. This bridge is ~36 m long and crosses the S. Anna River in the NE-SW direction. We inspected this bridge in detail because some of the local residents reported that “bumps” in the road surface of the abutment approaches worsened as a result of the main shock and aftershocks. Photos of the bridge are shown in Figure 18. As with the Yanceyville Rd bridge, this bridge has a two lane concrete deck that sits on two piers, in addition to the NE and SW abutments. Drawings obtained by Mark Carter, USGS, from the VDOT show that the abutments are founded on ~2.75 m (9 ft) of brown sandy silt with an SPT N-values of 5-7 blws/ft. Team members inspected the bridge on 24 August, the day after the main shock, but did not notice any obvious slumping of the abutments or evidence of seismic compression in the approaches (Figure 18a). However, after hearing from additional local residents that the bumps in the abutment approaches had gotten worse as a result of the main shock and aftershock, the bridge was revisited on 2 September, and it was found that the approaches already had been levelled and resurfaced (Figure 18b). Although heavy rains had fallen as a result of hurricane Irene, there was still evidence of a ~2.5 cm gap between SW pier and the soil on the riverside, shown in Figure 18f. As with the Yanceyville Rd bridge, it is uncertain whether the gap was due to movement of the pier due to earthquake shaking (i.e., movement of the bridge in the NE direction relative to the ground) or due to slumping of the river bank. Also, there was ~2.5 cm gap between the bridge deck and the SW abutment, shown in Figure 18e. It is likely that this existed prior to the earthquake to allow thermal expansion of the bridge deck.

Figure 18. SR 604 bridge (37.95915, -77.98269): (a) small bump in the approach to the bridge possibly due to seismic compression; (b) approach after relevelling and resurfacing of the bridge; (c) side view of bridge; (d) bridge abutment; (e) ~2.5 cm gap between bridge deck and the SW abutment; and (e) ~2.5 cm gap between the SW pier and soil (riverside only).

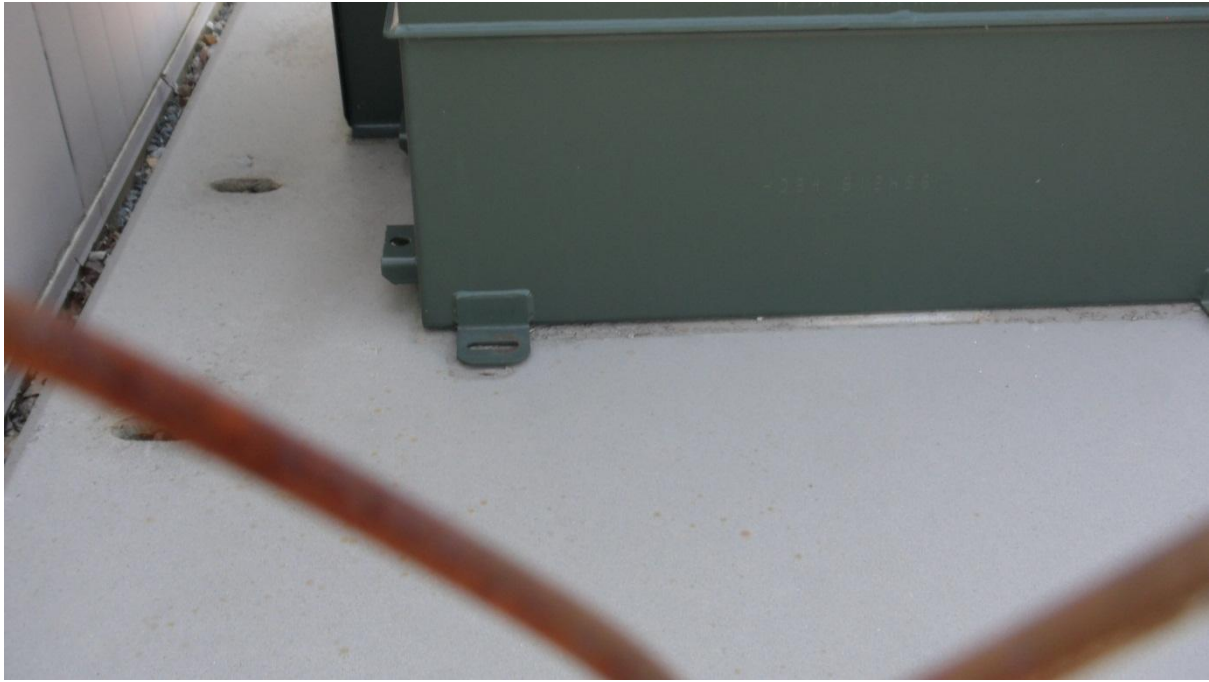
Approximately 3000 customers lost power as a result of the main shock. However, virtually all the power was restored within 4 hrs after the event. Team members inspected the Cuckoo Substation on Jefferson Hwy, the location of which is shown in Figure 19 and photo of the substation shown in Figure 20a. The only evidence of the earthquake shaking on the substation was that a green metal equipment box slid ~2.5 cm to the north, as shown in Figures 20b,c. The box was not anchored to the concrete base slab.

Figure 20. Cuckoo Substation (37.97058, -77.91917): (a) photo of substation; (b) photo showing ~2.5 cm movement of green metal equipment box to the North; and (c) photo showing ~2.5 cm movement of the green metal equipment box to the North.

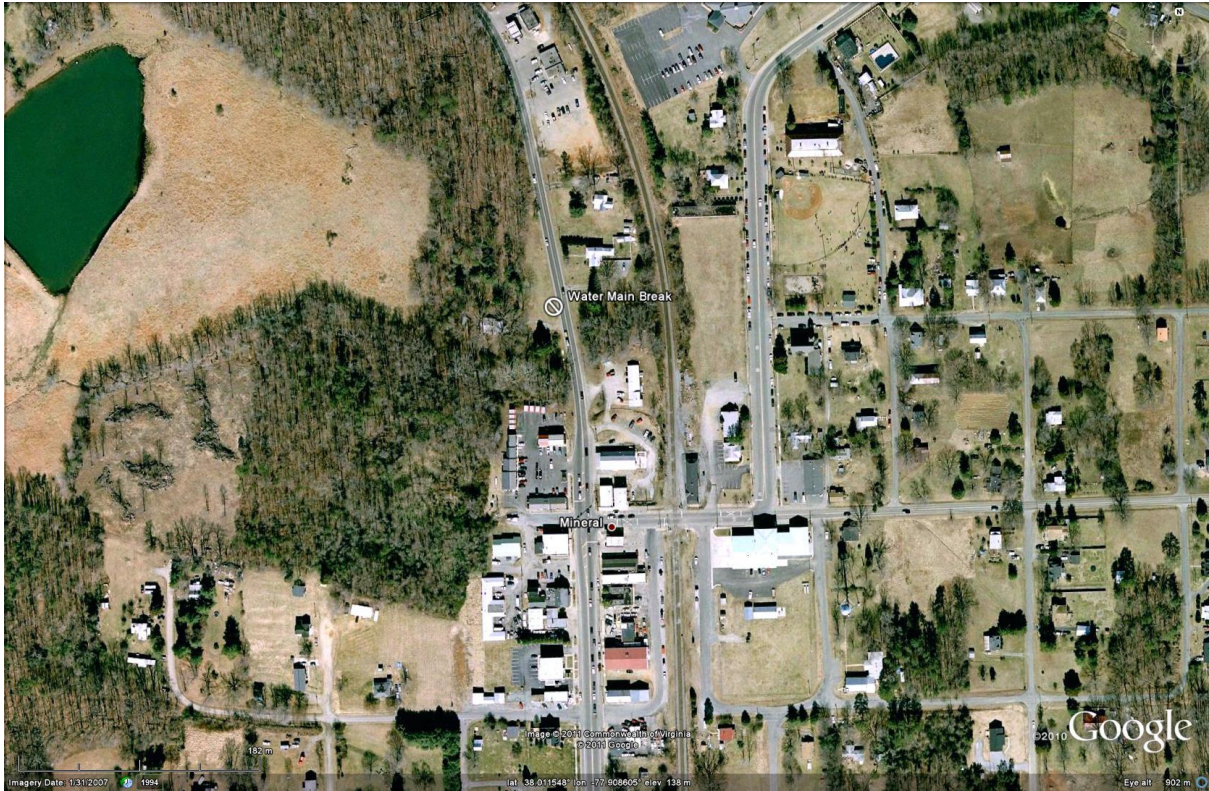
There were no reported gas leaks as a result of the earthquake. However, a 5 cm dia. water main in Mineral broke as a result of the earthquake, the location of which is shown in Figure 21. A photo of the excavated trench used to access the broken main is shown in Figure 22a. As may be observed in Figure 22b, the valve was heavily corroded and would have likely eventually failed even without the occurrence of the earthquake.

Figure 21. Aerial image of Mineral showing the location of the water main that broke during the earthquake.

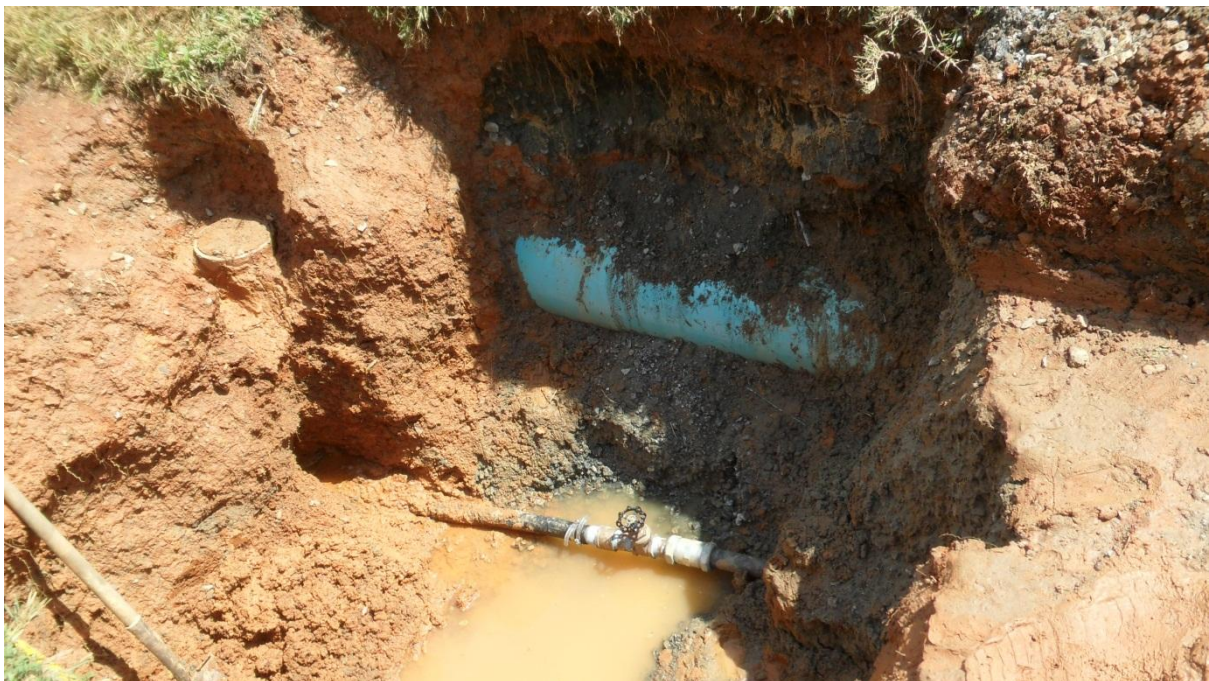
Figure 22. Water main break in Mineral (38.01215, -77.90903): (a) trench showing broken water main; and (b) corroded water main valve with a crack that was caused by the earthquake.

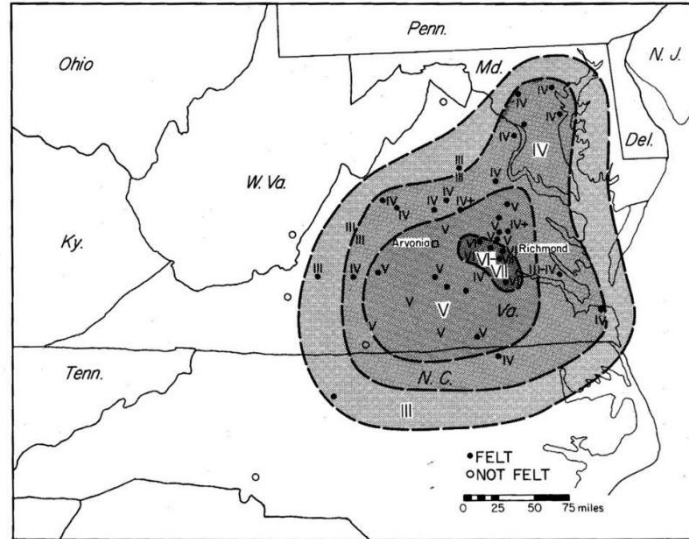
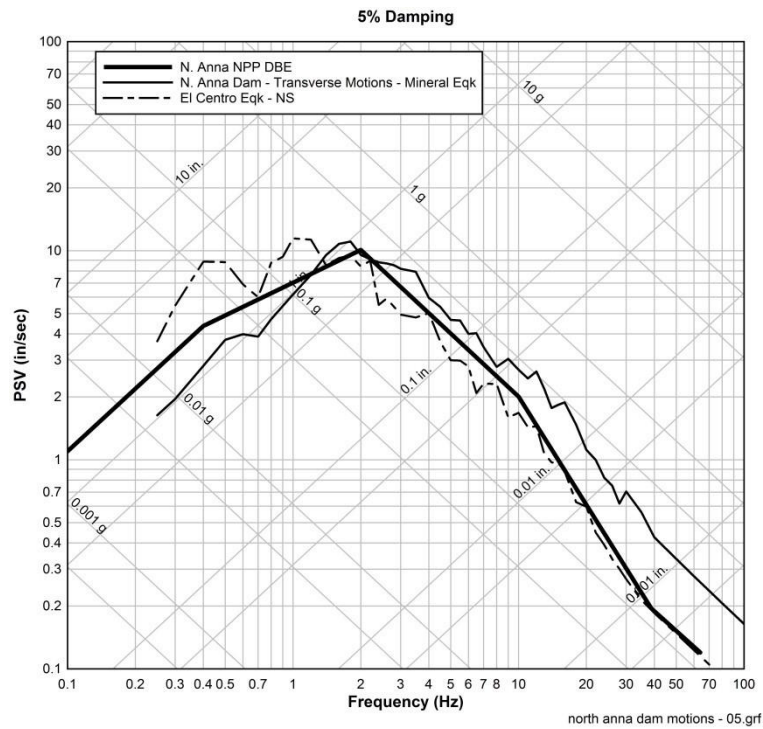
Because the Lake Anna serves as a secondary source for cooling water for the NAPS, the dam was designed to the same Design Basis Earthquake (DBE) as the NAPS. The DBE for the NAPS was assumed equal to the largest shock associated with the Arvonian Syncline, only with the epicenter of this event occurring at the site of the NAPS. The largest event associated with the Arvonian Syncline occurred on 22 December 1875 just west of Richmond, Virginia, had a maximum Modified Mercalli Intensity (MMI) of VII (Figure 26a), and had an estimated magnitude of 4.5. The peak horizontal ground acceleration (PGA) for rock sites was estimated to be less than 0.12 g. Accordingly, the PGA for the DBE for rock sites was assumed to be 0.12 g. To define the entire response spectrum for the DBE, an envelope was taken of the response spectra for the east-west and north-south components of the  $M_w6.0$ , 31 October 1935 (18:38) Helena, Montana earthquake and the south-east component of the Golden Gate record of the  $M_w5.28$ , 22 March 1957 San Francisco, California earthquake scaled to 0.12 g. The resulting 5% damped DBE response spectrum is shown in Figure 26b. However, although the response spectrum for the DBE was developed from motions recorded during the 1935 Helena and 1957 San Francisco earthquakes, time history analyses of the North Anna Dam were performed using the north-south component of the  $M_w6.95$ , 19 May 1940 Imperial Valley (El Centro) earthquake scaled to 0.12 g. The 5% damped response spectrum for this latter event is also shown in Figure 26b. (Dominion, 2009, 2011)

Motions from the 2011 Mineral, Virginia earthquake were recorded by a seismograph located on the basemat of the containment structure for Unit 1 of the NAPS, where the basemat is founded on rock. This seismograph is ~23 km from the epicenter of the event and ~8.5 km NW of the North Anna Dam; the dam is ~26 km from the epicenter. Assuming that the motions recorded at the NAPS were similar to those experienced at the North Anna Dam, the authors rotated the recorded motions to obtain motions that were oriented transverse to the longitudinal axis of the dam. The 5% damped response spectrum for these motions are shown

in Figure 26b. As may be observed from this figure, the motions from the Mineral earthquake exceed those of the DBE for oscillator frequencies greater than ~1.2 sec. Despite the DBE being exceeded over a wide range of frequencies, the team inspected the dam on 2 September 2011 and could not see any evidence of distress to the dam from the earthquake (Figure 27).

**Figure 26.** Design Basis Earthquake (DBE) for the North Anna Dam: (a)  $\sim M_w 4.5$ , 22 December 1875 earthquake, which is the largest historic event associated with the Arvonian Syncline (Chapman, 2012b); and (b) DBE, response spectrum for the 1940 El Centro N-S component scaled to 0.12 g, and response spectrum for the 2011 Mineral earthquake oriented in the transverse direction to the longitudinal axis of the dam.
