## Geotechnical Quick Report on the Affected Region of the 23 August 2011 M5.8 Central Virginia Earthquake near Mineral, Virginia

EDITOR: James R. Martin, II, Team Leader (Virginia Tech, Blacksburg, VA)

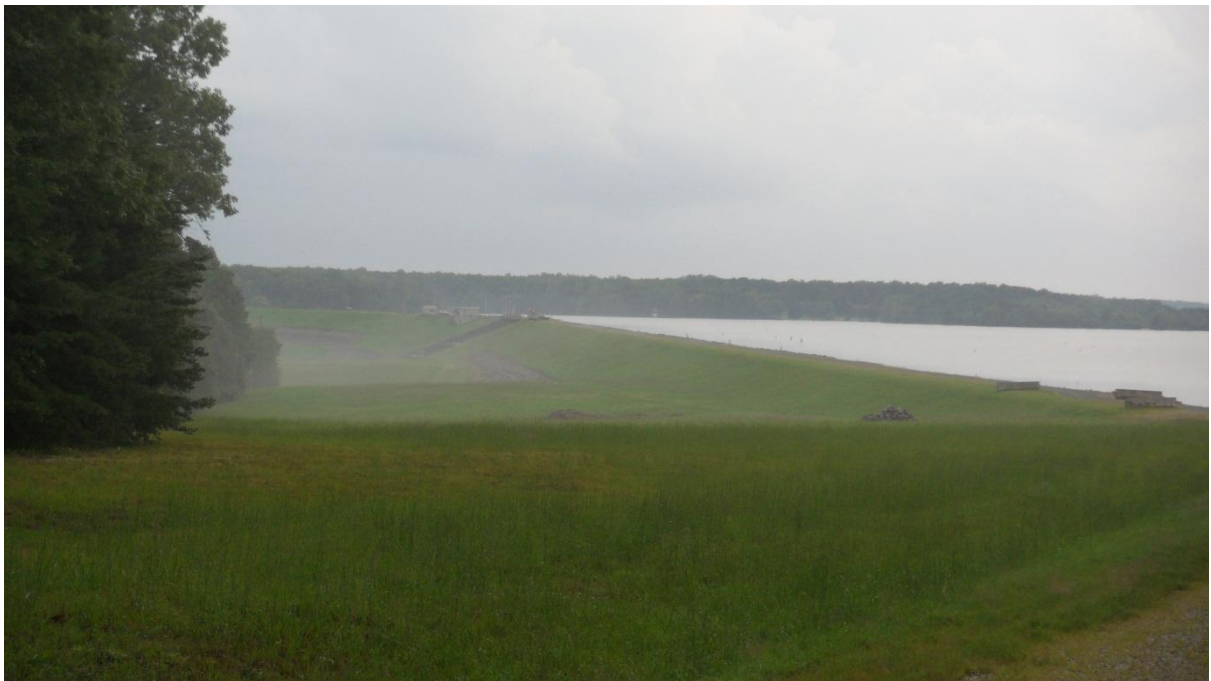
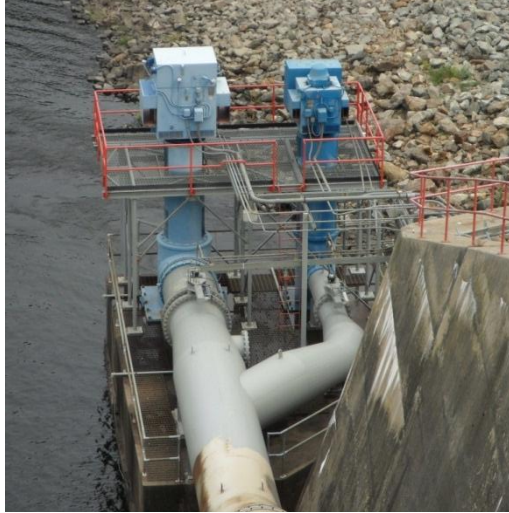
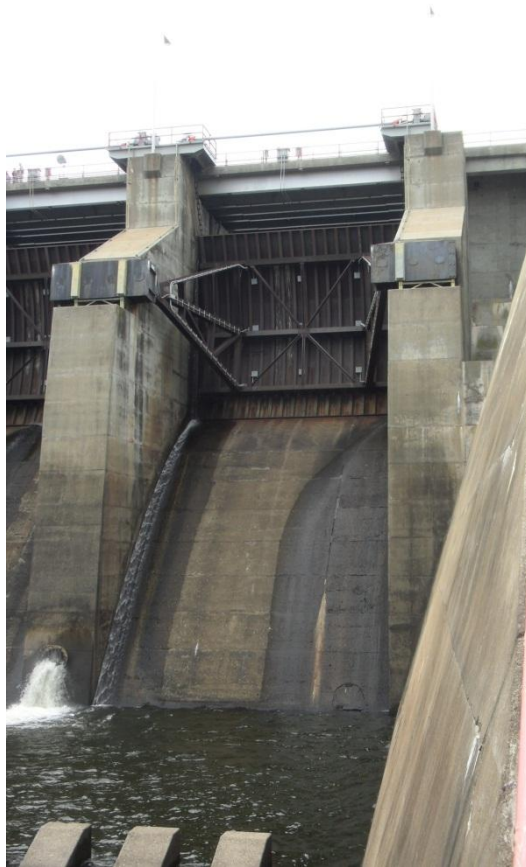
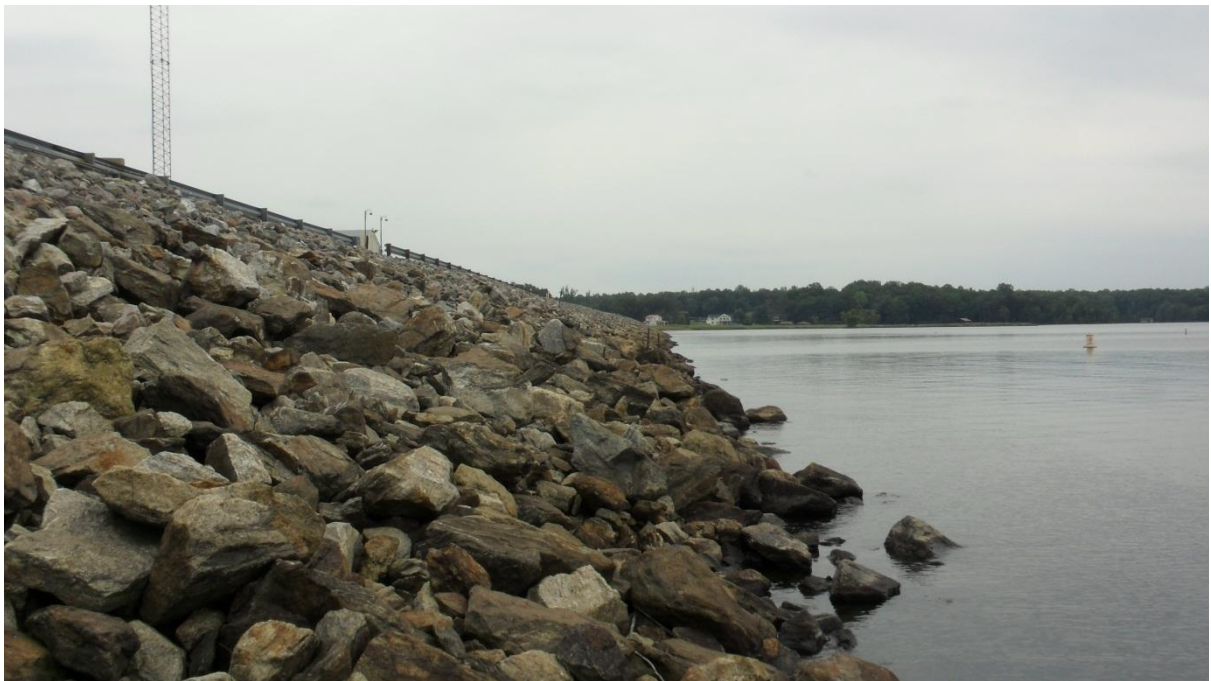
in Figure 26b. As may be observed from this figure, the motions from the Mineral earthquake exceed those of the DBE for oscillator frequencies greater than ~1.2 sec. Despite the DBE being exceeded over a wide range of frequencies, the team inspected the dam on 2 September 2011 and could not see any evidence of distress to the dam from the earthquake (Figure 27).

Figure 27. Lake Anna hydroelectric dam. (a) 38.00621, -77.71210. (b) 38.01739, -77.70918. (c)(d)(e)(f) 38.01315, -77.71297. (g) 38.01259, -77.71347.

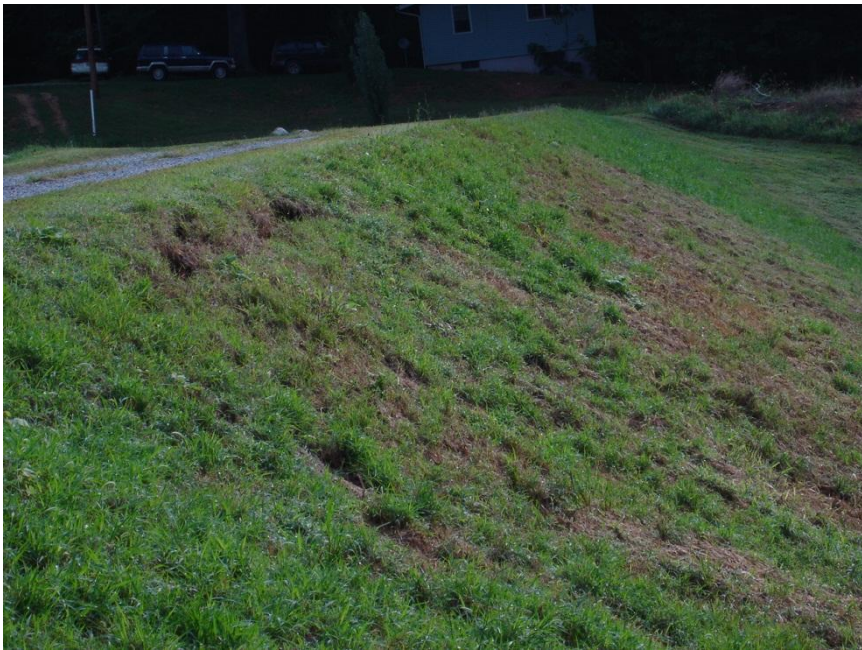
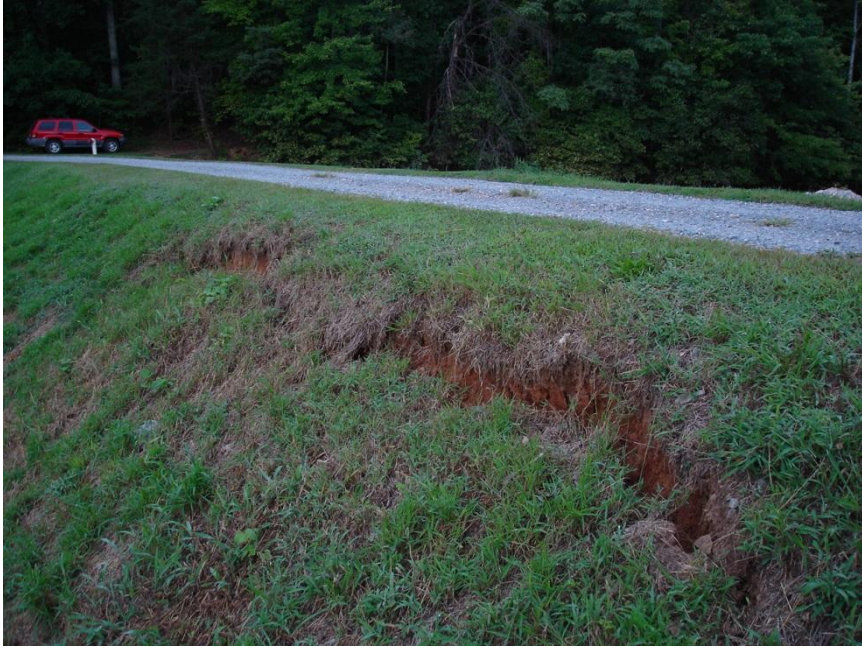
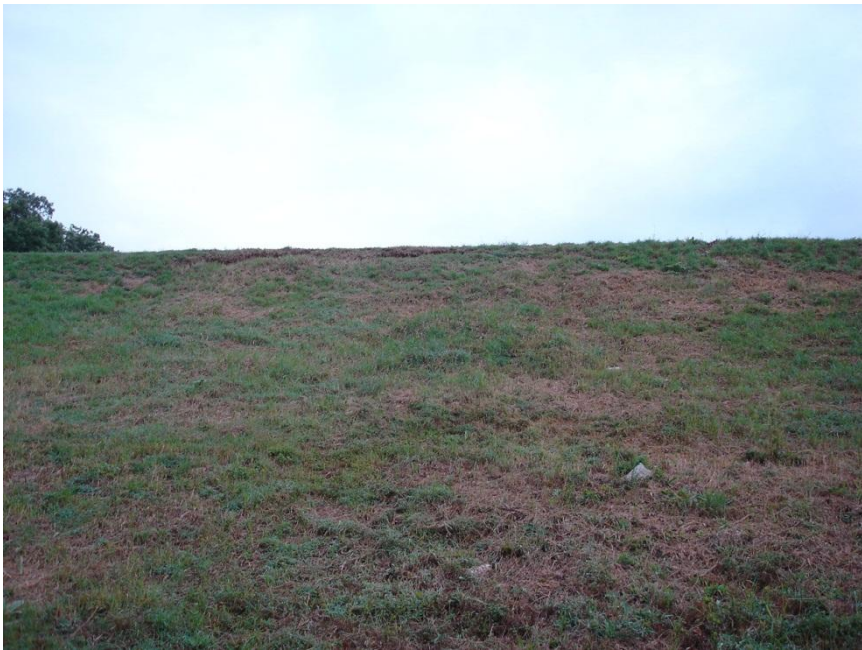
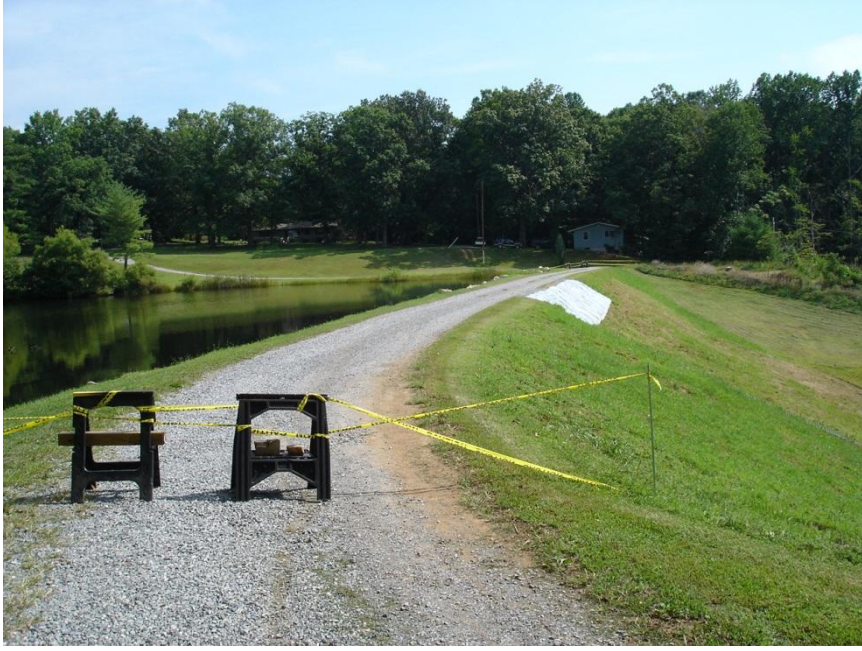
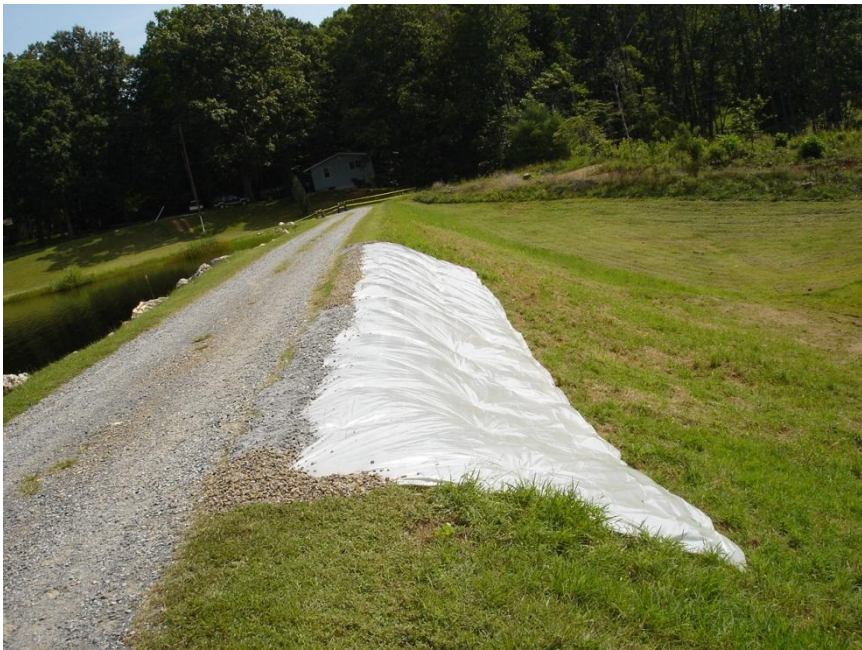
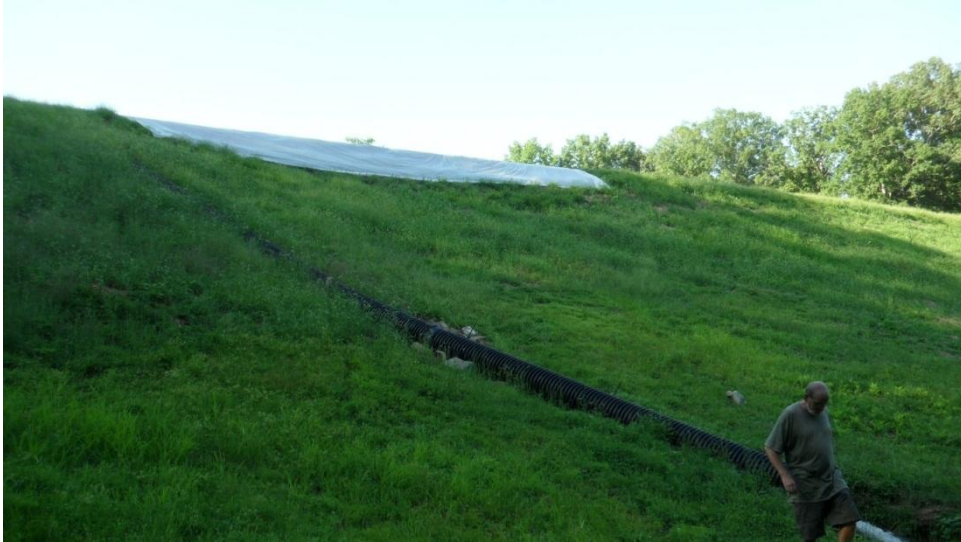
A team member met with W. Gray, the president of the homeowners association that owns the dam, on 9 September and inspected the dam. W. Gray said that 3 days before the earthquake they had 17.8 cm of rain in 12 hours. The saturated ground conditions likely triggered the initiation of the slide that occurred while the homeowner was weed eating, with the earthquake shaking making the slide worse. W. Gray said they covered the slide shortly after the earthquake with a plastic sheet to prevent water from flowing into the scarp. Photos of the slide taken both before and after it was covered with the plastic sheet are shown in Figure 34.

Figure 34. Shallow slide in the Elk Garden Lake Dam (37.4223, -79.5009): (a) photo of the shallow slide on the downstream face of the dam; (b) closer view of the shallow slide on the downstream face of the dam; (c) photo of head scarp of slide; (d) photo of slide taken from downstream toe of the dam; (e) photo showing head scarp covered with plastic sheet; (f) closer view of plastic sheet covering the head scarp; and (g) photo of plastic sheet taken from downstream toe of dam.

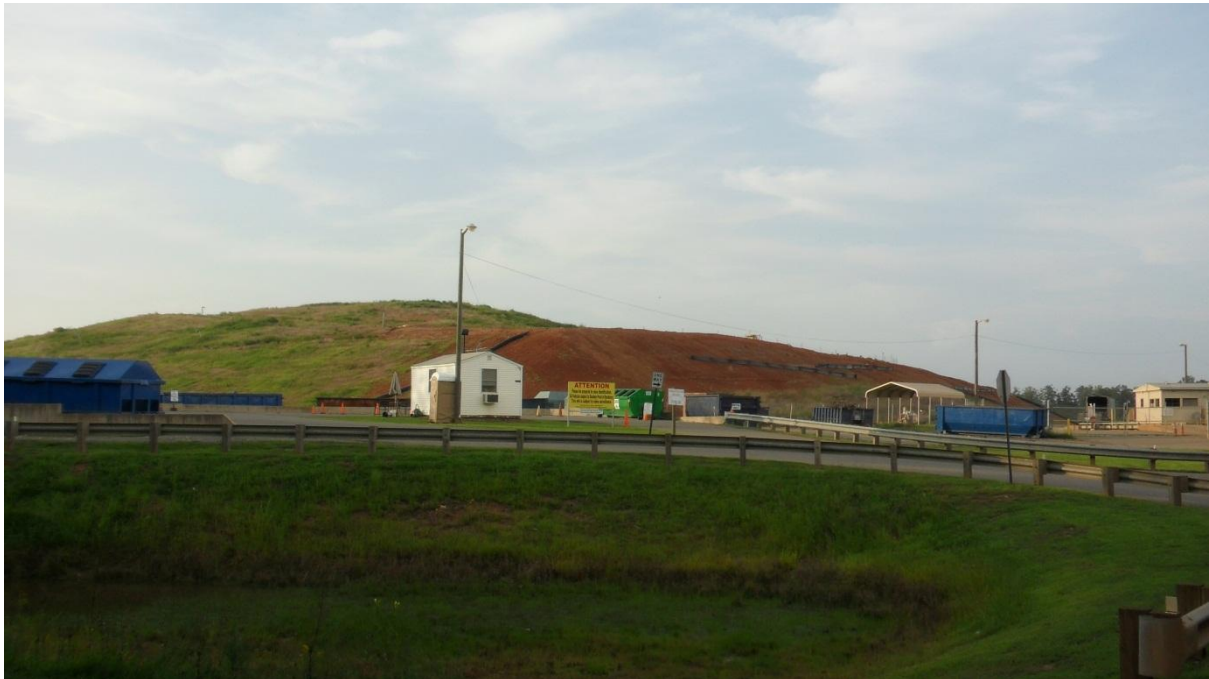
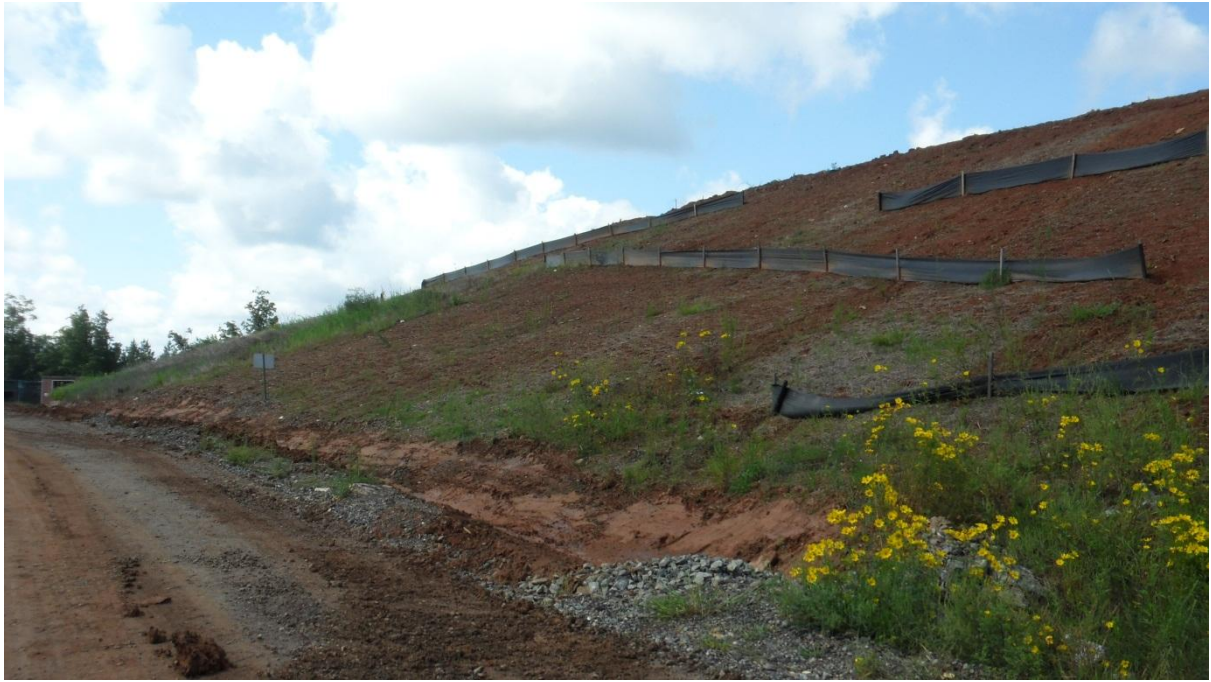
Figure 36. Photos of the front slope of the Louisa County landfill (37.98670, -77.88474).

The Louisa County landfill was inspected on 9 September. It is located ~10 km from the epicenter of the main shock as shown in Figure 35. A team member talked with R. Petty, who is the operations manager for the landfill and who was present at the landfill during the earthquake. R. Petty said he noticed a small crack on the front slope of the landfill immediately after the earthquake. The crack was ~2.5 cm wide, but R. Petty was uncertain whether it was there prior to the earthquake. Photos of the front slope of the landfill are shown in Figure 36. By the time R. Green visited the landfill, the crack had largely filled in as a result of the heavy rains from hurricane Irene. However, the crack looked like it was the scarp of a shallow slide in the temporary clay cover; remnants of the crack are shown in Figure 37.

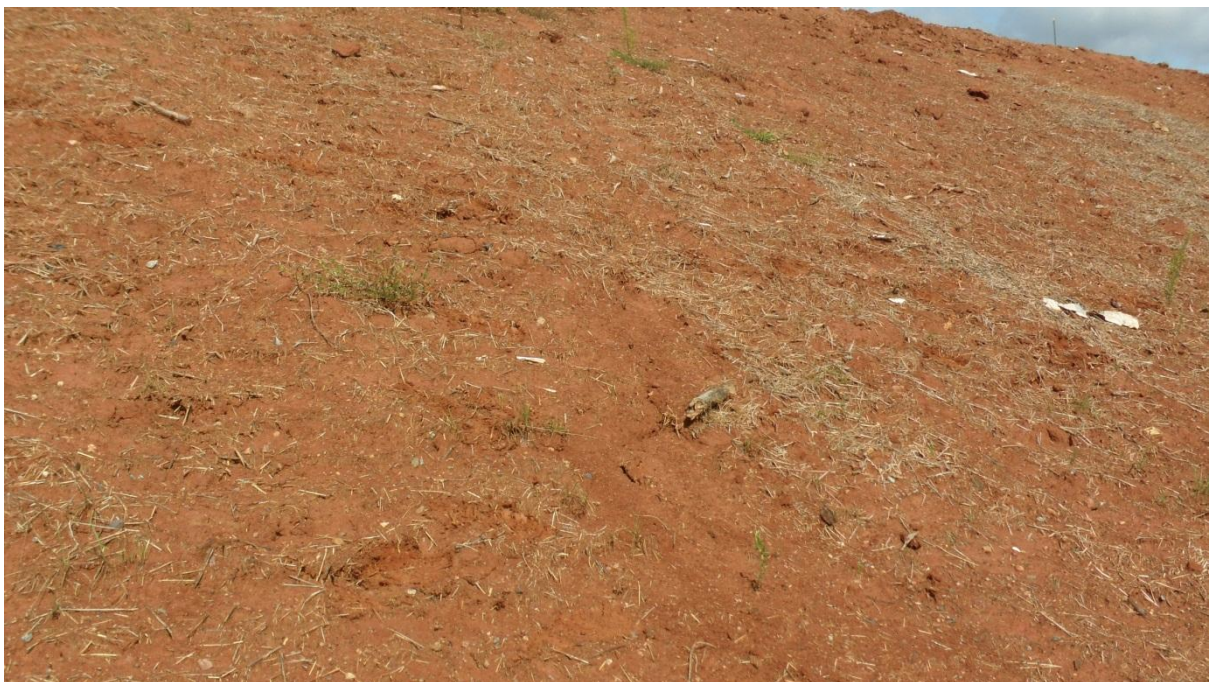
Figure 37. Photos showing the remnants of a crack in the front slope of the landfill that might have formed as a result of the earthquake shaking.

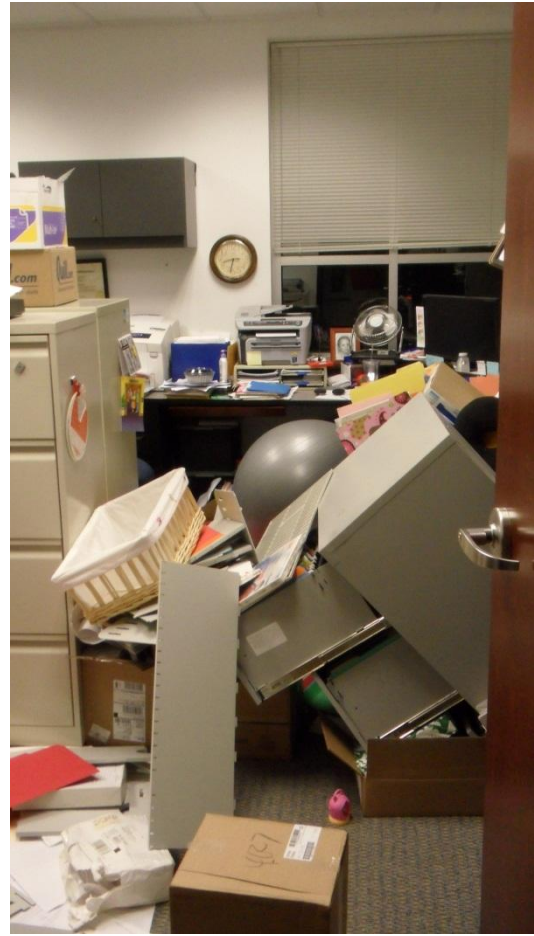
Figure 40. Typical damage to internal contents of offices in the Louisa County Public School Administration Building (38.02066, -77.92373).

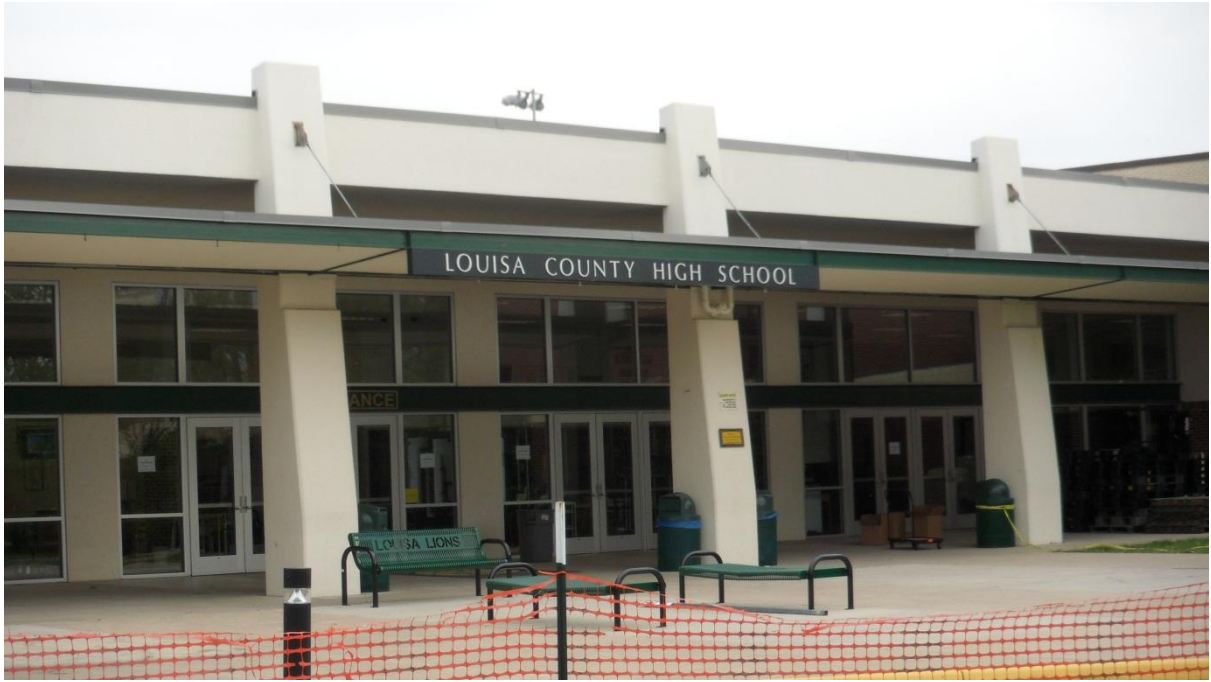
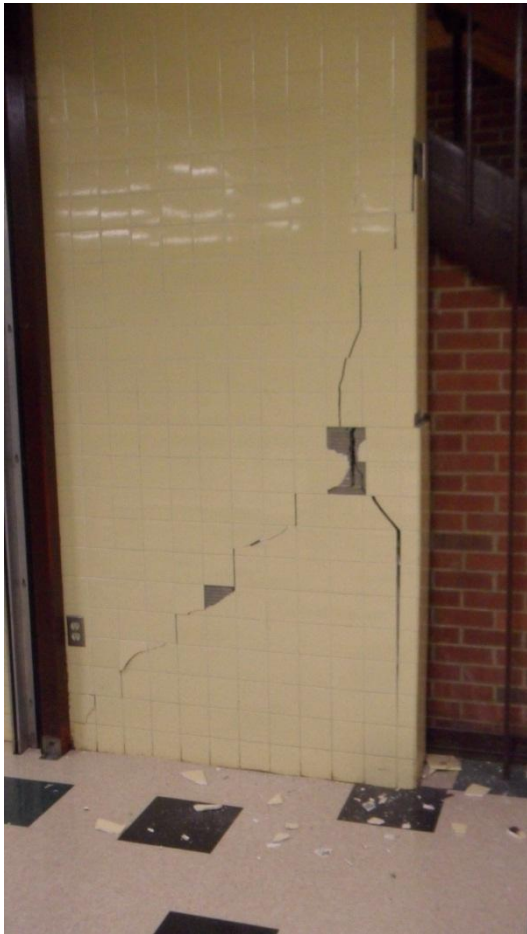
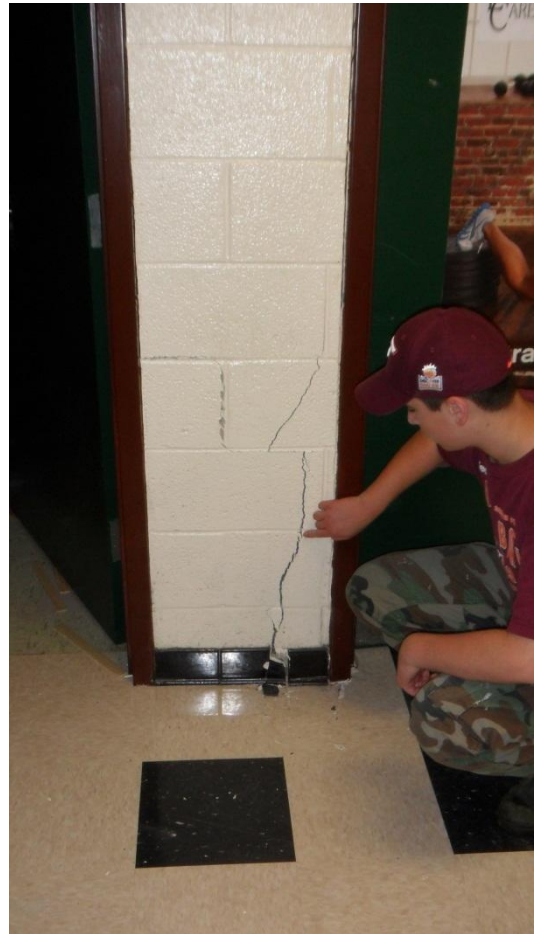
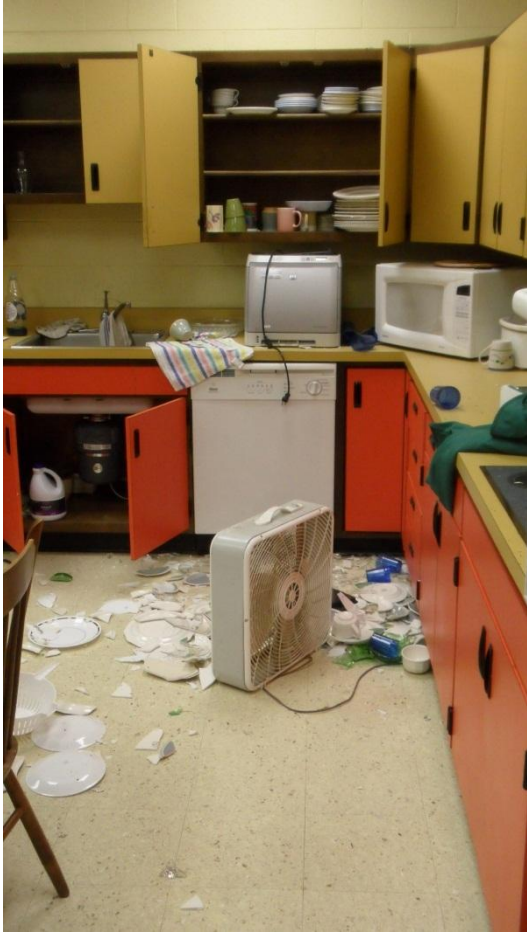
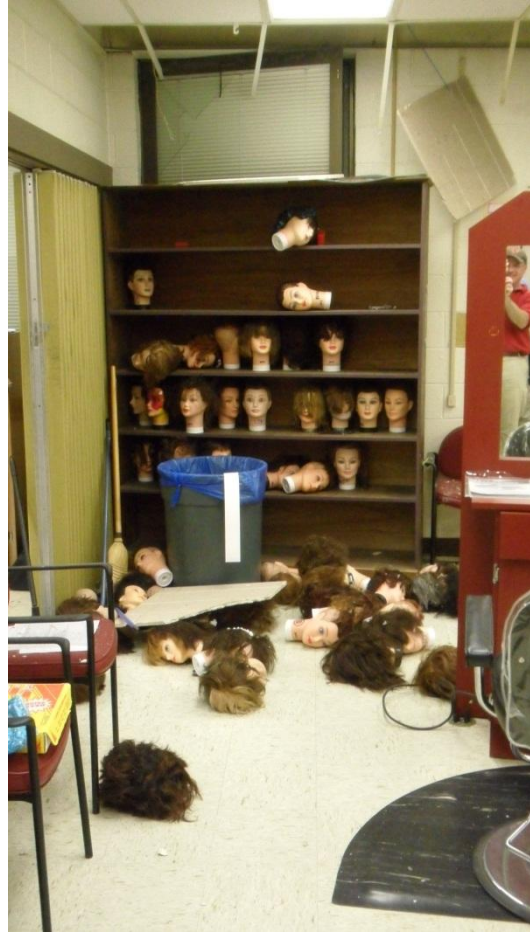
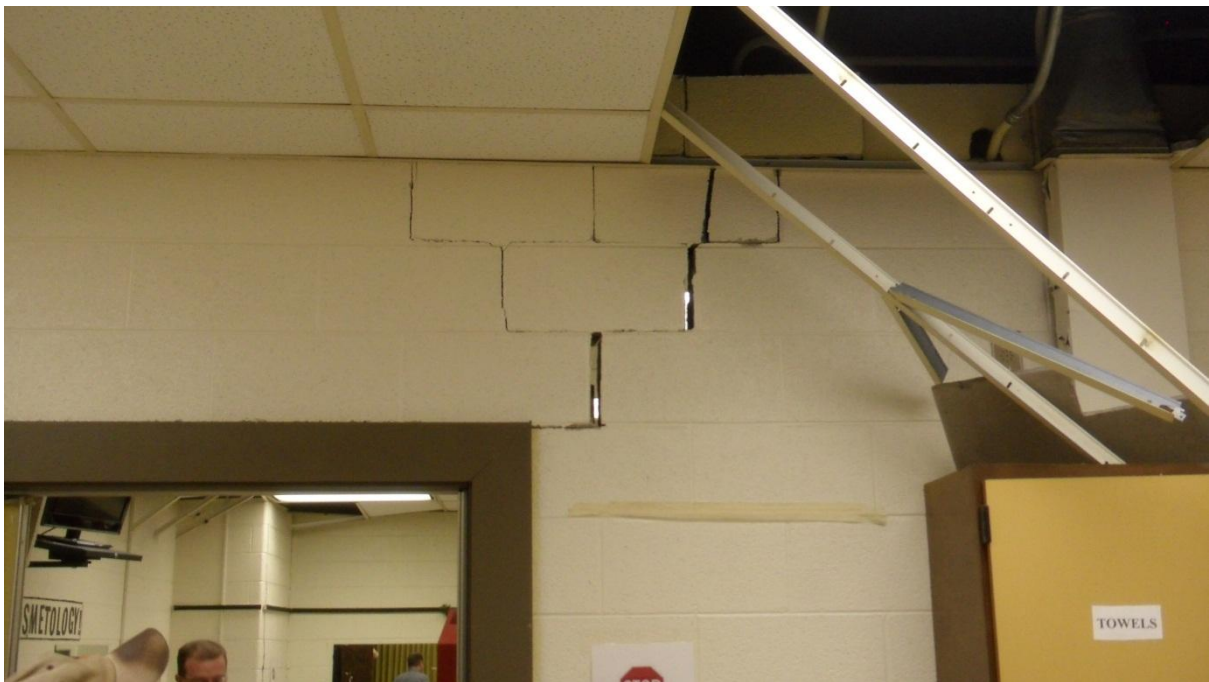
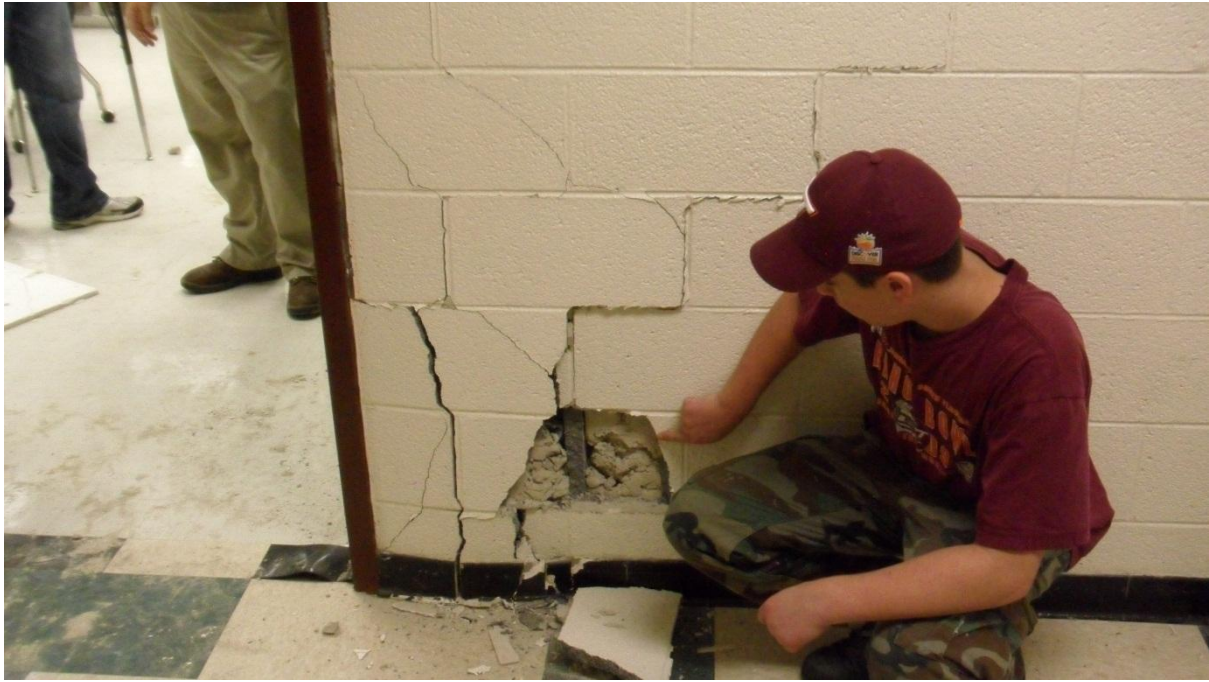
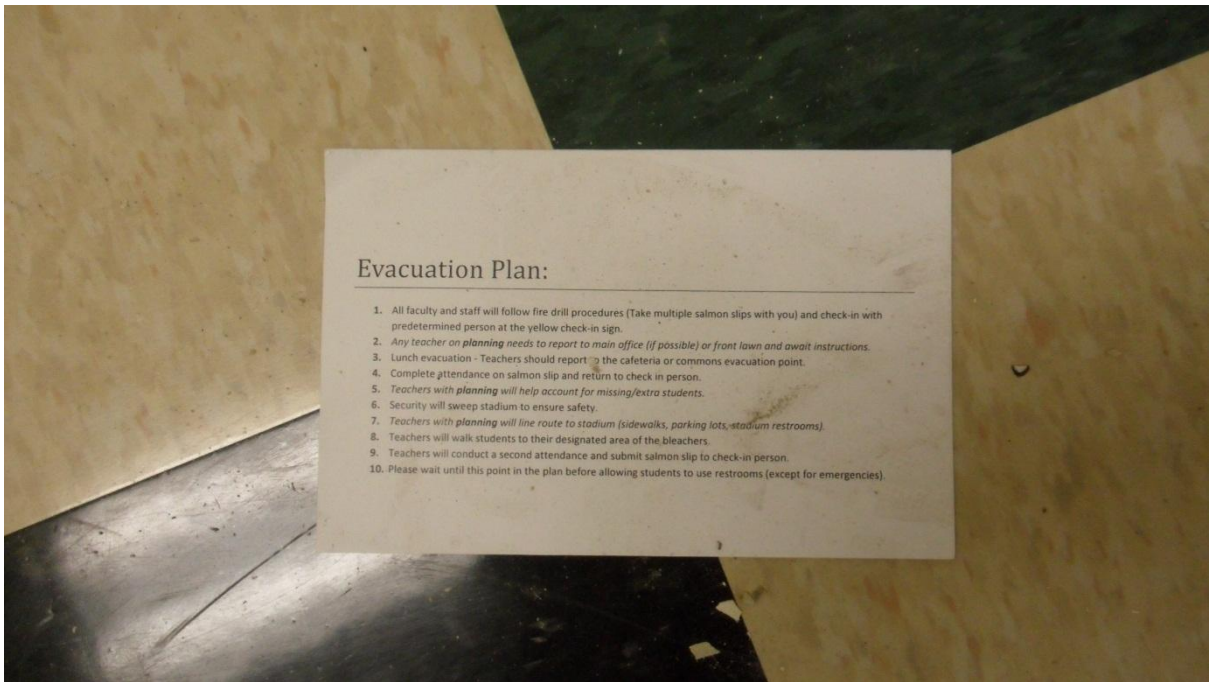
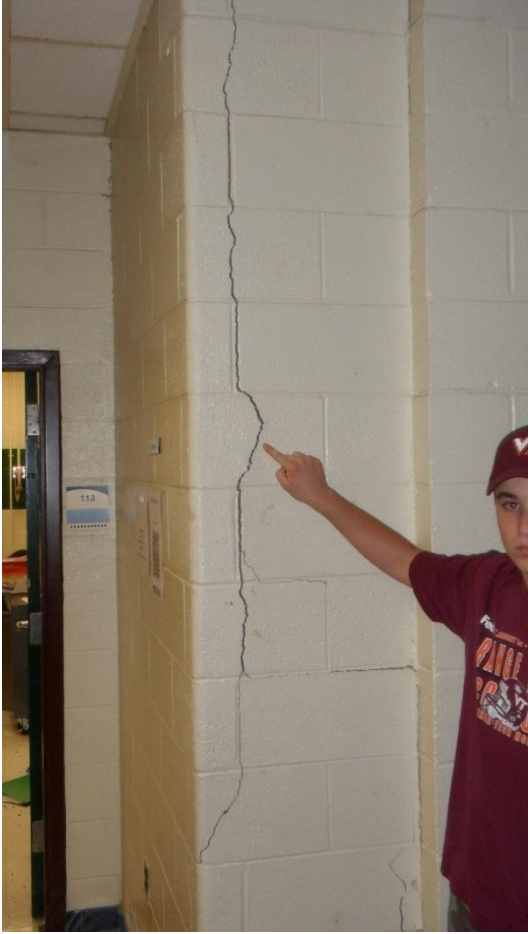
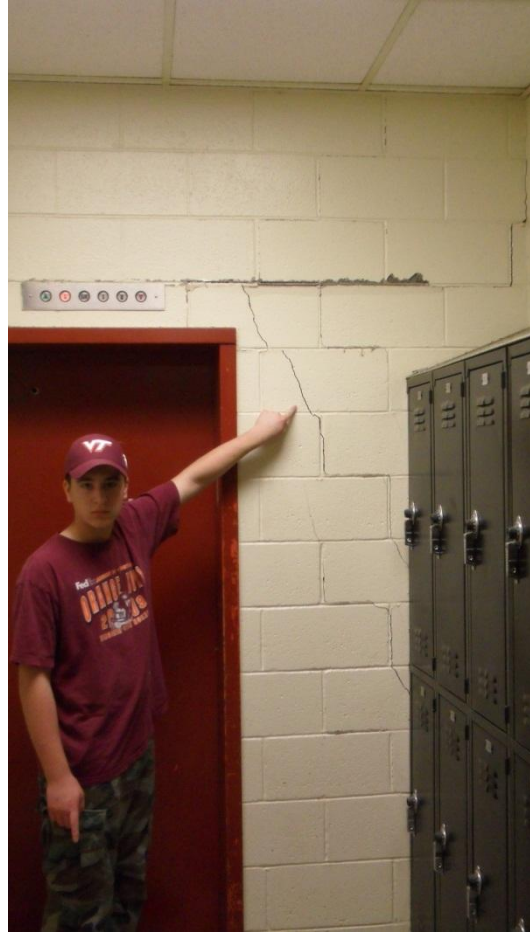
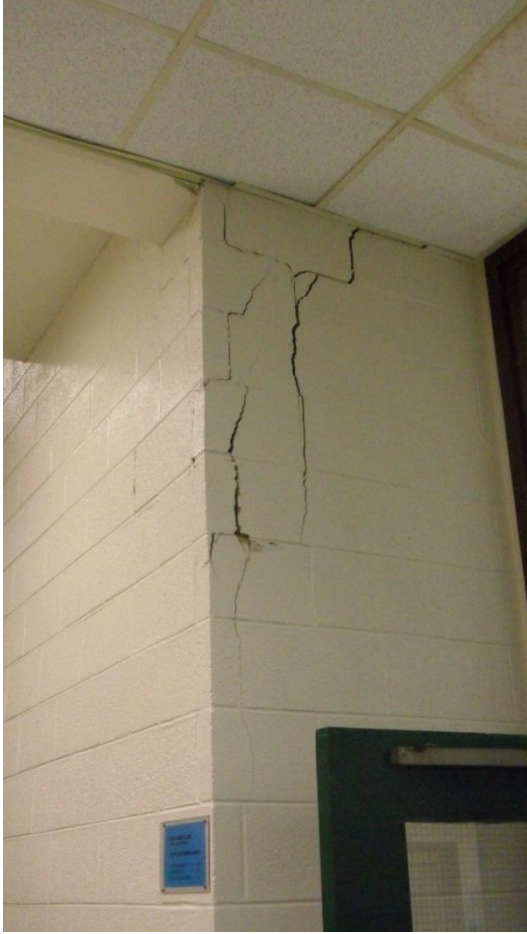
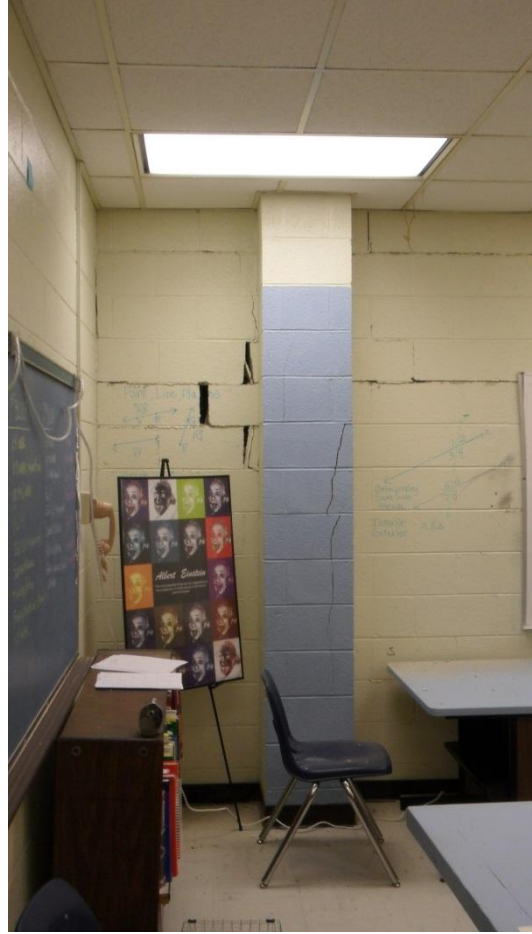
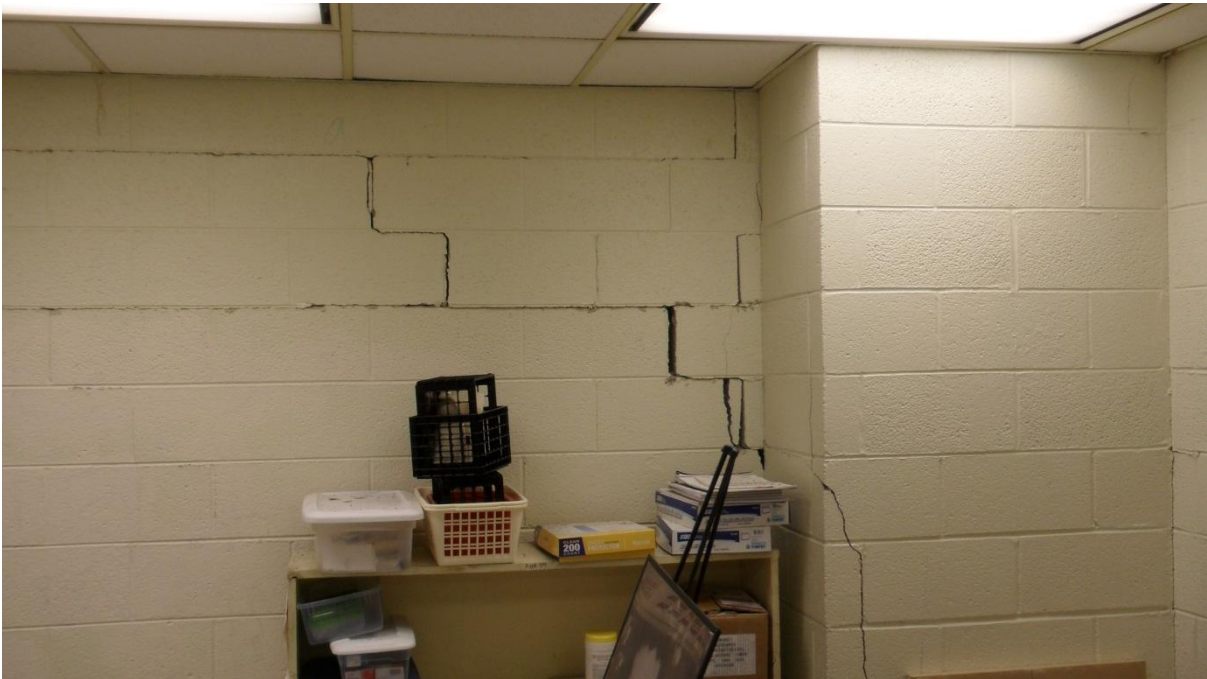
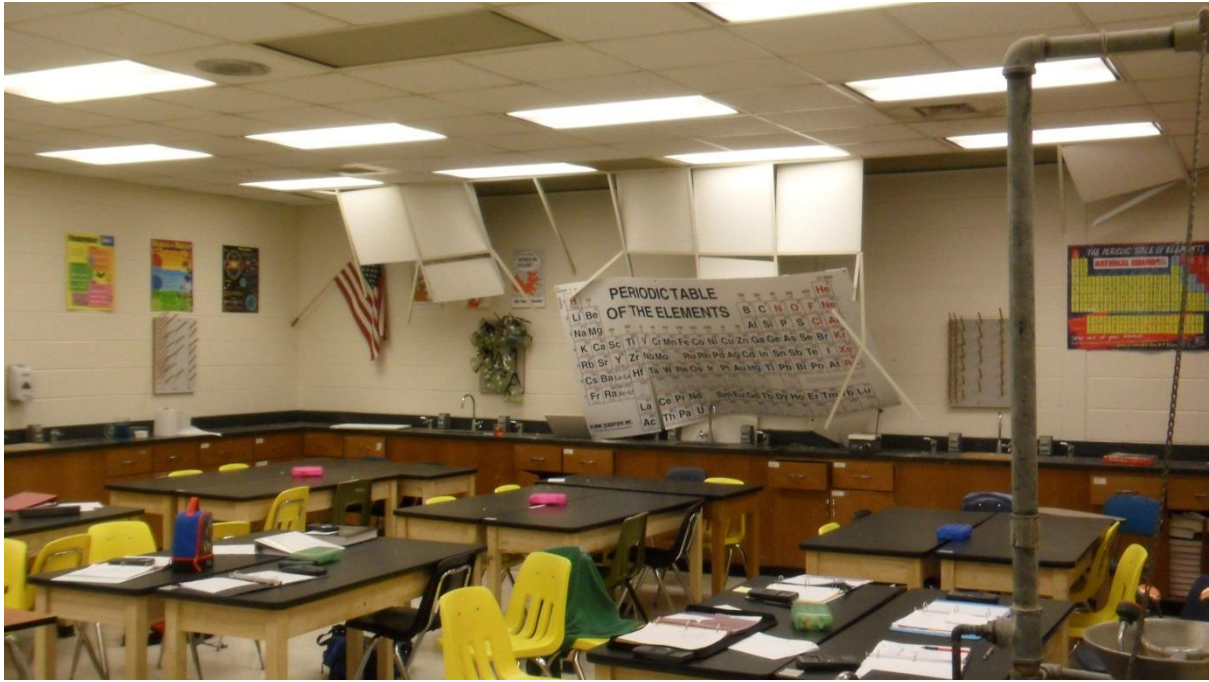
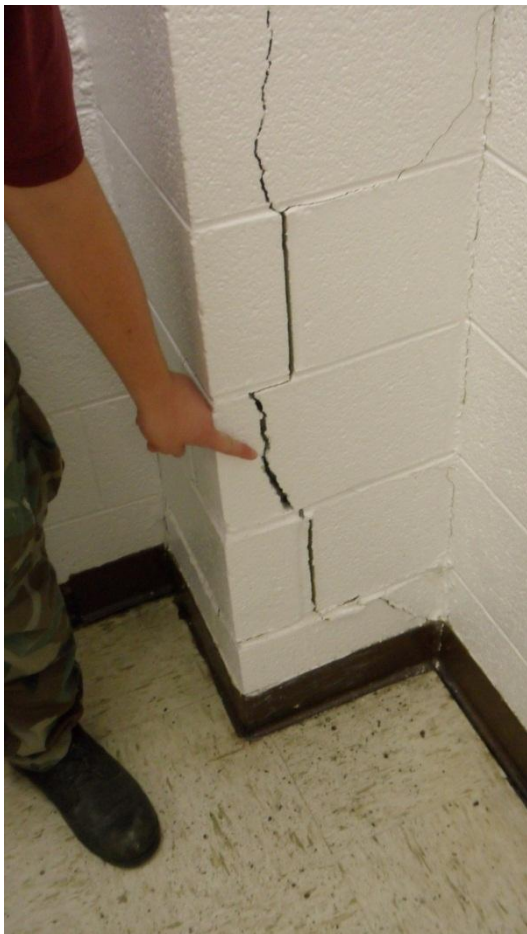
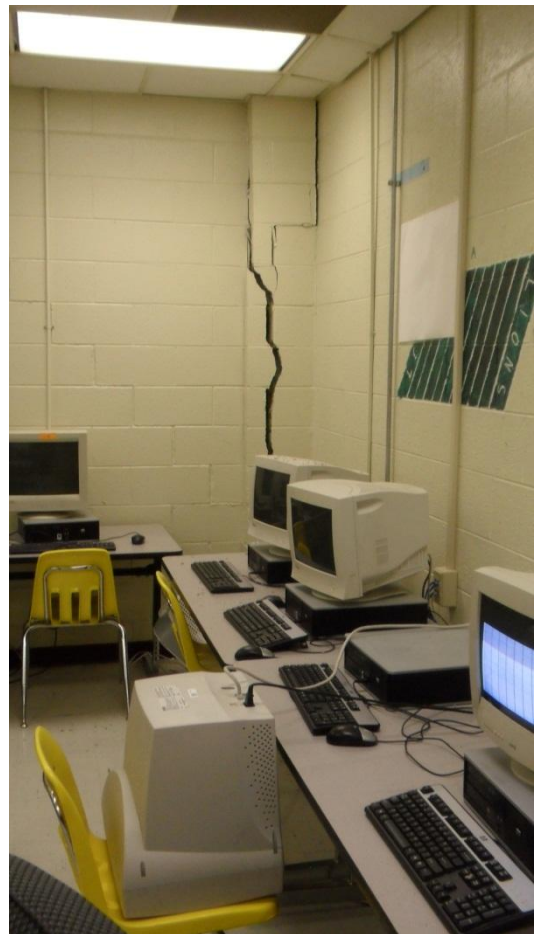
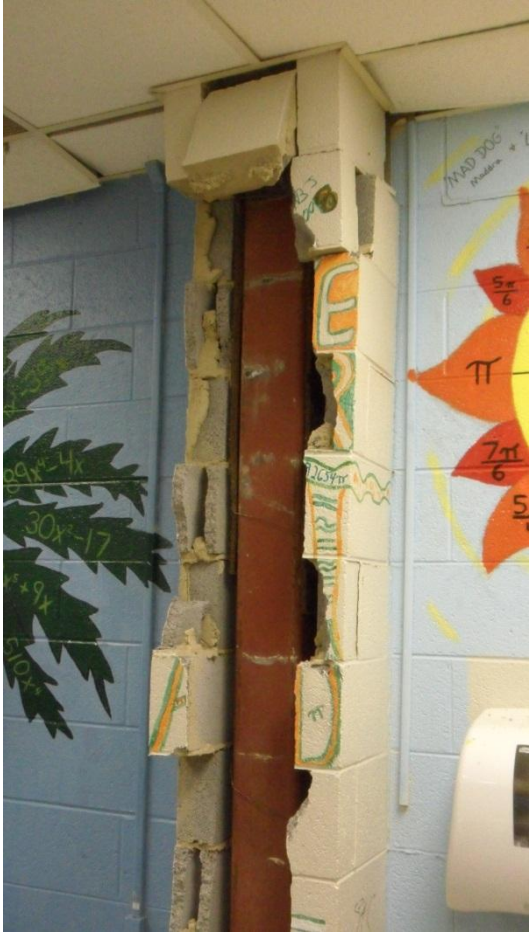
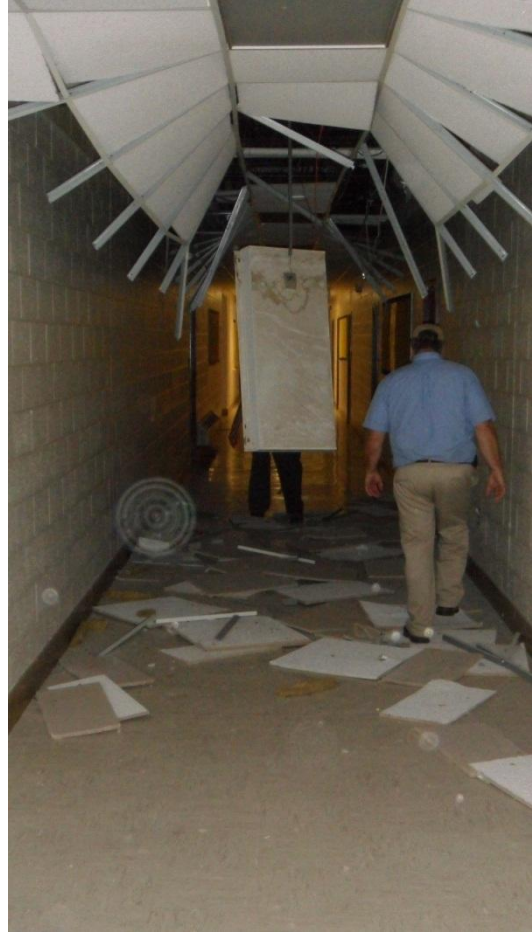
The Louisa County High School building was built in sections over a period of several decades. The most severe damage to the building was in a portion that had a steel frame with concrete block infill walls and a brick façade; it is uncertain whether this same type of structural system was used in all sections of the building. The observed damage included cracks in the infill block walls, with blocks from the top of the walls falling through the dropped ceiling in places. Additionally, in many rooms ceiling tiles along opposite walls fell, indicating a pronounced direction of shaking; unfortunately, the orientations of the walls were not determined. As with the Administration building, the internal contents in many rooms were in disarray. Photos showing some of the damage in the High School building are shown in Figure 41.

Figure 41. Typical damage to the Louisa County High School Building (38.01764, -77.92107).

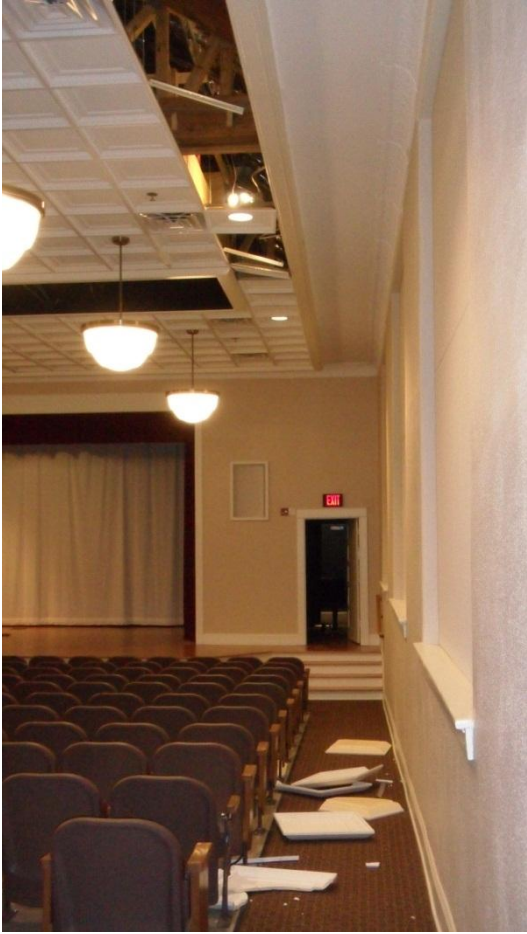
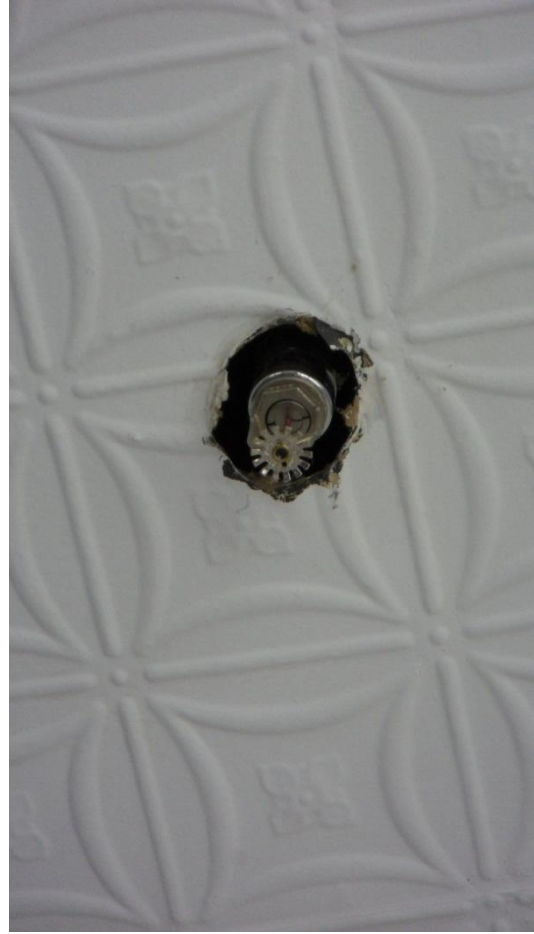
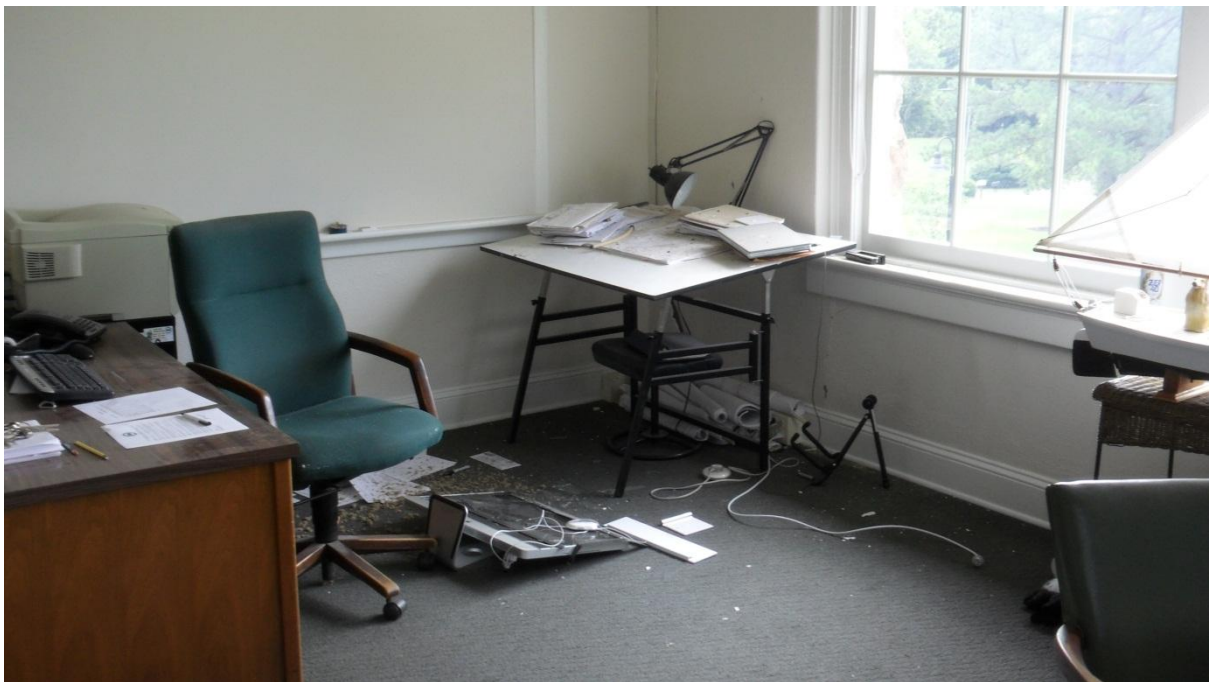
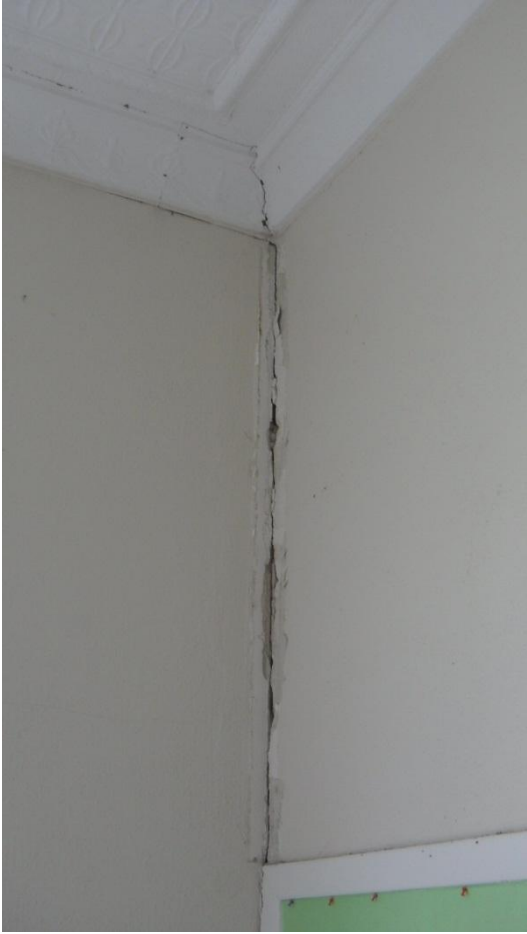
We had received reports on the night of the earthquake that the Louisa Town Hall (Figure 43) had a partial roof collapse. This prompted an inspection of the building on 24 August, the morning after the main shock. The building was constructed in 1907 (Figure 44a) and was damaged by fire in 1924 (Figure 44b); sometime between 1907 and 1924 a second story was added. The reports of damage were grossly exaggerated and most of the damage was cosmetic (e.g., fallen ceiling tiles, cracked plaster); photos of some of the damage are shown in Figure 45. The only structural damage was that the front wall of the building was slightly bowed outward as a result of the earthquake shaking.

Figure 45. Photos showing examples of damage to the Louisa Town Hall.
