## Geotechnical Quick Report on the Affected Region of the 23 August 2011 M5.8 Central Virginia Earthquake near Mineral, Virginia

EDITOR: James R. Martin, II, Team Leader (Virginia Tech, Blacksburg, VA)

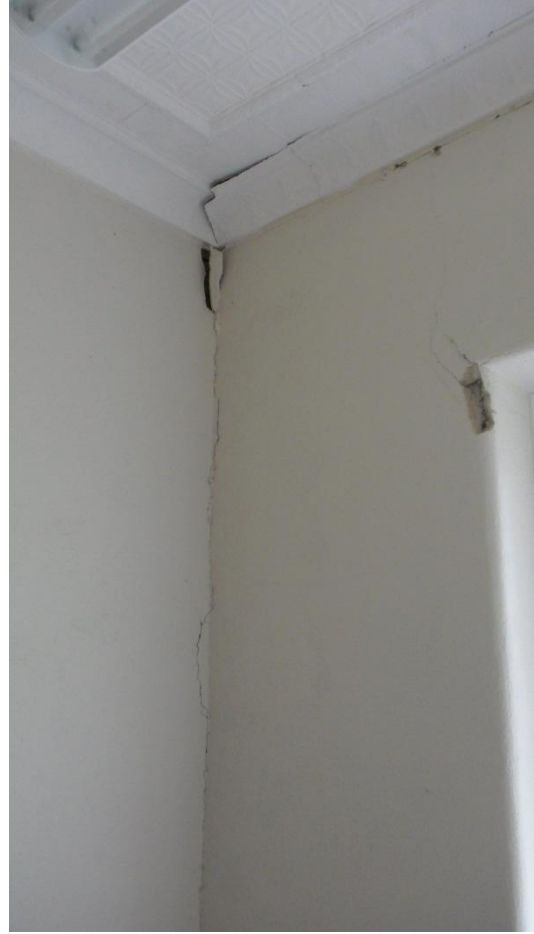
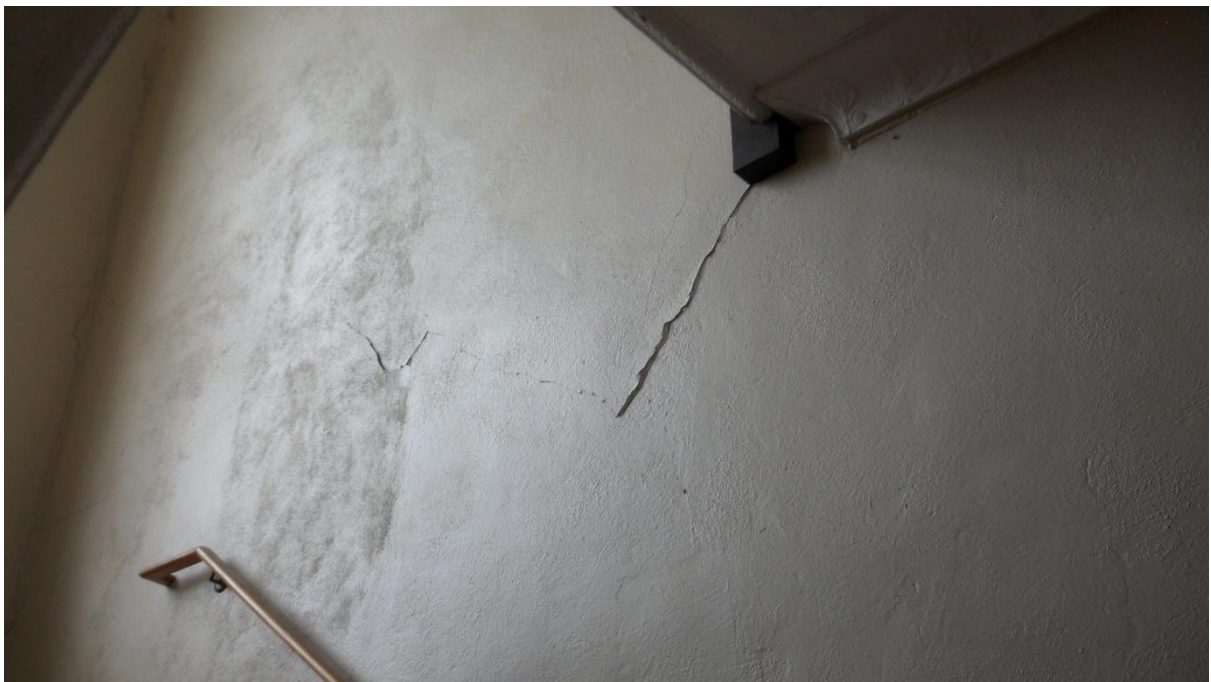
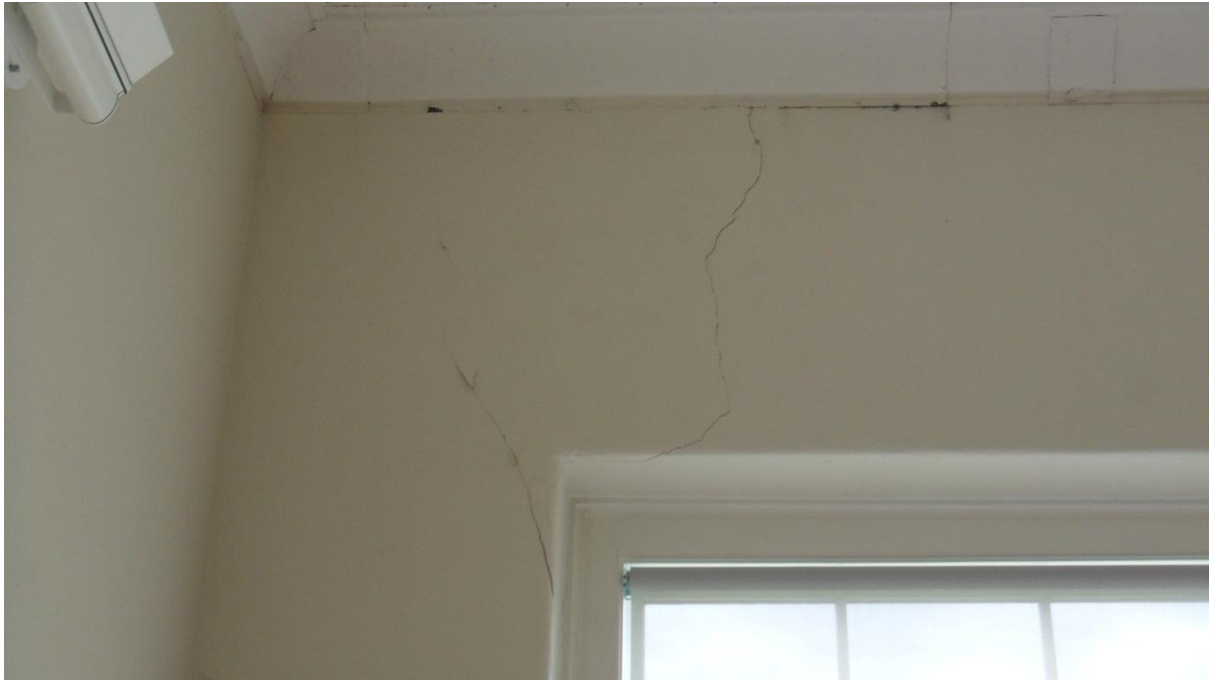
Figure 45. Photos showing examples of damage to the Louisa Town Hall.

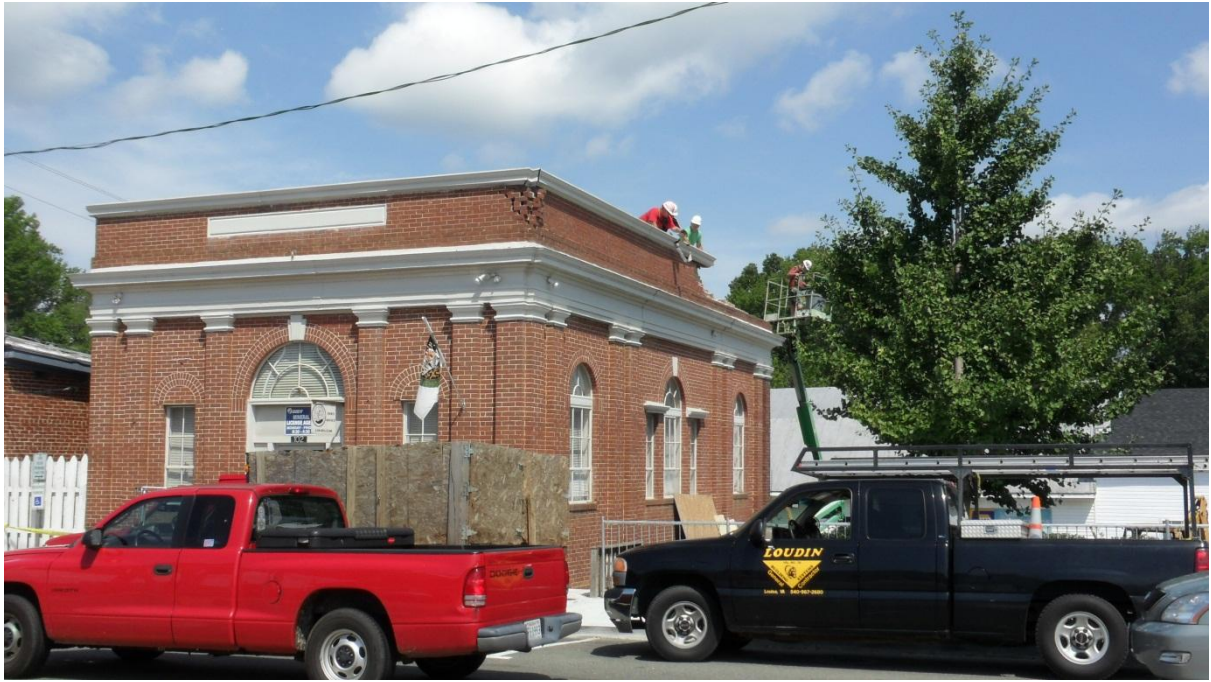
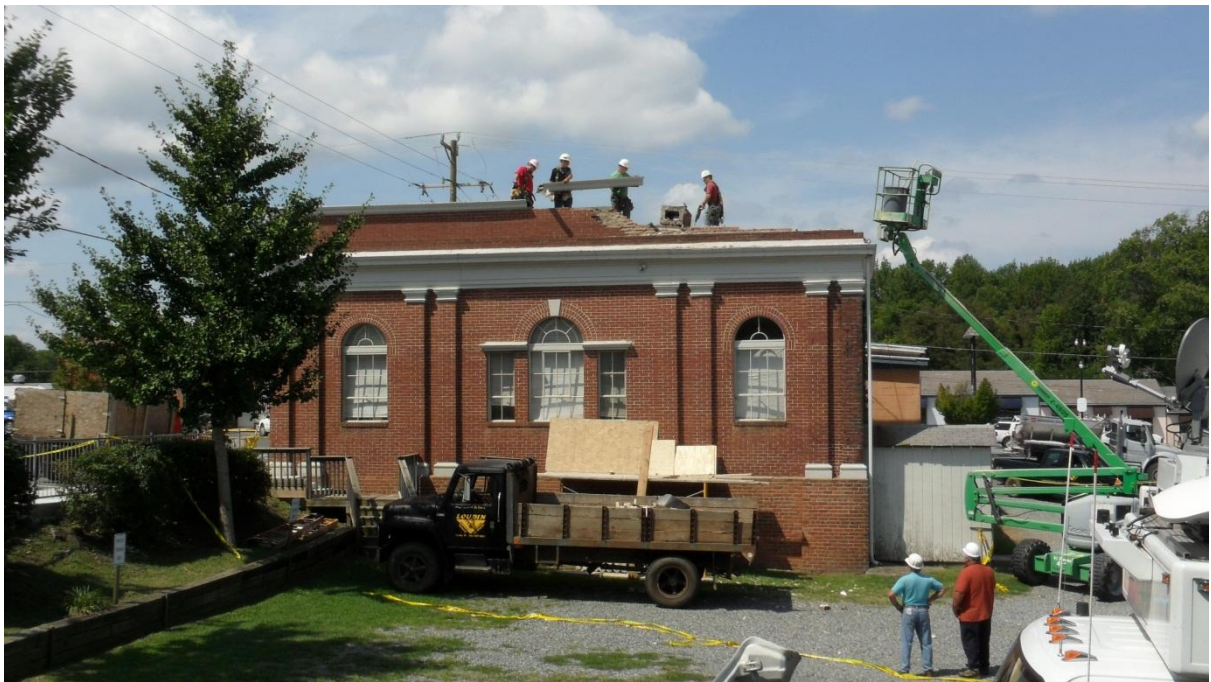
We had received reports on the night of the earthquake that the Mineral Town Hall had completely collapsed during the earthquake. This prompted team members to inspect the building on 24 August, the morning after the main shock. As with the Louisa Town Hall, the initial damage reports for the Mineral Town Hall were grossly exaggerated. A photo obtained from the internet believed to have been taken within hours after the earthquake on 23 August is shown in Figure 46. As shown in this figure, the damage was mainly limited to the brick parapet towards the back of the building. Photos taken by a team member on 24 August are shown in Figure 47. We did not inspect the inside of the building.

Figure 47. Damage to the Mineral Town Hall (38.01090, -77.90848).

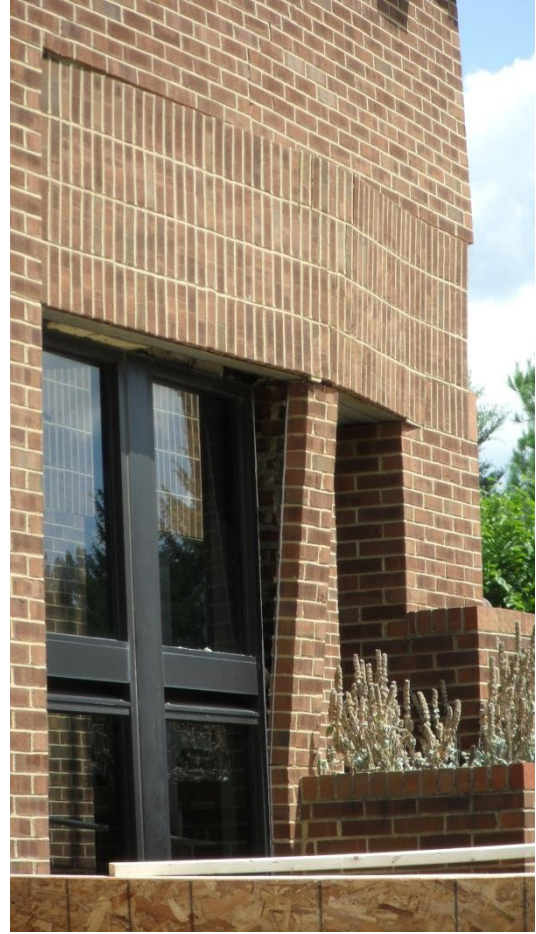
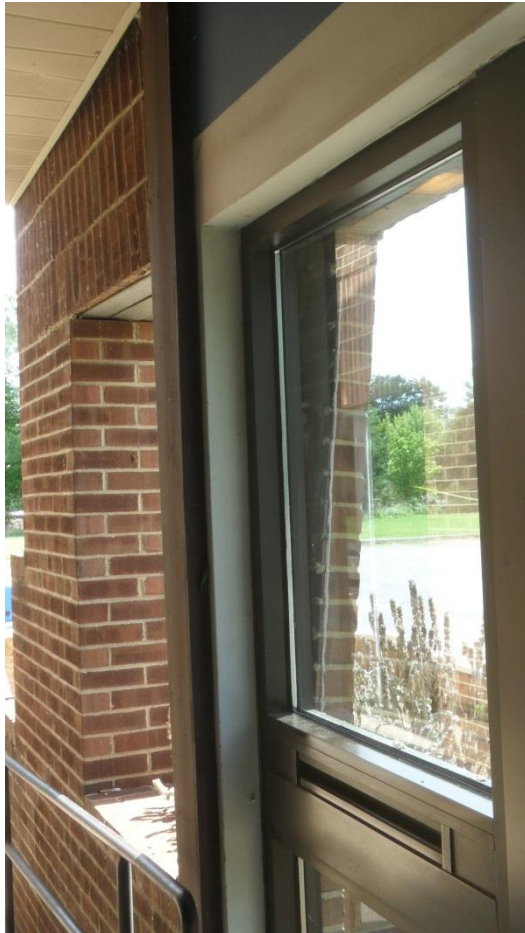
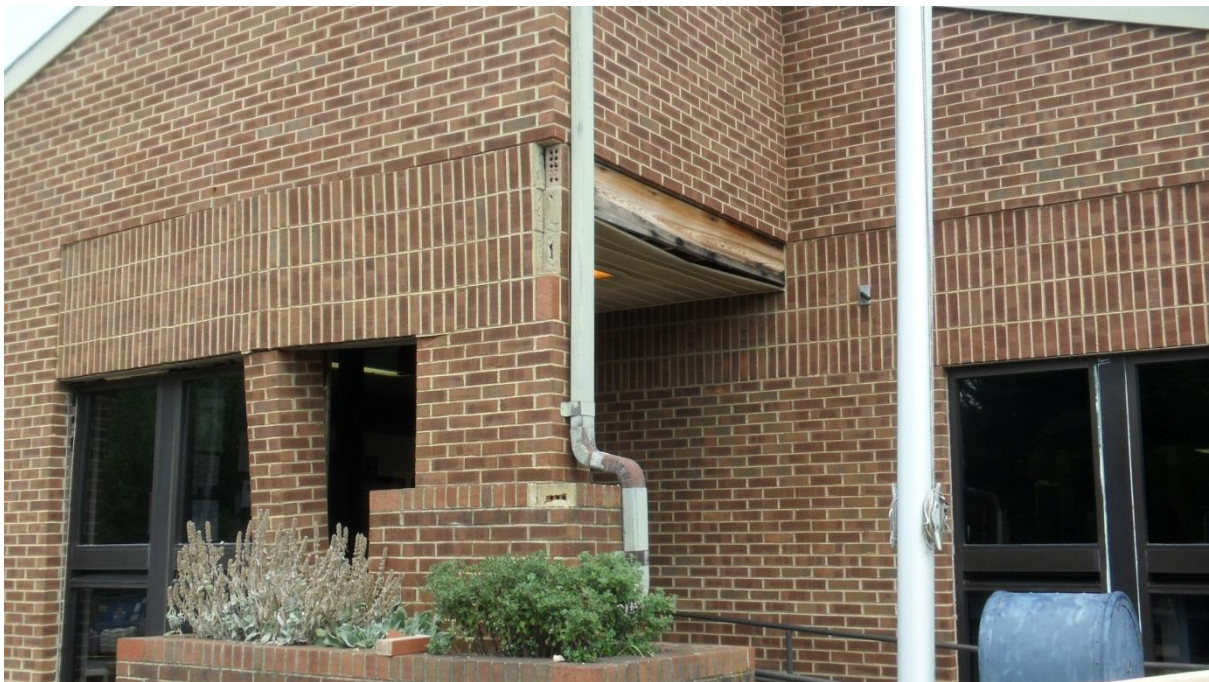
Team members inspected the US Post Office in Mineral on 24 August, the morning after the main shock. The post office was open when we visited, but the main entrance and foyer were closed and residents had to use the backdoor to pick up their mail. Figure 48 shows the damage to the brick façade to the main entrance to the building. As with the Louisa County High School, ceiling tiles along opposite walls fell in the Mineral Post Office. In this case the tiles along the North and South walls fell (Figure 49), indicating a pronounced N-S direction of shaking.

Figure 48. Damage to the main entrance of the Mineral Post Office (38.00669, -77.90859).

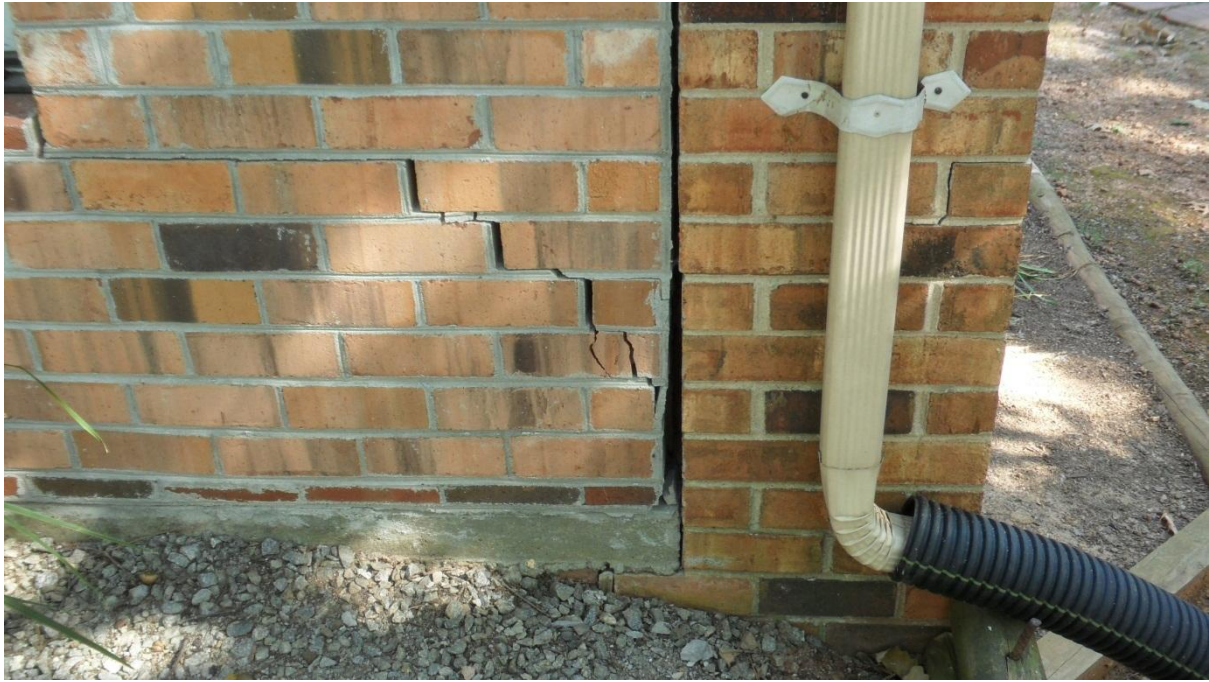
Figure 53. Representative severe damage to brick façade and block foundation walls (37.9923, -77.9513).

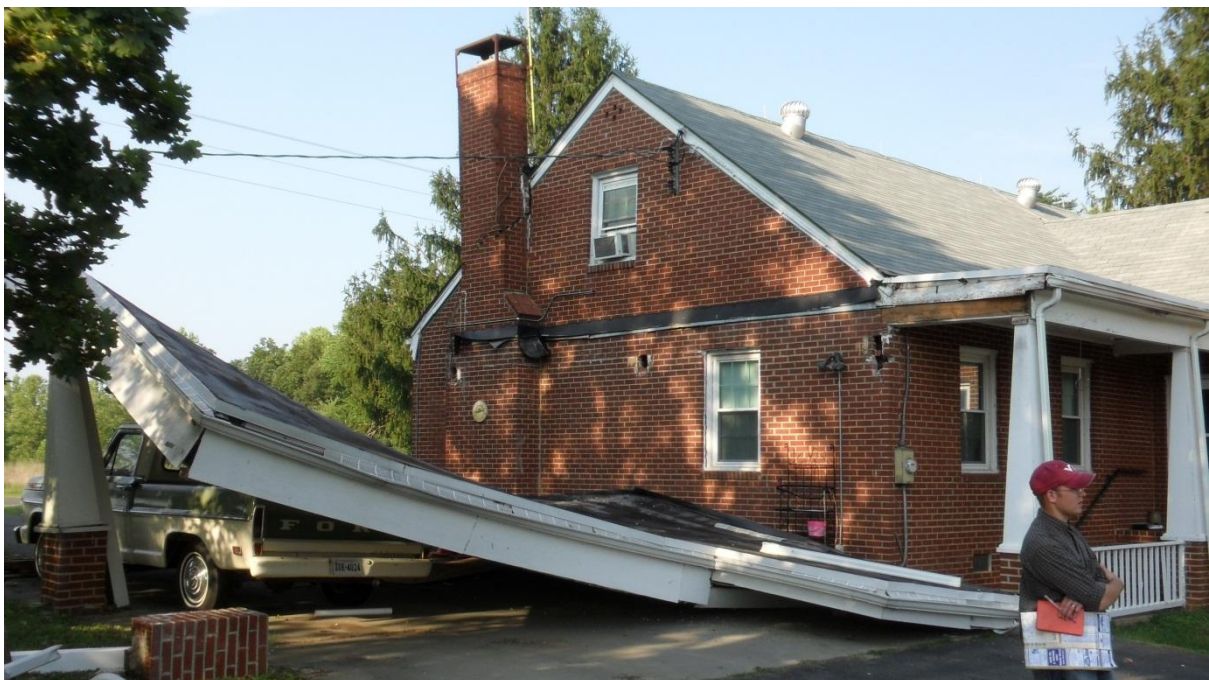
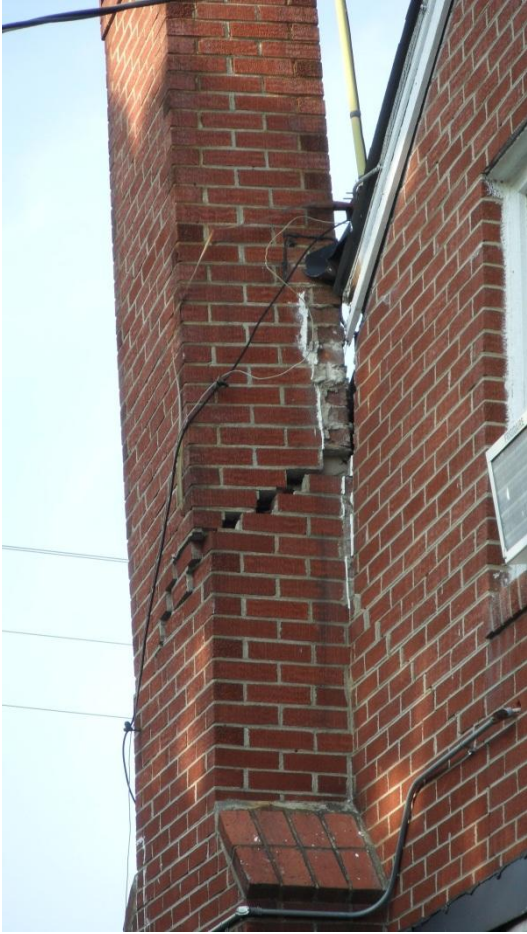
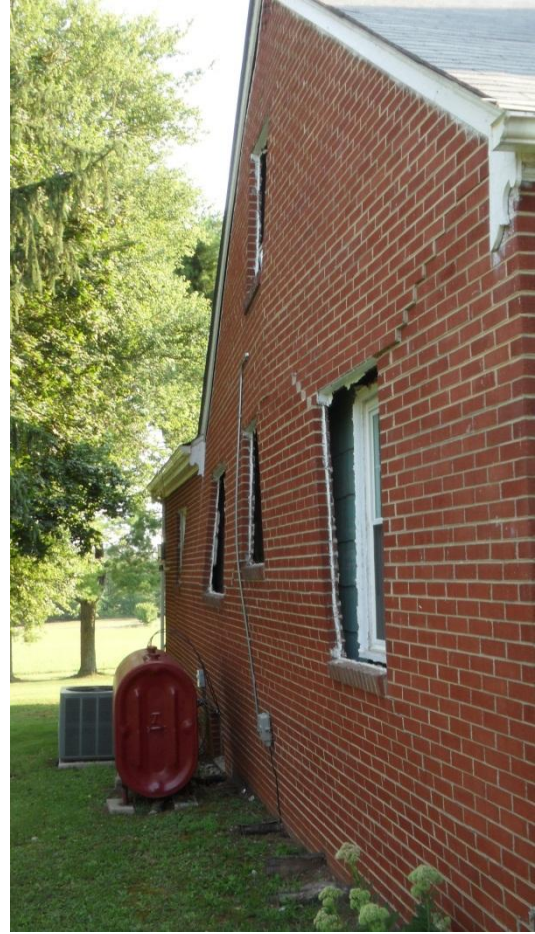
Figure 54. Representative severe damage to brick façade (37.9229, -78.0033).

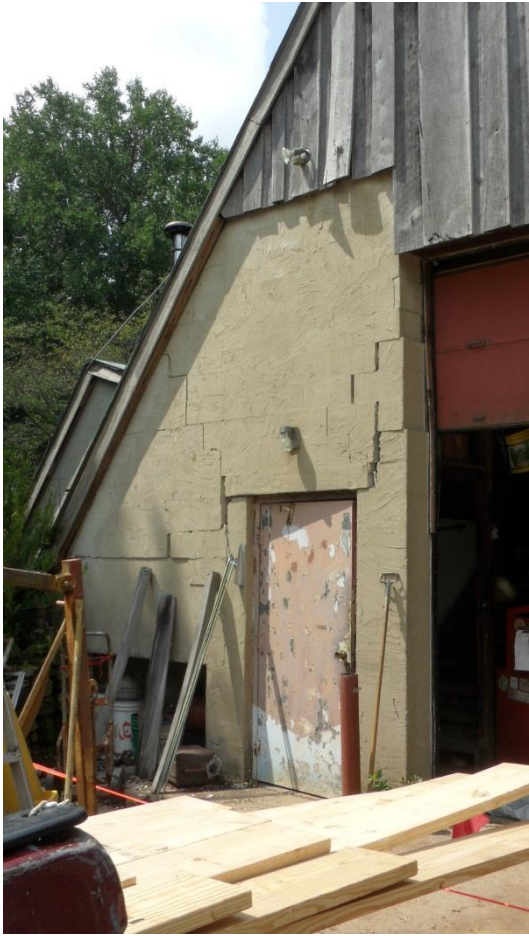
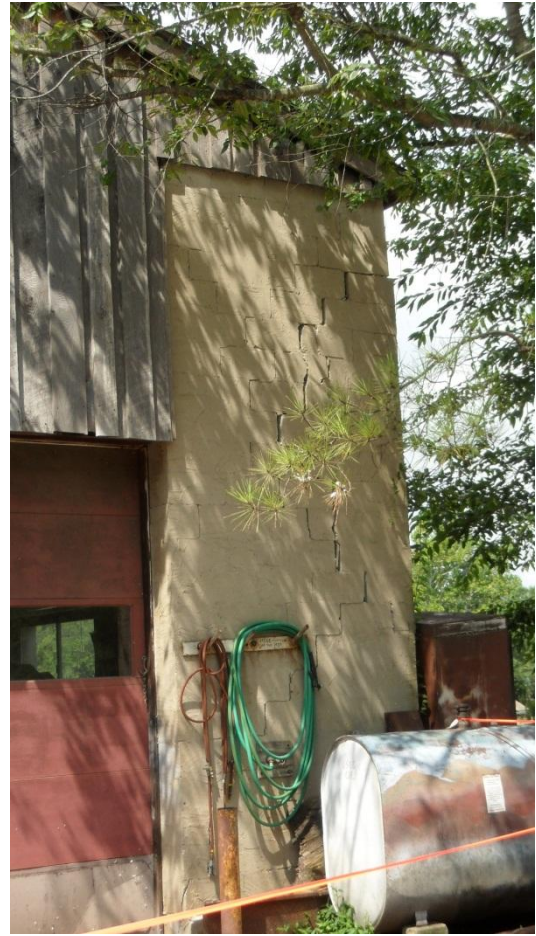
Figure 57. Damage to an unreinforced block garage structure (37.9314, -77.9903).

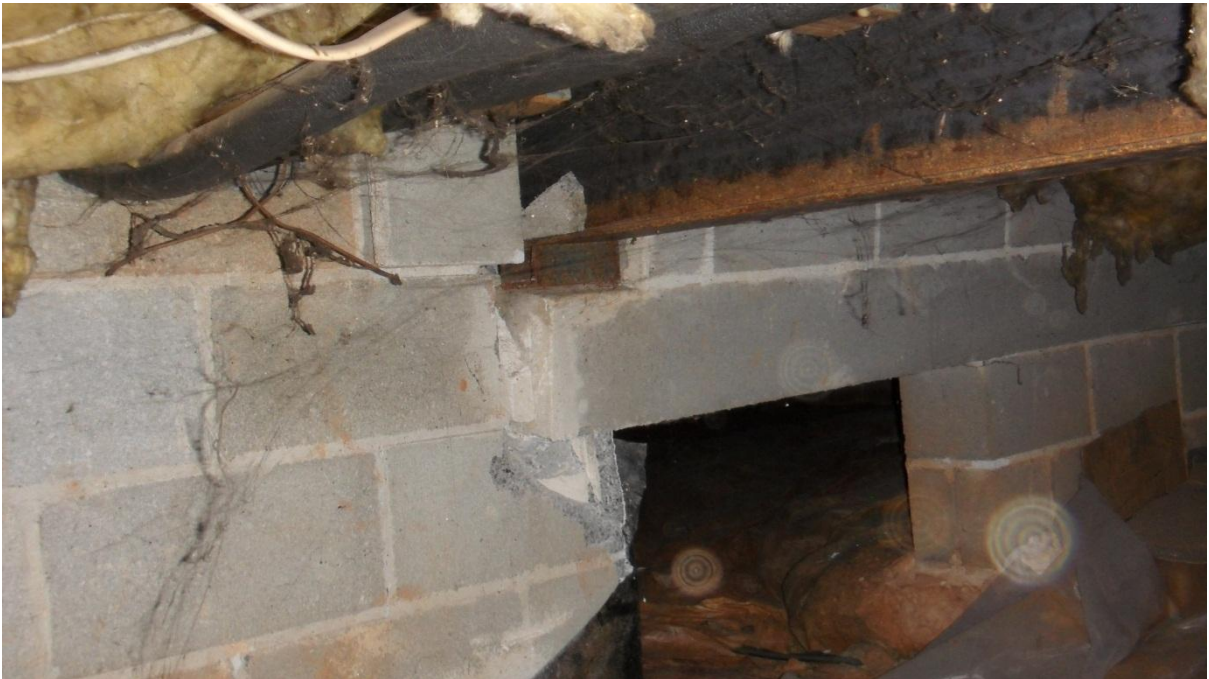
Figure 58. Damage to floor in dining facility (37.9306, -77.9898) caused by damage to unreinforced block foundation wall: (a) Crack in the tiled floor; (b) foundation wall below the crack in the tiled floor (note the broken block supporting the sill beam); (c) gap between sill beam and concrete block formed due to rotation of the sill beam resulting from the broken block supporting the sill beam.

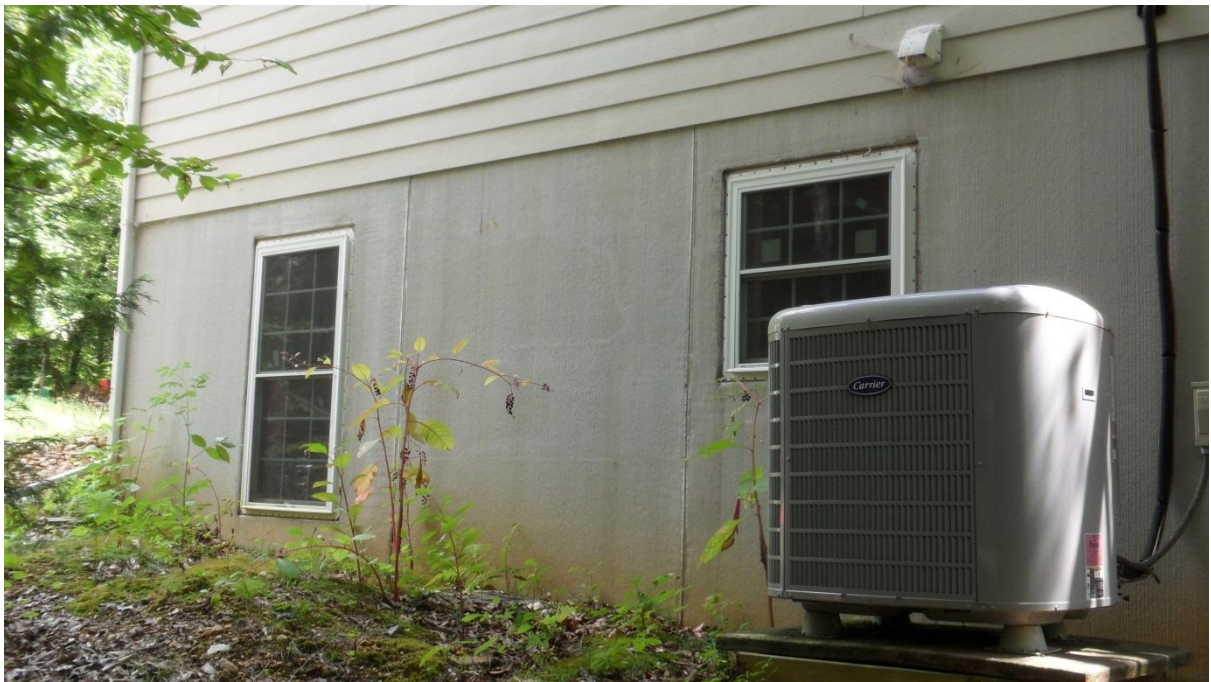
Team members inspected several houses on Bend of River Rd. The house shown in Figure 59 had a Superior Walls foundation system. The system consists of precast panels that are bolted together onsite. The owners of the house were home at the time of the earthquake and described the level of shaking as very intense. However, we could not find any damage to the foundation system.

Figure 59. Small house with a Superior Walls foundation system. We found no damage to the foundation system despite intense shaking. (37.95806, -78.00606)

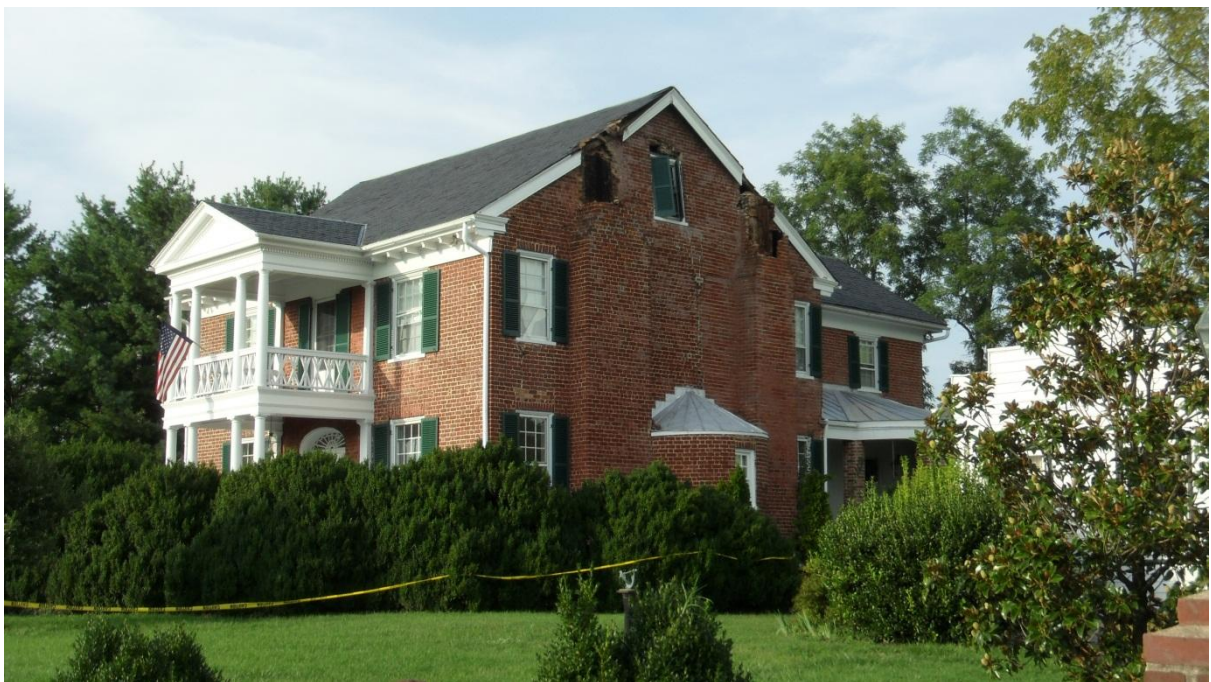
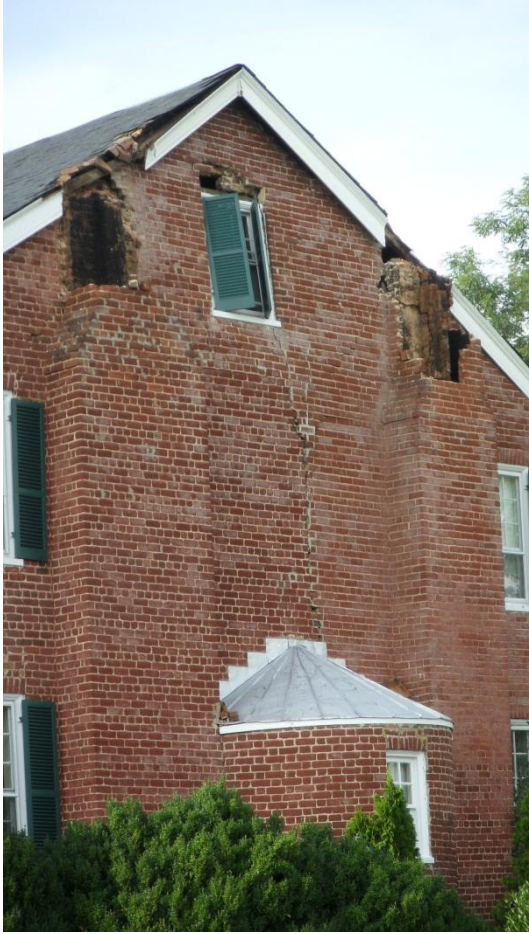
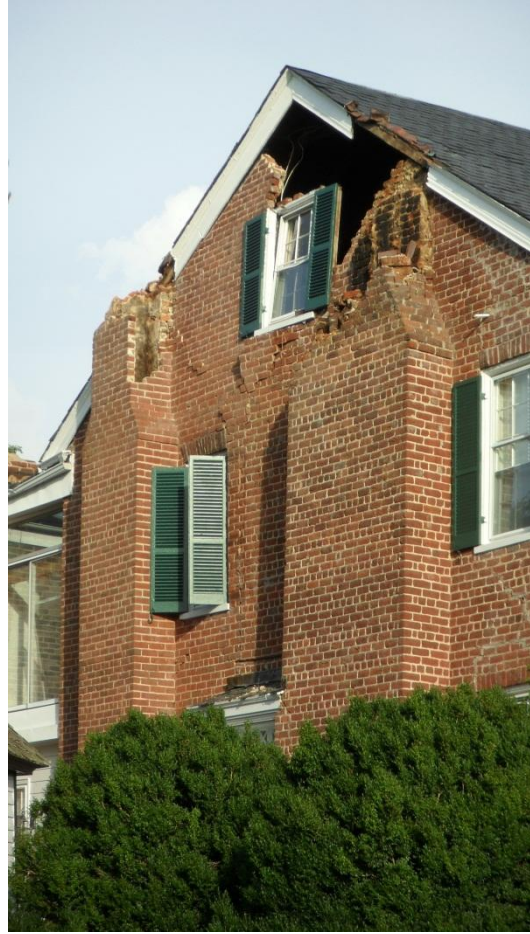
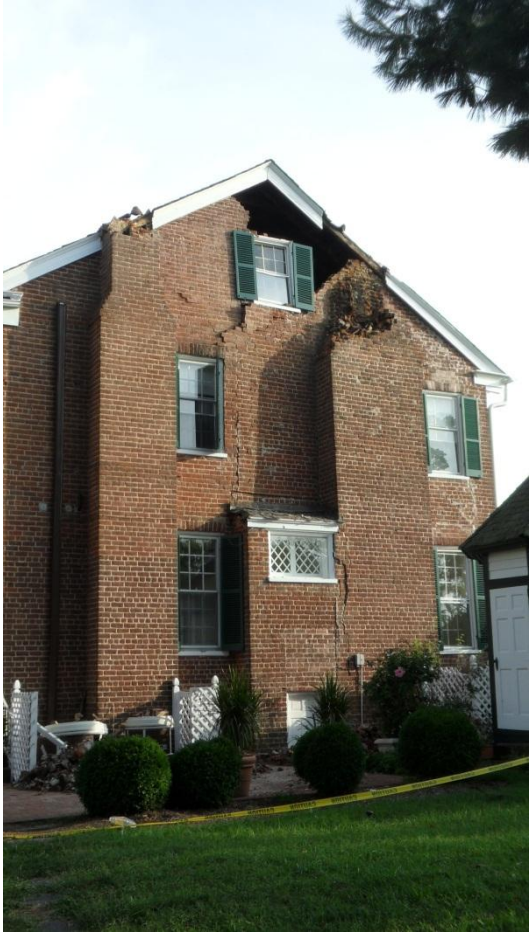
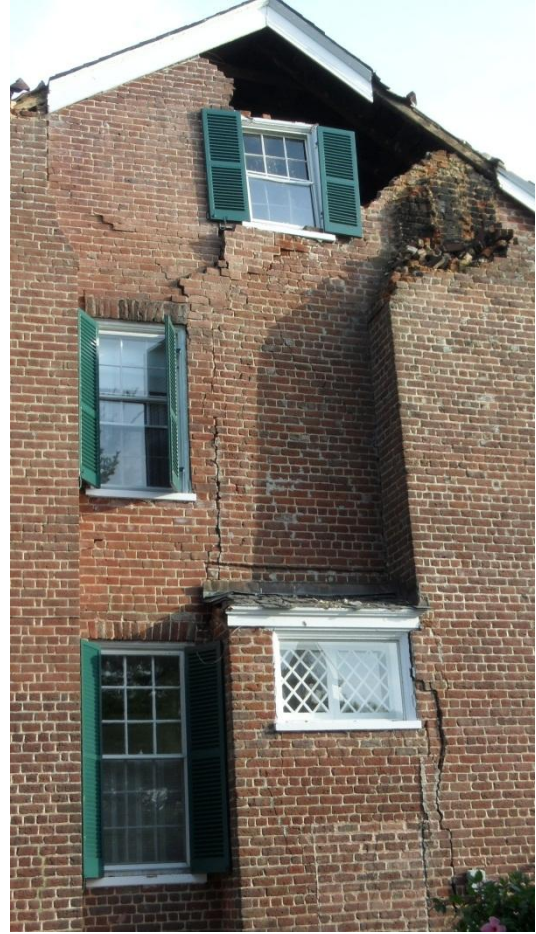
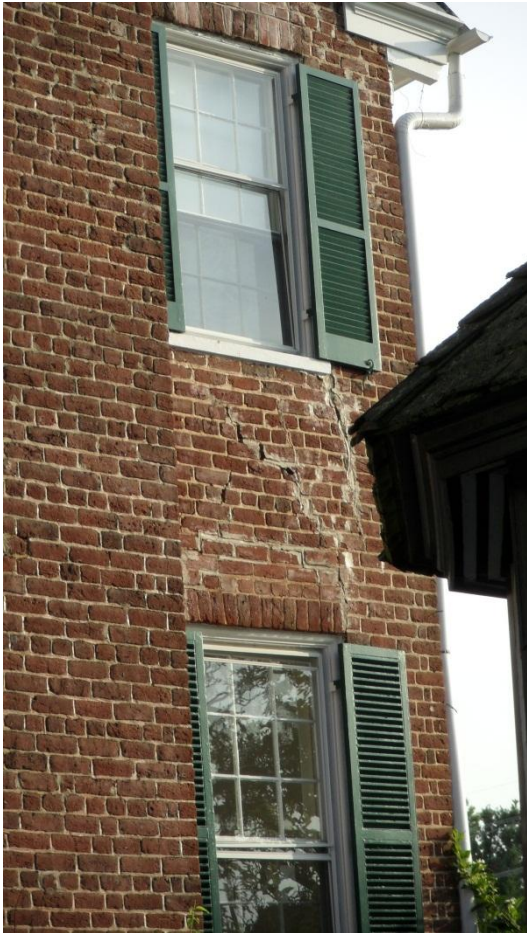
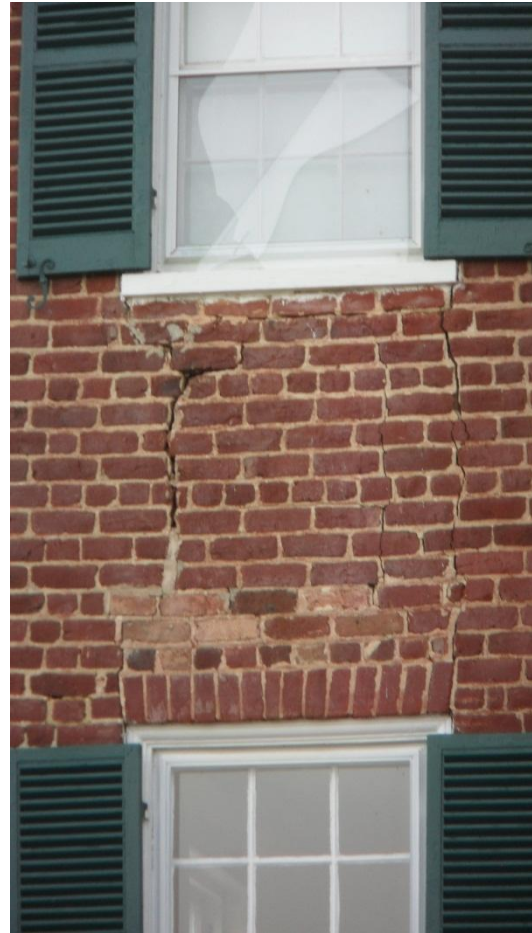
The Pendleton House was inspected on 26 August. The Pendleton House was completed in 1818 and is listed in the National Registry of Historic Places. Figure 60a is a photo obtained from the internet showing the house before the earthquake. The subsequent photos were taken on 26 August, after the earthquake. As may be observed from these photos, the brick chimneys and walls on both sides of the walls suffered significant damage. Team members were unable to inspect the inside of the house.

Figure 60. Pendleton House (37.95327, -77.89987), which is listed in the National Registry of Historic Places.

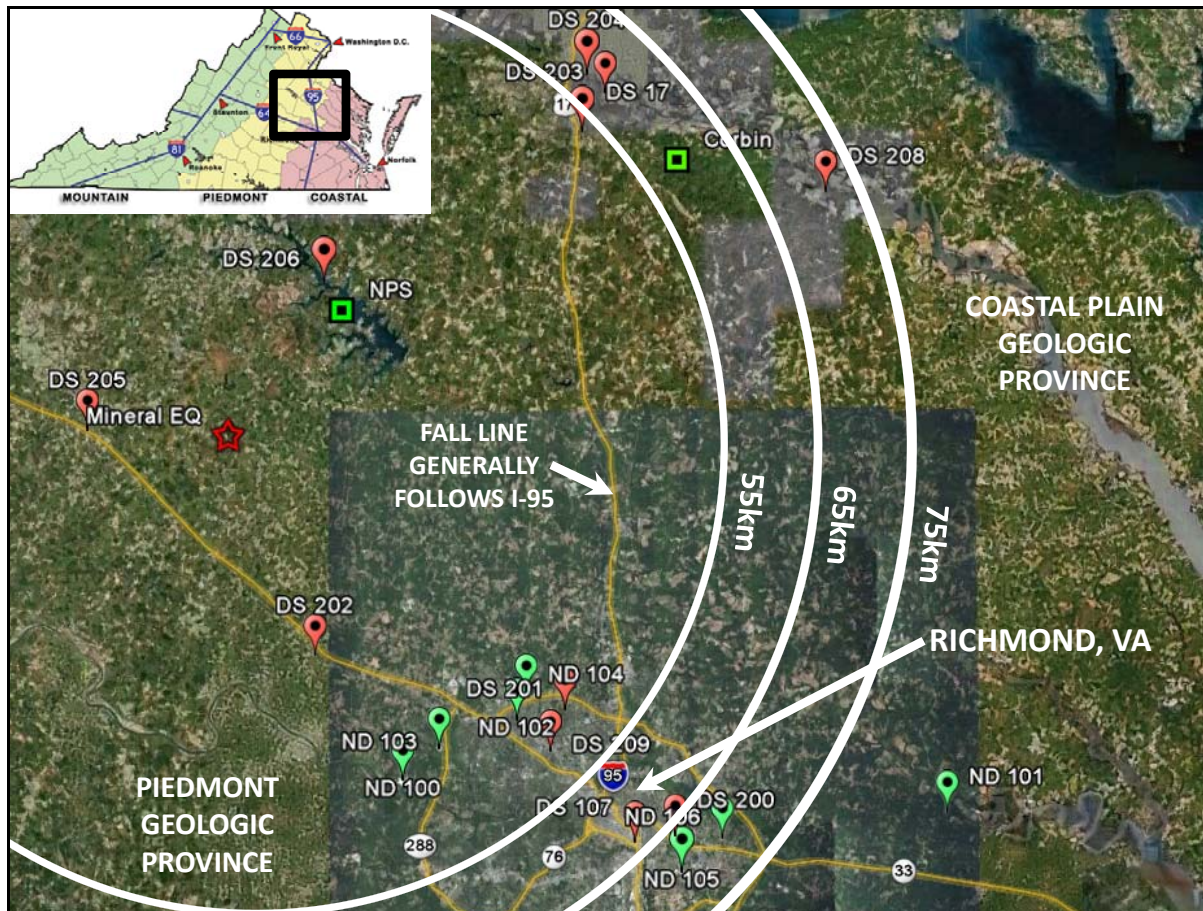
Regional reconnaissance involved limited site inspections by GEER team members guided largely by the observations of tens of other engineering professionals who reported very little in the way of ground failures. Primary attention was given to poor soil areas such as young alluvial deposits along rivers, creeks, and streams, including the James River. A summary of investigated sites is presented in Figure 5-1. Additional data for each site are available via the .kmz file on the GEER website.

**Figure 5-1 – Minor damage sites investigated by GEER in Richmond and Eastern Virginia.**
