# **H**AZARD **A**LERT **L**IVE **T**OMORROW

## Surface Mine – Near Miss

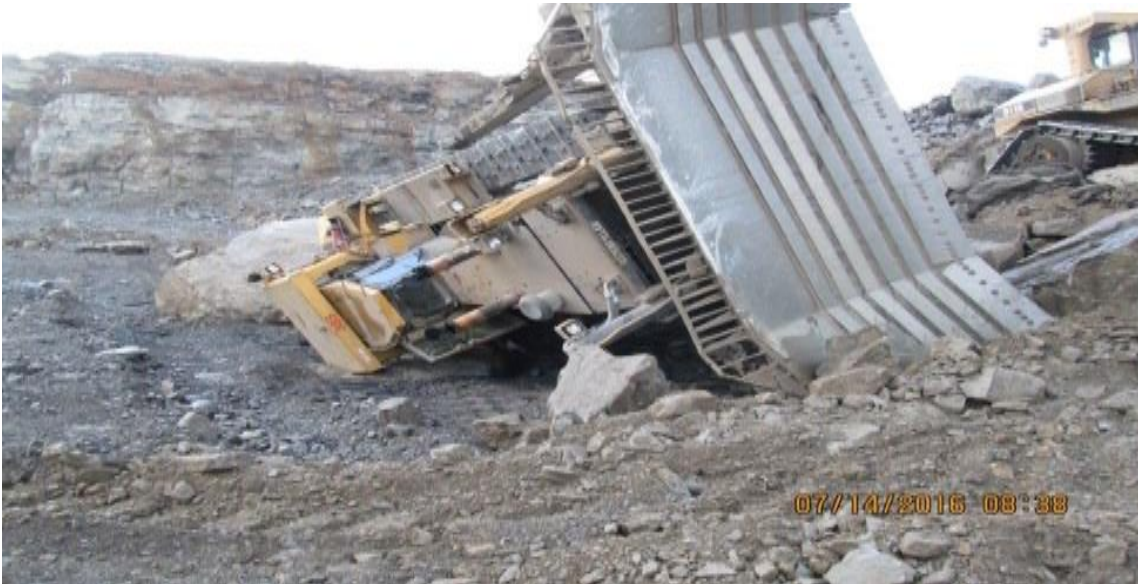
On Wednesday July 13, 2016 at approximately 4:00 a.m., a near miss accident occurred at a Wise County surface mine. A dozer operator was in the process of clearing a bench when the left corner of the dozer caught solid material. This caused the dozer to turn sharply. The right side tracks went over the bench and caused the machine to turn over. The operator was not injured.

- Conduct a risk analysis . Examine work areas to identify all possible hazards. Ensure that hazards are evaluated and eliminated so tasks can be performed safely.
- Benches (with roads and berms) should be wide enough to allow safe operation and passage of equipment. Remember the rule of thumb for roads . They should be at least two times the width of the largest vehicle when there is a single lane and three and a half times the width of the largest vehicle for dual lane traffic.
- Berms are used to keep people and equipment away from unstable/unsafe areas. Roads must have berms where there is a danger of overturning.
- Roadway berms must be big enough to “restrain “the largest piece of equipment working in the area.
- Regular safety meetings should be conducted with equipment operators regarding possible tipping and roll over situations.
