# **SAFETY ALERT BULLETIN**

## **CONTINUOUS MINER OPERATOR**

### **PINCH POINT ACCIDENT**

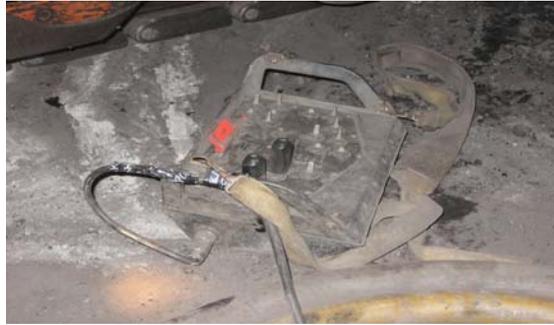
The injured miner was repositioning the continuous miner to complete the right side of the cut in the #2 entry, when he was caught near the cable handler/standoff and pinched between the machine and the right rib. The injured miner, who was alone, yelled for help. When other miners arrived the injured miner was on his knees, doubled over, facing out of the face and the continuous miner was de-energized. The remote control box had to be removed from between the injured miner's torso and legs in order to energize the continuous miner and move it in order to free the miner from where he was trapped, between the machine and the coal rib.

- When equipment is in operation or is being trammed, no miner should position himself or be placed in a pinch point between such equipment and the face or ribs of the mine.
- Always face in the same direction as the equipment being trammed by remote control.
- When performing any other tasks, such as moving the machine cable, while tramping a machine by remote control, de-energize the machine and place the remote control box in a safe area to keep from accidentally activating any operational levers or switches.
