HAZARD **A**LERT **L**IVE **T**OMORROW

ROOF BOLTER OPERATOR SERIOUS ACCIDENT

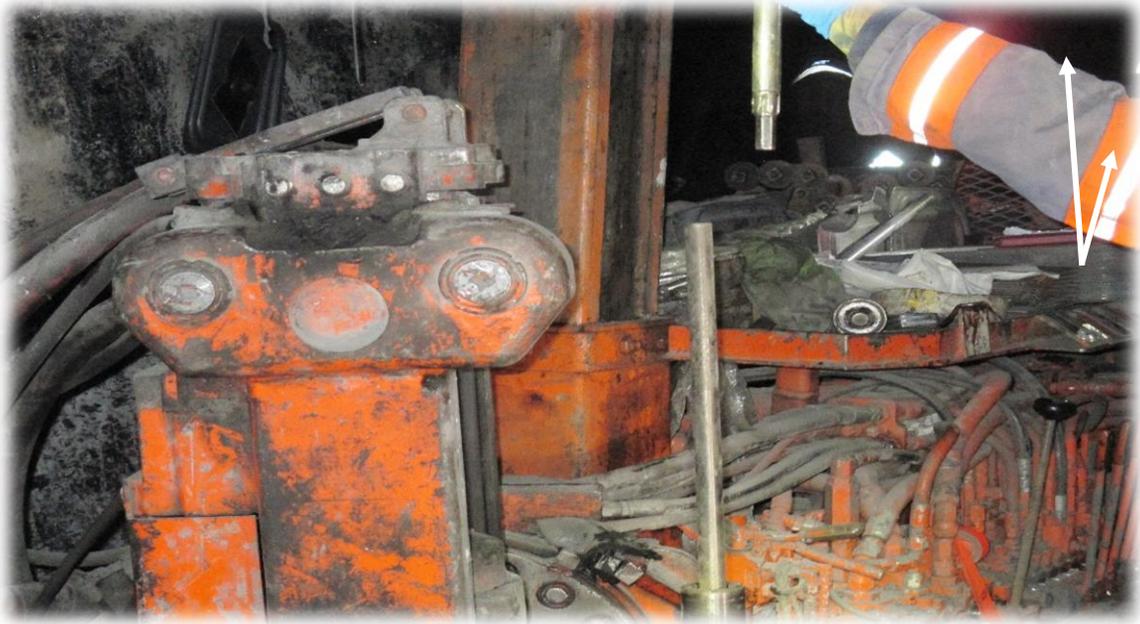
At approximately 5:00 A.M. on April 24, 2019 a serious personal injury occurred at an underground mine located in Dickenson County. The injured person was a roof drill operator with 13 years of coal mining experience and 10 years as a roof drill operator. He was seriously injured when his left arm was entangled in the rotating steel of the roof drill. The injured persons left arm was severed approximately mid-forearm. At the time of the accident, the injured person was in the process of drilling a hole for a cable bolt.

- * **Do not handle rotating drill steel.**
- * **Wear proper gloves and remove rings, watches and other jewelry.**
- * **Avoid wearing loose fitting clothing and materials.**
- * **Inspect drill steel, extensions and wrenches for jagged edges and burrs prior to using.**
- * **Always keep hands away from pinch points.**
- * **Ensure hands and clothing are free from drill steel before rotation is started.**
- * **Ensure there is proper alignment with drill steel and drill head.**
