## SERIOUS INJURY ACCIDENT: January 2010 Crane Helper Injured By Outrigger

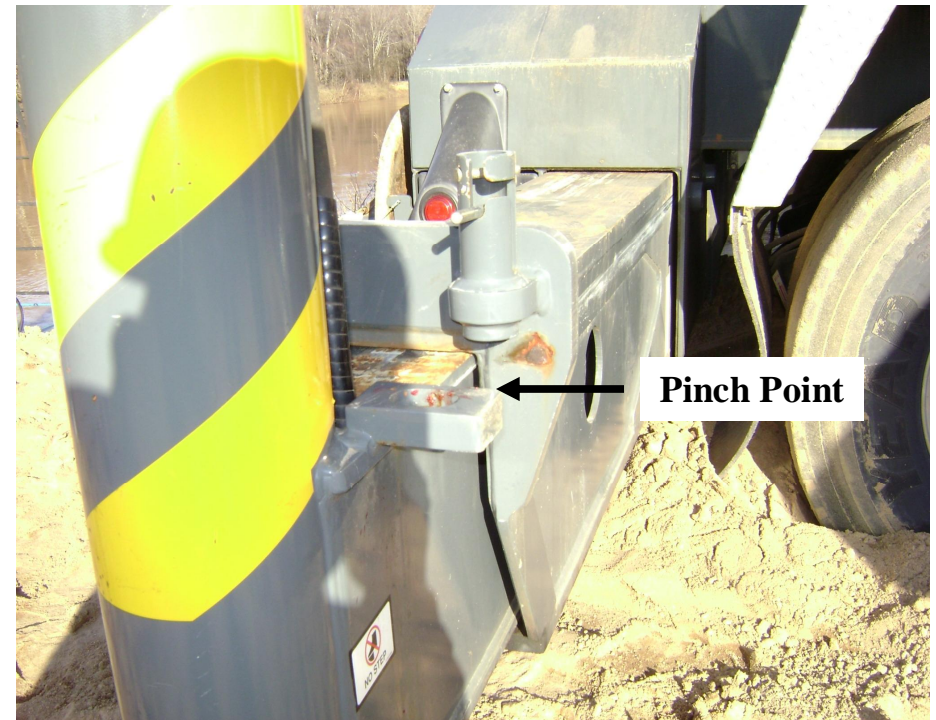
On January 19, 2010, a crane service employee with two and a half years of experience was seriously injured during the breakdown of a crane. The crane had completed setting a sand dredge in a river and the crew was breaking down the crane to leave the property. As the crane operator was retracting the right rear outrigger, the helper reached down to drop the pad off the outrigger. While reaching for the pad, he placed his left hand on the outrigger allowing his hand to be caught in a pinch point between the moving and stationary parts of the telescoping outrigger. The injured worker was hospitalized and treated for a broken and degloved thumb, broken little finger, and had surgery to repair tissue and nerve damage.

- The injured miner failed to follow safe operating procedures and placed his hand in a dangerous location (i.e., a pinch point).

Telescoping outrigger where miner was injured

- Re-evaluate or establish safe work procedures for each task and review them with the miners assigned to those tasks.
- Remind miners of their responsibility to inspect their work areas prior to starting work and frequently thereafter. Unsafe conditions are to be corrected or reported to the certified mine foreman.
- Miners must be alert and remain clear of moving machinery or equipment and avoid potential pinch points that may be present.
- Equipment operators must be certain that all persons are in the clear before starting or moving machinery and equipment.
- Review this accident and all contributing factors with all mine and contractor personnel.
