## SERIOUS INJURY ACCIDENT: January 2005 Plant Operator Caught in Machinery

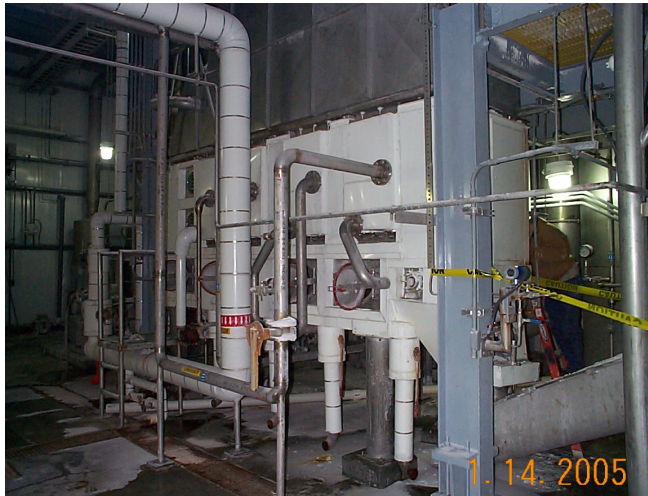
View of dryer assembly

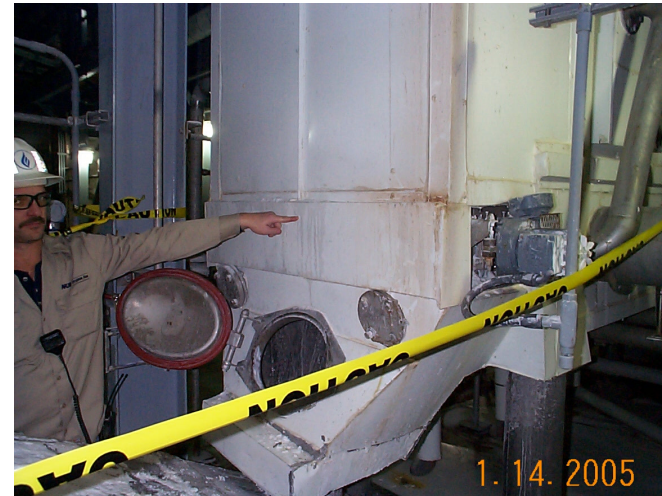
A brine processing plant operator was seriously injured when his left hand came in contact with the moving part of a rotary valve located inside a fluidized bed dryer assembly. The worker was looking into the dryer through the upper inspection doors to determine if it needed cleaning when his cell phone fell from his pocket into the dryer. Unable to see his phone from any of the inspection doors, he reached into the dryer and began feeling around blindly for the phone. While doing this, the fingers of his left hand contacted the moving rotary valve, which had been left in operation. The worker's hand became trapped in the valve, nearly severing four fingers. Co-workers had to manually reverse the rotary valve to free the injured man's hand. The man was admitted to a hospital where three of his four fingers were successfully re-attached.

Approximate location of rotary valve inside dryer

This accident occurred due to the injured worker's failure to follow proper safety procedures which would have included de-energizing, locking out and tagging the power source for the dryer prior to reaching inside.

- All miners should be reminded of the requirements in DMM safety regulation **4VAC25-40-2140** which include de-energizing electrically powered equipment and locking out and tagging power switches. This is to be done prior to activities where contact with energized machinery is possible.
