Serious Injury Accident: Contractor Seriously Burned

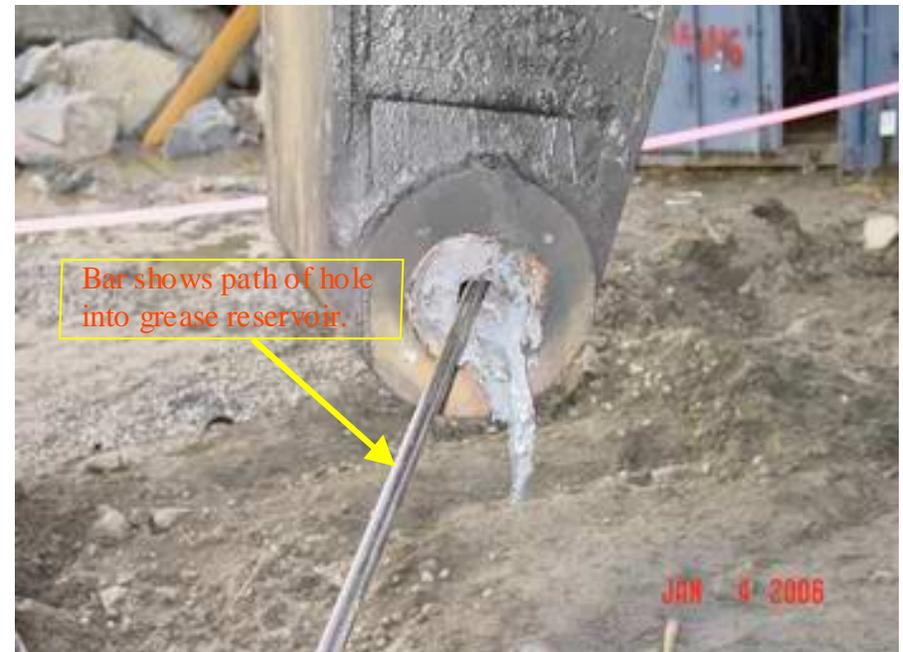
A contract equipment operator was seriously injured while performing maintenance on a Volvo EE460B excavator. The injured worker and a contract welder were attempting to remove a seized pin from the stick of the excavator by burning out the center of the pin with approximately 10-foot long burn bars. Throughout the process the burning bar would become unsecured in the holder and the assembly would separate. While the victim was holding/stabilizing the burning bar, the tip burned through the side of the pin into the grease reservoir located in the stick of the excavator causing grease to flashback into his face and setting his clothes on fire. The injured worker was hospitalized for 1st and 2nd degree burns to his face, neck and chest area, left hand and wrist, and legs, and possible respiratory burns. DMM's investigation determined that the injured worker had not been task trained to use a burning bar nor to perform the task that he was assisting with. The investigation also revealed that the injured worker and welder were not wearing fire resistant clothing, as required when working with molten metal.

The pin shown from the side of the flash

RECOMMENDATIONS: All miners must be trained in State and company safety regulations and task trained prior to being assigned a task or duty (4 VAC 25-40-100). Training must include the use of proper personal protective equipment such as fire resistant clothing and face shields or goggles, which is required to be worn when working with molten metal (4 VAC 25-40-1750). Foremen and supervisors should provide clear, concise instructions when making task assignments and request feedback to ensure that the instructions are understood. The Division of Mineral Mining requires that defective equipment, such as the burning bar in this incident, must be taken out of service immediately and not used (4 VAC 25-40-360).
