## SERIOUS INJURY ACCIDENT: May 2009 Contractor Employee Injured Crossing Silt Fence

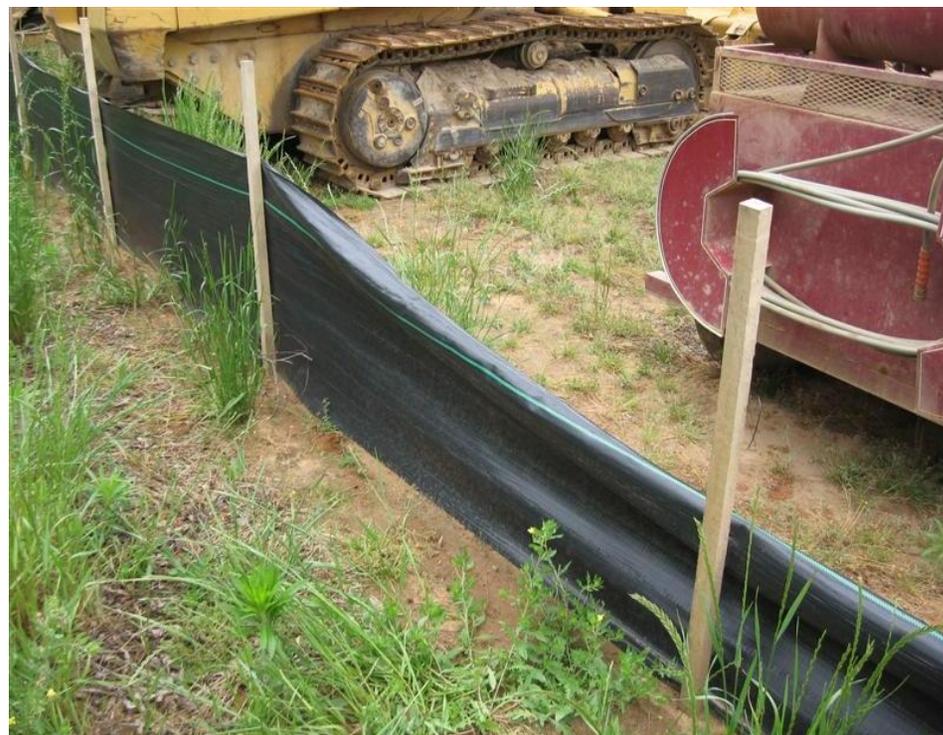
A contractor employee with eleven years of mining experience was seriously injured when he attempted to step over a silt fence, caught his right foot in the fence, and fell forward. He landed on the side of his right foot dislocating and tearing the ligaments in his right ankle, and breaking both the tibia and fibula just above the ankle. The silt fence was located in a grassy yard area between an equipment parking area and newly established parking area for contractor employees. The contractor employees who parked in the new parking area had established a path through the yard from the parking area to the equipment lot that required them to step over the silt fence at a location in the fence where it had come loose from the support stakes and folded over (similar to that shown in the photograph below). An unobstructed gravel road located approximately 85 feet from the accident scene could have been utilized as a travelway instead of the “short-cut” across the yard and over the fence.

Section of silt fence similar to where the accident took place.

- The accident and all factors that led up to it should be reviewed with all mine employees.
- Operators and contractor management should review related Division of Mineral Mining Safety Alerts and MSHA’s “SLAM” program with all employees. Employees should be trained in safe procedures for dealing with travelway obstructions including silt fence, process water lines, power cables, and others.
- Employees should be reminded of their responsibility to examine their work areas prior to starting work and frequently thereafter. Unsafe conditions should be corrected or reported to the certified foreman (4VAC25-40-460).
